# WEEKLY INCIDENT SUMMARY

Week ending Friday 15 October 2021

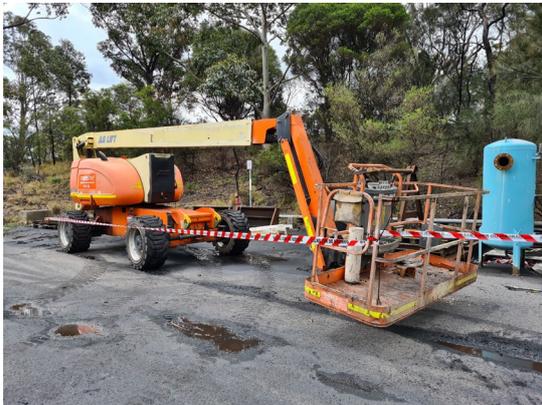
INCIDENT TYPE	SUMMARY	COMMENTS TO INDUSTRY
Dangerous incident IncNot0040901 Coal processing plant

<p>A team of fitters were replacing a hydraulic cylinder above a conveyor. A hired elevated work platform (EWP) was required to access the cylinder. The EWP basket was moved into position to allow</p>	<p>Mechanical engineering control plans must set out the control measures for the unintended operation of plant. This must include function testing as part of the introduction of plant to site process and pre-use inspections by operators.</p> <p>Refer to: <a href="#">SB15-04 Collisions of mobile elevated work platforms increase</a></p>

removal of the old cylinder. After releasing the joystick (while the operator's foot was still on the deadman switch), the basket moved up approximately 200 millimetres. The safety bar contacted the cylinder support structure, which activated and stopped the EWP. The fitters were standing beside the cylinder support structure. No personnel were injured during this incident.

The investigation found the boom control joystick locking collar was not functioning correctly. The locking collar requires the operator to lift the collar before selecting a function to prevent accidental activation. The grub screw that secures the top of the joystick was missing, allowing the mechanism to partly unscrew. As a result, the function could be activated without lifting the locking collar, resulting in an unplanned movement.

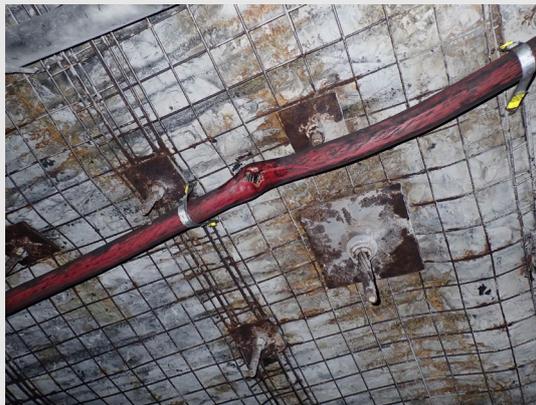
Dangerous incident  
IncNot0040868  
Underground coal  
mine

A high voltage cable supplying a conveyor starter in an underground coal mine was found to have impact damage. The PVC outer sheath was damaged and the armouring distorted, exposing the internal lead sheath. It was discovered hanging from the roof about one metre from the rib. A duckbill carrying an air track was sitting underneath the cable.

When developing control measures to manage the risks associated with roads or other vehicle operating areas, the placement of services that may be exposed to risk of damage such as cables and pipelines must be considered. Factors for consideration include:

- roadway height and width
- height and width of loads that are required to be transported in the roadways, including the effect of bumps and dips with overhanging loads
- positioning of cables and other services suspended from the roof
- effect of roadworks that may alter the effective roadway dimensions over time.
