**NSW  
Resources  
Regulator**

**CAUSAL INVESTIGATION REPORT**

# **PIN EJECTION INCIDENT**

**Ravensworth Open Cut Mine**

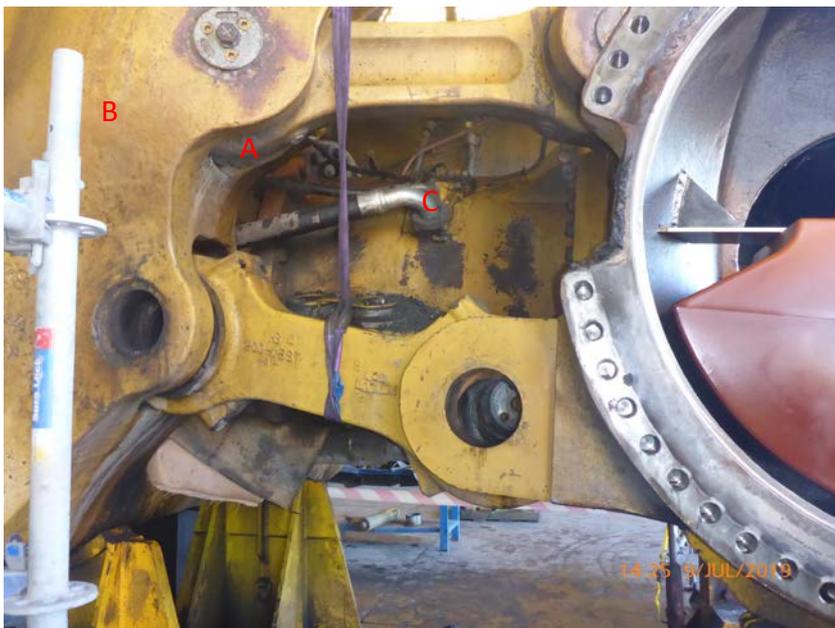
Figure 1 Left hand side lower link and pin assembly (A), front pin location (B), rear pin location (C)

Before the incident, the haul truck has lost oil from the front pin bearing of the lower left-hand side rear suspension link (see figure 1). The oil is normally retained by seals installed on both sides of the bearing in the link. Failure of the seals, resulting in the loss of lubricating oil, has occurred with enough regularity to warrant releasing a Caterpillar technical information bulletin TIBU7881-00 dated 10 February 2015. The bulletin advised haul truck operators of that model truck to fill the oil cavity with grease until the seals could be replaced. This was done to the haul truck involved in the incident, but the mine was unable to confirm how long before the incident this occurred. Prolonged operation with grease was not advised in the bulletin because of the potential for bearing failure. There was no indication that the bearing had failed in this case.

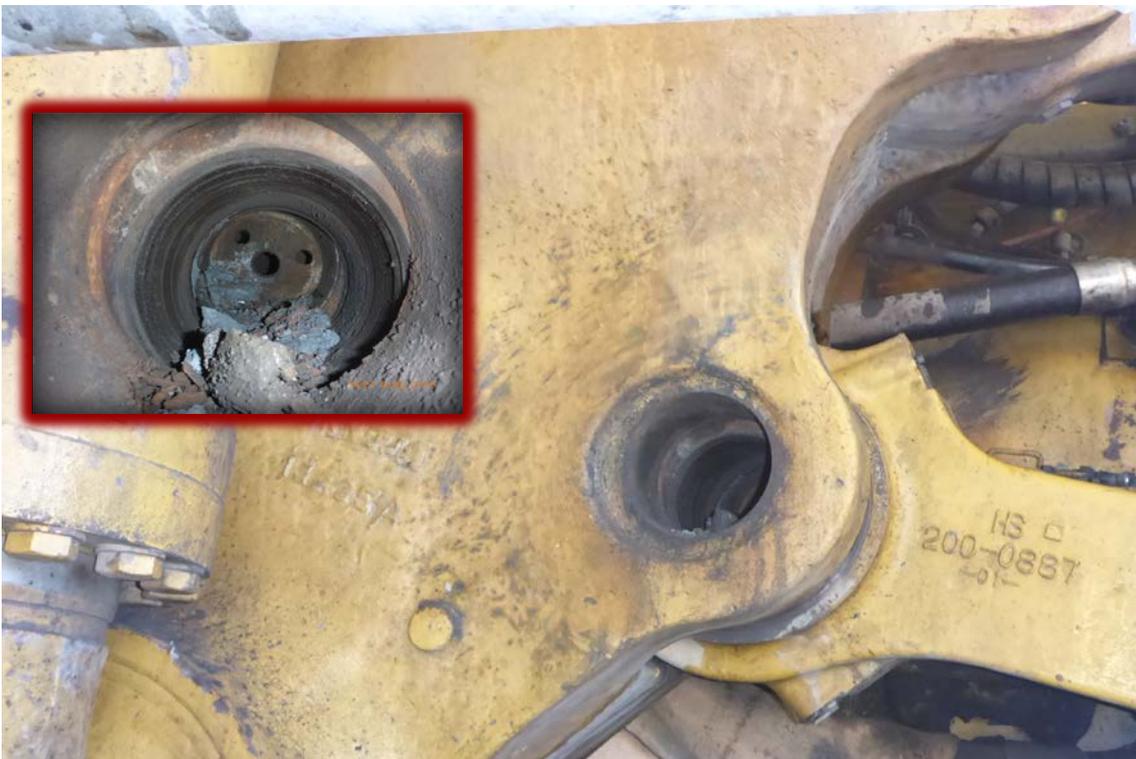
Figure 5 Pin bore with slag remnants

- The inner collet remained in position and slag was found to be covering one of jacking screw holes (refer to Figure 5).
- Video footage from the workshop cameras showed the moment the incident occurred.

Important indicators to the rapid expansion were the creation of the void behind the pin, the deposit of very hot slag into that void, and the addition of water into the void. This rapid expansion, coupled with the limited passage for the steam to exit, would have resulted in a build-up of pressure behind the pin. Coupled with a weakened bond between the pin and bearing, the build-up of pressure overcame the frictional resistance to expel the pin.
