Bellbird Colliery

A HISTORY OF THE EVENTS LEADING TO AN
IGNITION OF INFLAMMABLE GASES DURING
THE ATTEMPTED RECOVERY OF A DISTRICT
PREVIOUSLY SEALED BECAUSE OF A
SPONTANEOUS HEATING

R. A. MENZIES

DMR 1962 CF2

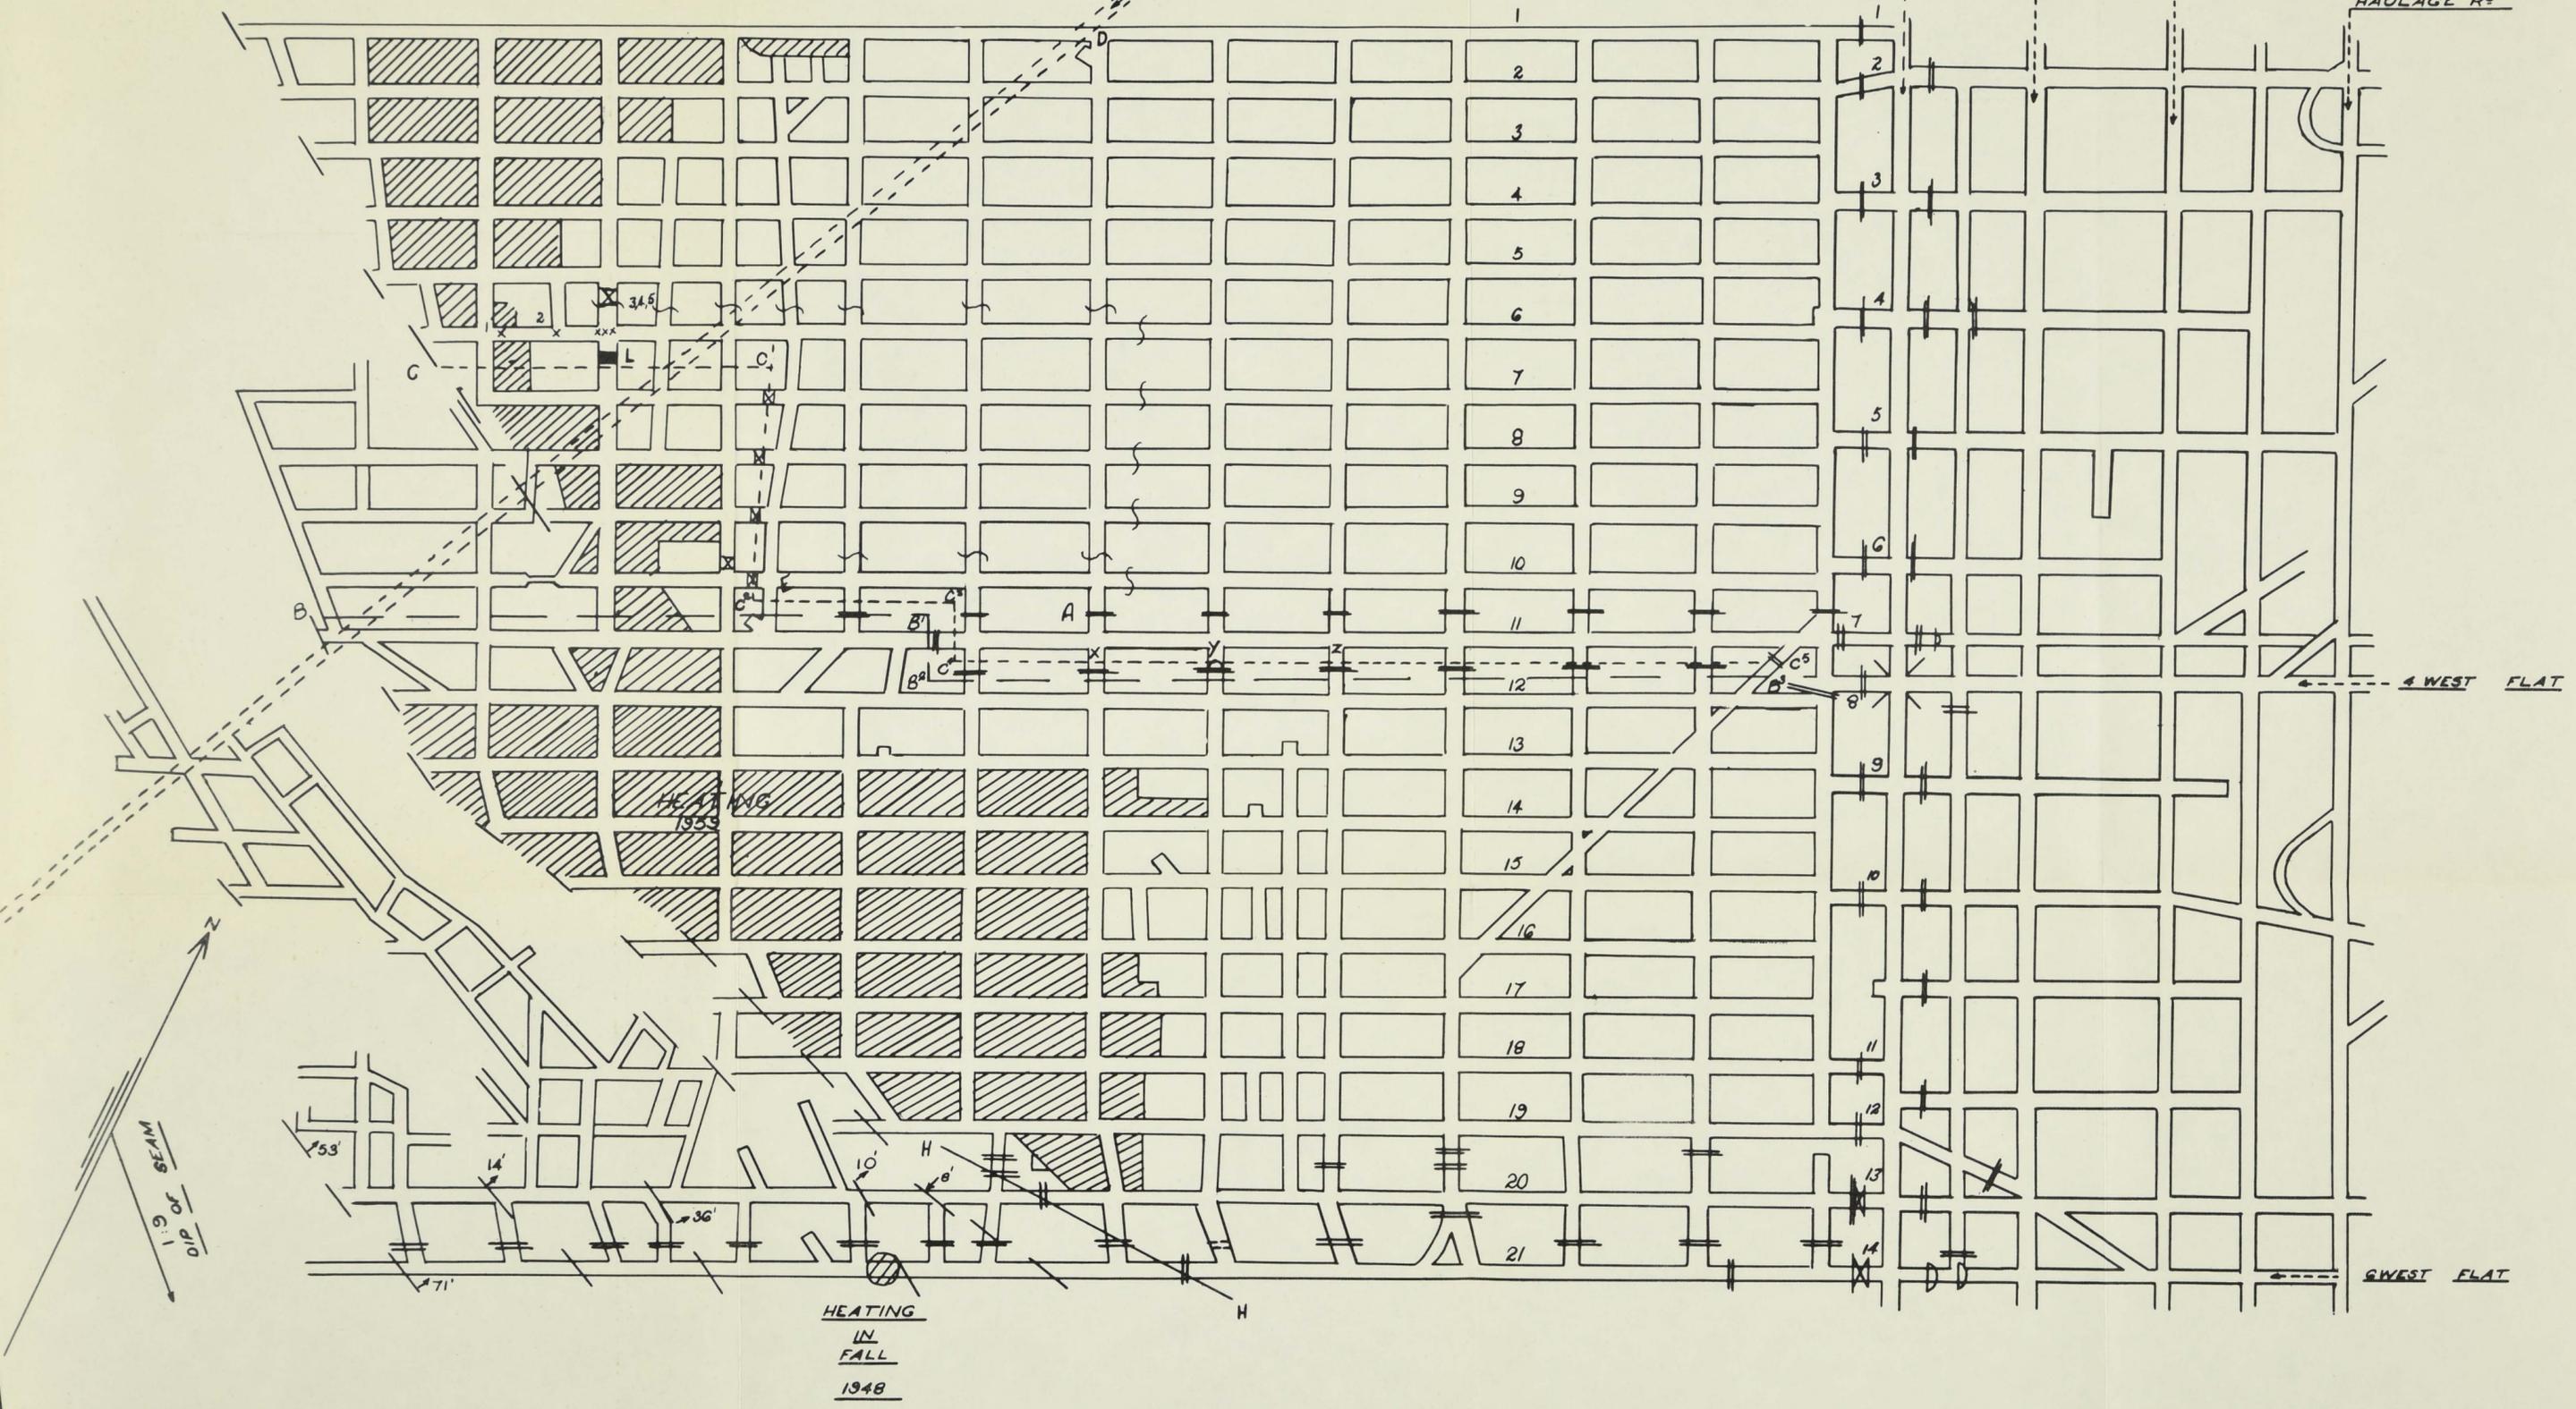
BELLBIRD COLLIERY
N°4 & N°6 WEST SECTIONS N°1 TUNNEL
SCALE: 2 CHAINS = 1 INCH

About the year 1948, a spontaneous heating was detected in a fall in the bottom level of 6 West district in the approximate position shown on the plan. This heating was contained by the sealing of the entire area comprising 4 West and 6 West districts.

In March of 1958, some twelve or thirteen pillars of coal were recovered by an operation which resulted in the containing of the original heating on 6 West level by the seals along the line HH shown on the plan.

Depillaring continued in the area until June, 1959, when a heating was detected in the section and it appeared that the heating was centred in the area indicated on the plan. Unsuccessful attempts were made to isolate this heating and finally the whole area was sealed in July, 1959. This sealing was effected by the line of seals on the inbye side of the West Return (*see* plan) and numbered 1 to 14. Here the position rested until January, 1961, when the area had been closed for some 18 months.

The exploration indicated that the air when entering at No. 7 seal had presumably travelled along the level from No. 7 seal, in along No. 11 level or bord, through holes in stoppings at X, Y and Z, over the goaf in which the heating was assumed to exist and from there by devious means to the seal No. 1 at No. 1 level or bord.

Although conditions were oppressive and small quantities of CO were present, no undue difficulty was experienced until position L on line CC¹ was reached. It was apparent that this was acting as the main return from that area in which the heating existed. At position L it became obvious that a seal could not be erected in fresh-air conditions.

This seemed to indicate a worsening of the position and this was borne out by traces of smoke being detected coming through breaks in the rock rib at point E on the plan.

An investigation at this point indicated that what had been thought to be a normal cut-through driven to the 8-foot parting was, in fact, a cut-through opened to the 18-foot parting and what was thought to be a solid rock rib was, in fact, a mere shell. When this shell was broken smoke poured from the area.

Work continued on increasing the thickness of this seal and ramming the loam tightly to attempt to form a completely effective seal until about 8 o'clock that evening whilst some men, including an overman and a deputy, were still at work, tongues of blue flame were seen emanating from the seal near the roof.

There appears little doubt that the flames which were seen were caused by the ignition of inflammable gas (possibly methane) within the sealed area and that the flames passed through the seal and were finally extinguished when the fuel supply was diluted as the inflammable gases passed through the seal.

- (d) As the sealing at E became more effective these gases were retained within the area until the build up was sufficient to allow them to be ignited by the hot material at the seat of the fire.
