# SAFETY BULLETIN

## In-Service failures of explosion protected diesel engine systems during 2010 and 2011

# In-Service Failure of Explosion-Protected Diesel Engine Systems (ExDES)

January 2010 - October 2011

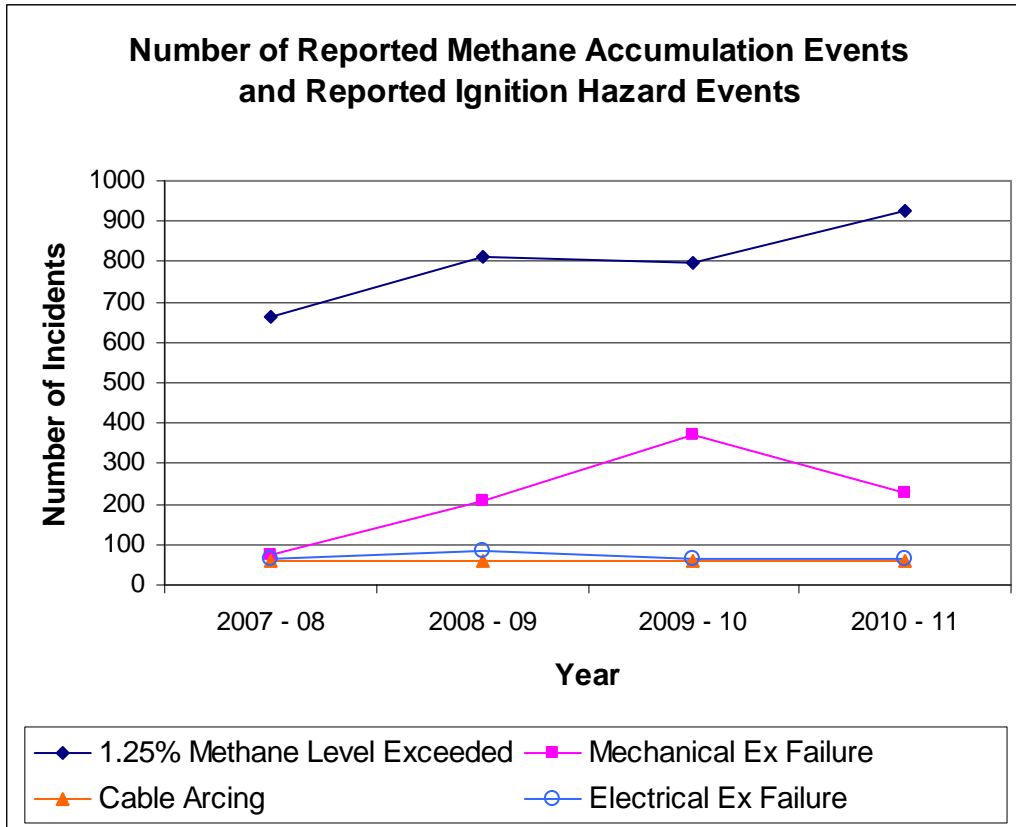
Figure 1 below shows a graph of the reported numbers of such methane events and incidents from underground coal mines in NSW.

Figure 1 shows that the number of reported Ex DES failures (mechanical Ex failures) is significantly greater than the number of reported Ex electrical failures. The figure also shows an improvement in the number of ExDES reported failures in the last 12 months.

Last year there were 230 ExDES failures and 65 Ex electrical failures reported. This conservatively<sup>1</sup> equates to an annual probability of failure of –

- 23% for each ExDES item
- 0.12% for each Ex electrical items

This means last year an individual DES was about 190 times more likely to have failure of its explosion protected characteristics than an individual explosion protected electrical item.

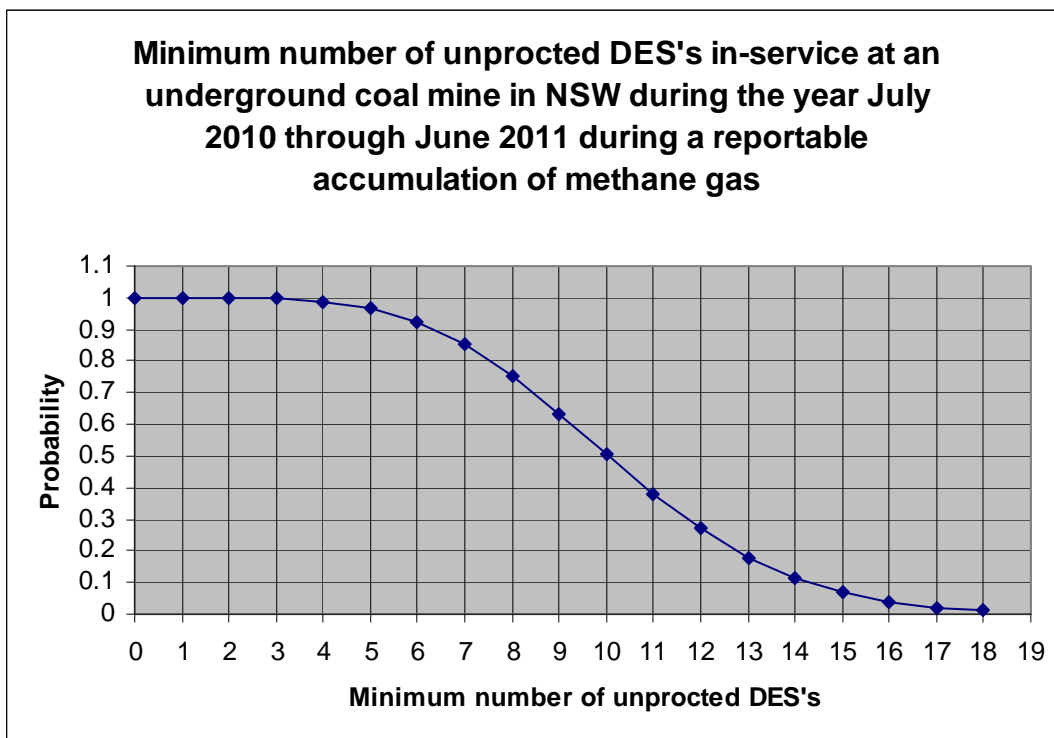
**Figure 2**

Figure 2 below shows it can be reasonably assumed<sup>3</sup> that in NSW last year –

- There was greater than 90% probability that there were 6 or more occasions when a diesel engine was in-service with failed explosion-protection characteristics during a reported accumulation of methane gas in an underground coal mine.
- There was a 10% probability that this occurred 14 or more times.

<sup>3</sup> Figure 2 uses foregoing assumptions and also assumes 900 reportable methane accumulations. Values were calculated using the binomial probability equation.

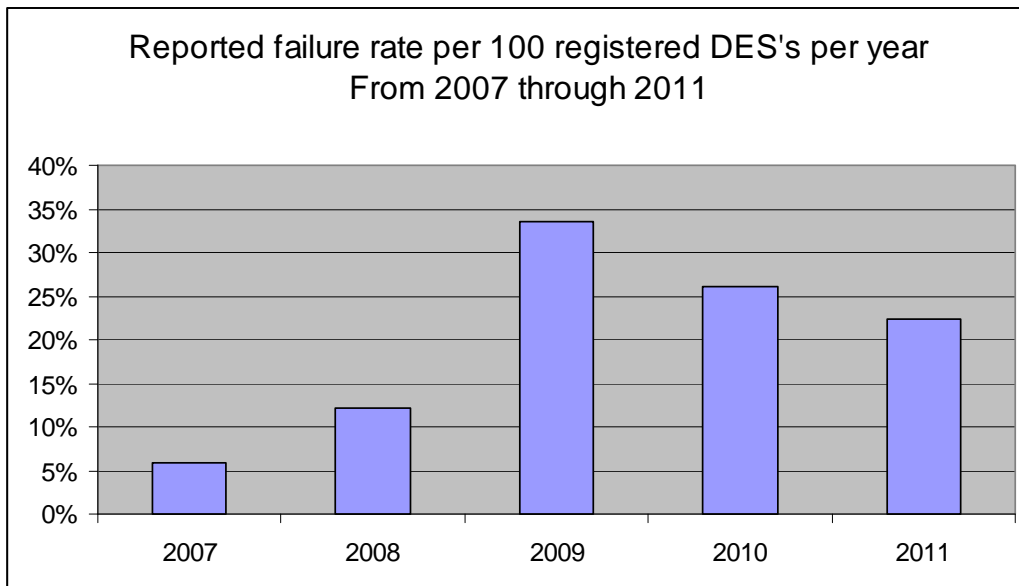
**Figure 3**

Figure 3 below shows the percentage of ExDES's that failed during each year.

The failure rate shows a pleasing decline since 2009<sup>4</sup>.

It is believed that from 2007 to 2009, the proportion of actual incidents reported increased. Anecdotal evidence from industry members suggests the number of incidents may still be under-reported.

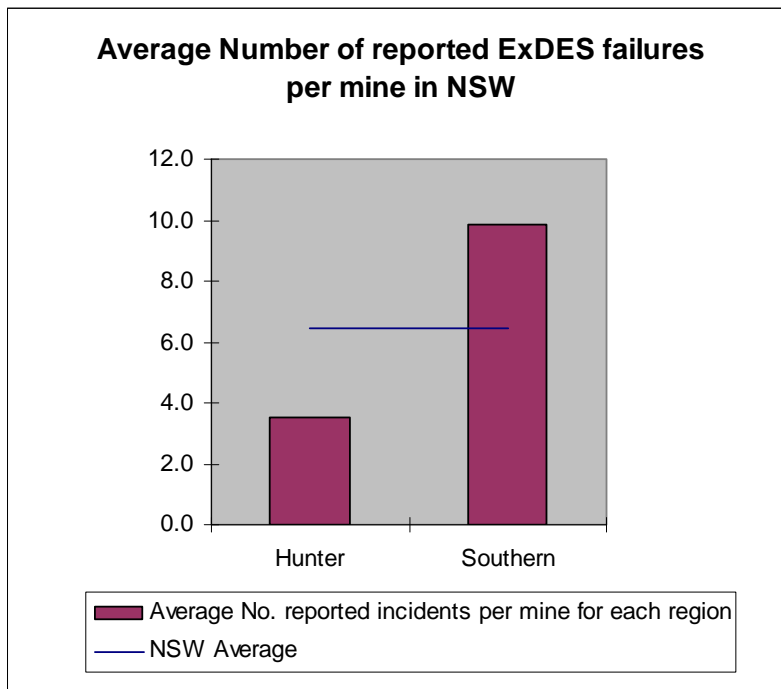
Figure 4 Regional Reporting

Figure 4 below shows the average number of reported ExDES failures per underground coal mine in NSW by region for 2011. This supports anecdotal evidence that Southern mines are more diligent in reporting actual incidents.

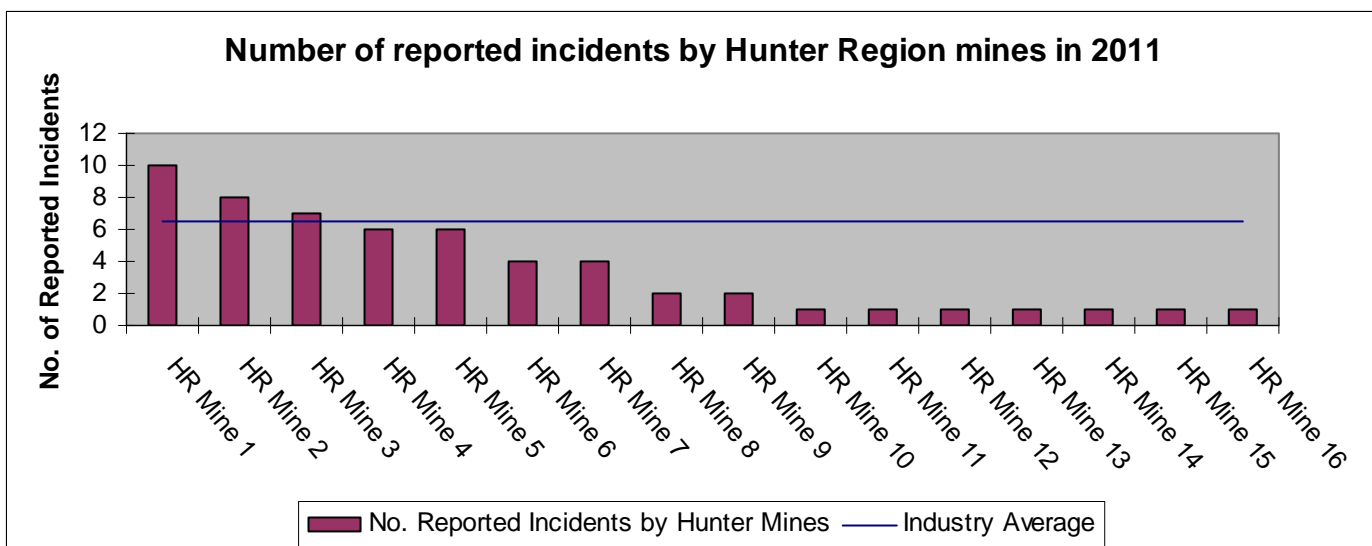
Figure 5 Hunter Region Mine Reporting

Figure 5 below shows the number of ExDES failures reported by Hunter region mines. Most Hunter region mines report below the industry average number of ExDES incidents. The highest reporting mines report 10 times more incidents than the lowest. Is the high variation due to unreported incidents at the lowest reporting mines?

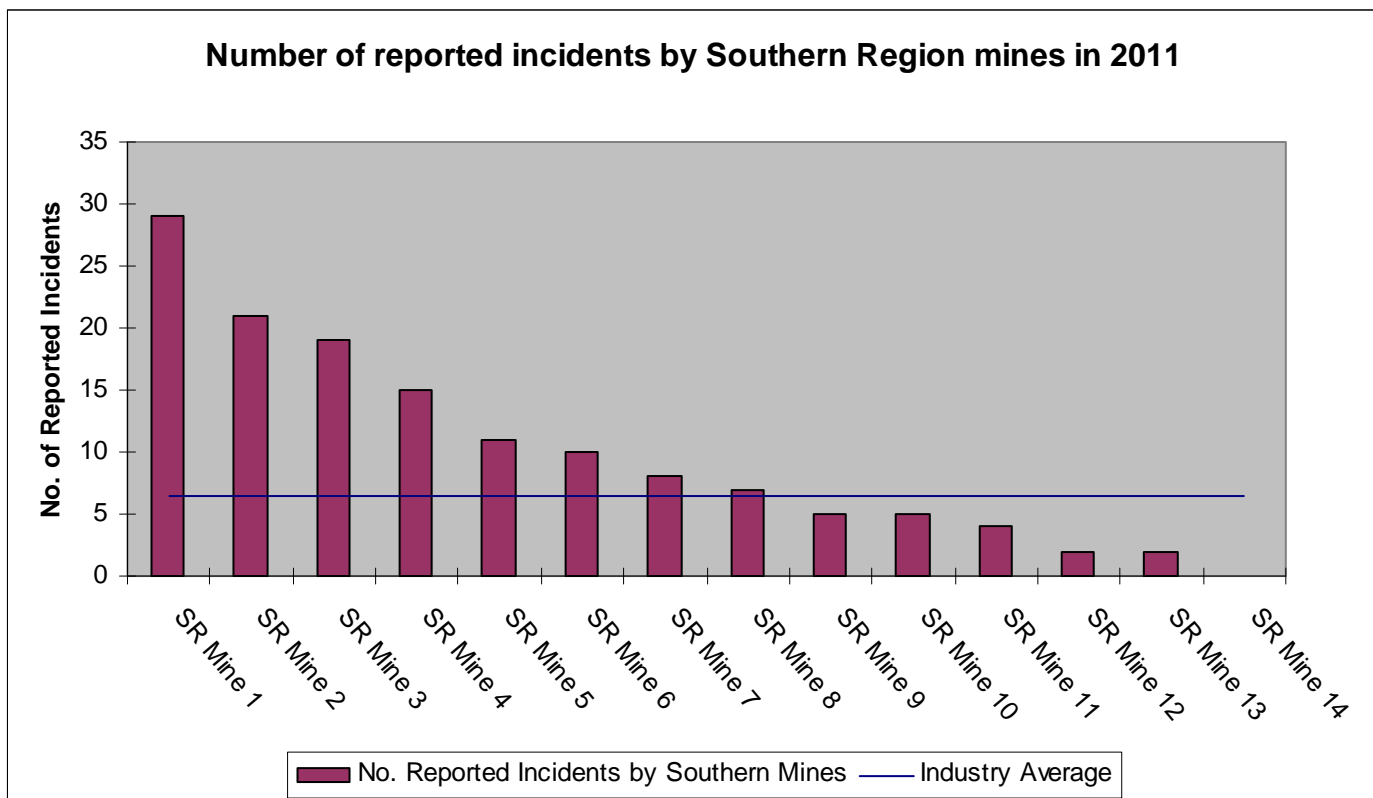
**Figure 6 Southern Region Mine Reporting**

Figure 6 below shows the number of ExDES failures reported by Southern region mines during 2011.

A majority of Southern region mines have an above average incident reporting rate. The highest reporting mines report over 10 times more incidents than the lowest. Is the high variation due to under-reporting of incidents at the lowest reporting mines?

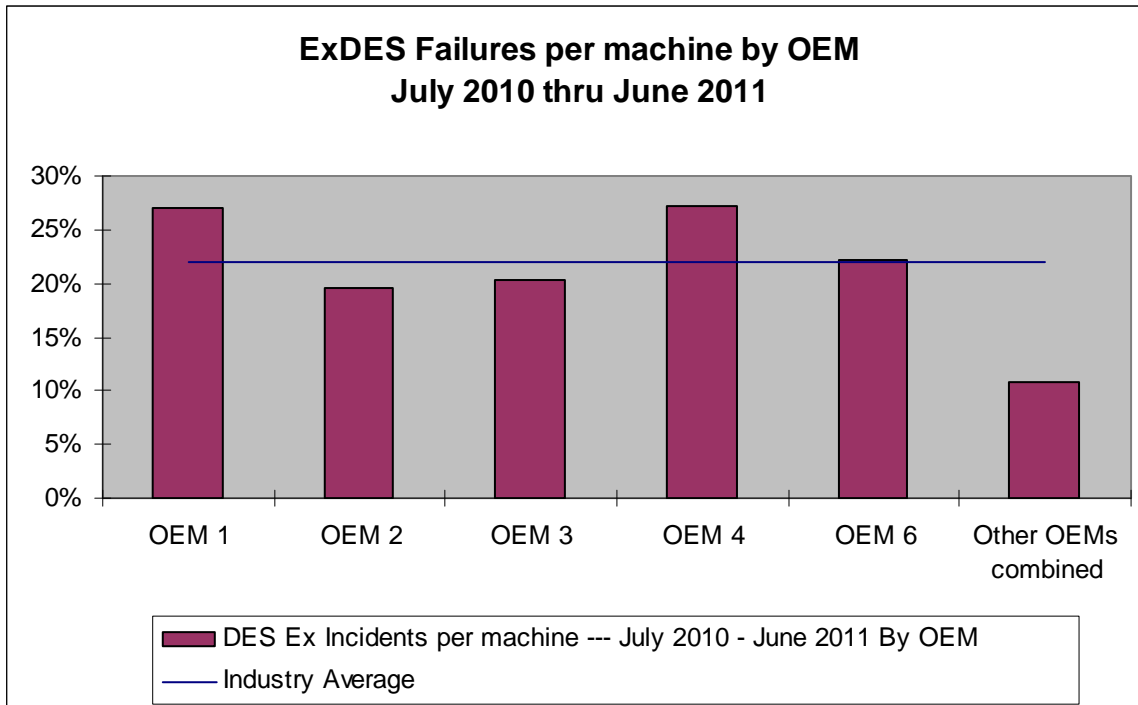
Figure 7 Failure rate by OEM

Figure 7 below shows the likelihood of ExDES failures for the major OEM's for the year July 2010 through June 2011.

The industry average is 22%, or 22 failures per 100 machines in service per year.

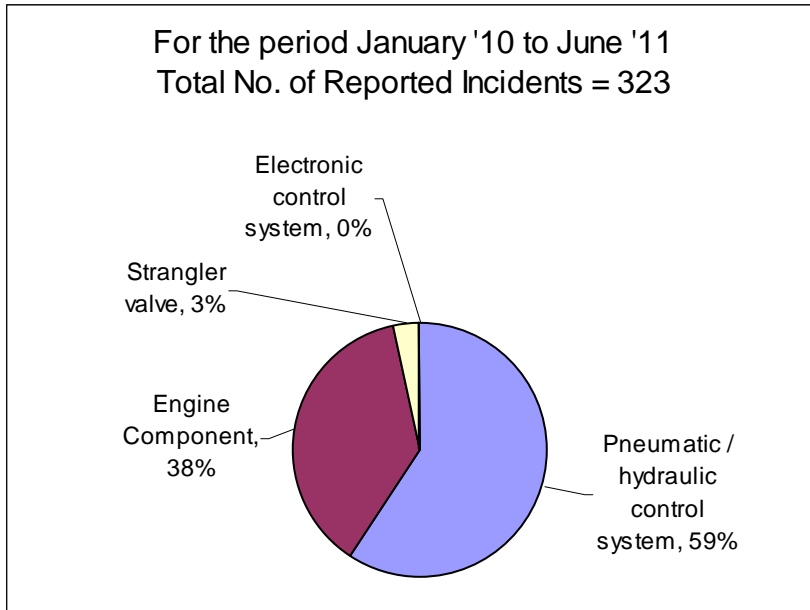
**Figure 8**

Figure 8 below shows a breakup of the reported failures for the year January 2010 through October 2011<sup>5</sup>.

- 59% were a failure of the control system to keep the DES in an explosion-protected state.
- 38% occurred in a major DES component.

While not strictly reportable, 3% of reported incidents related to a failure of a strangler valve to shut down the engine.

The data contained no reported incidents of the failure of an electronic control system to keep the DES in an explosion protected state. This suggests that if electronic control systems were used in all diesel engine systems, the best part of 59% of failures could be reduced.

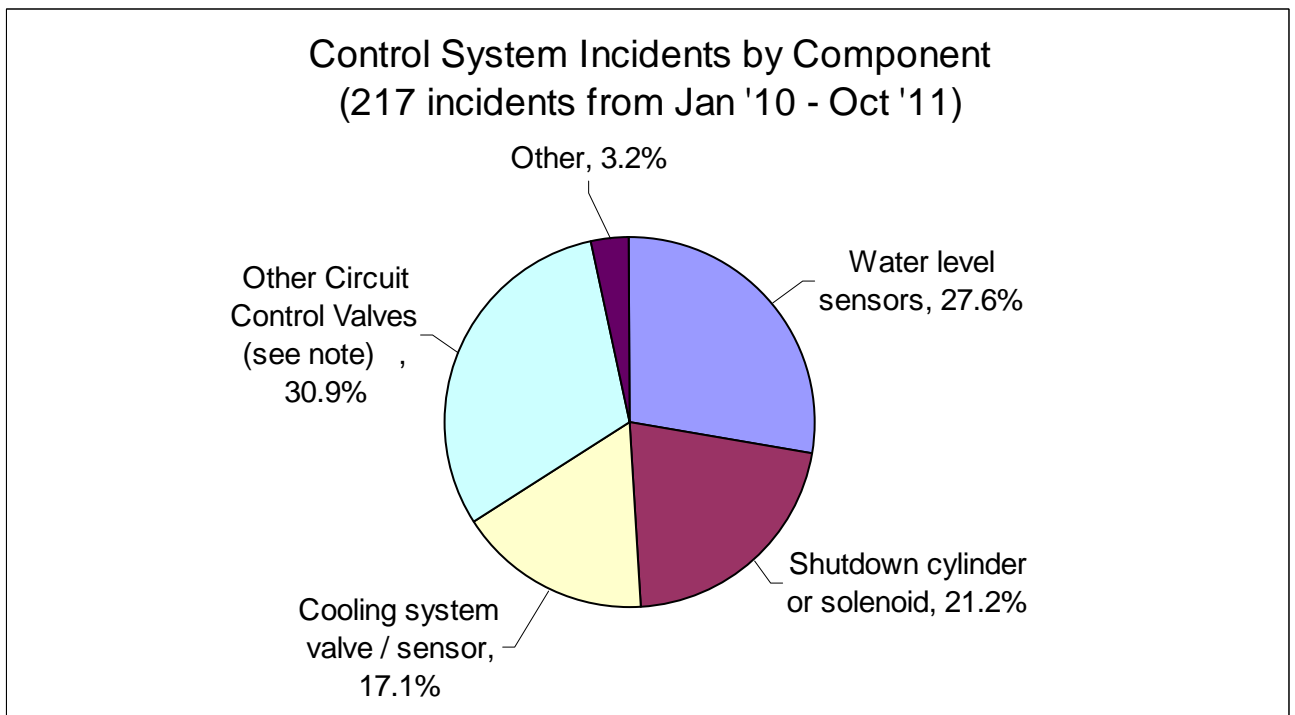
**Figure 9**

Figure 9 below shows the distribution of failures among control system components<sup>6</sup>:

Water level sensors were the biggest single item among control system components that failed, causing 27.6% of failures. These were mainly Humphrey valve failures. Sometimes this sensor was installed wrong.

The next most frequent location of failure of the DES was at the shutdown cylinder, at 21.2%, mainly by jamming of the cylinder, and sometimes by wrong pressure setting, loose bolts/nuts/studs or bent linkage.

Cooling system valve/sensors contributed 17.1% of failures, mostly by non-operation of the valve/sensor. A couple of failures here were due to wrong installation.

Although contributing 30.9% of failures, "Other circuit control valves" encompassed a number of different functions and types of valves. These included the flow control valve, oil pressure, safety circuit pressure valve, relief valve etc (needle valve, pilot valve etc).

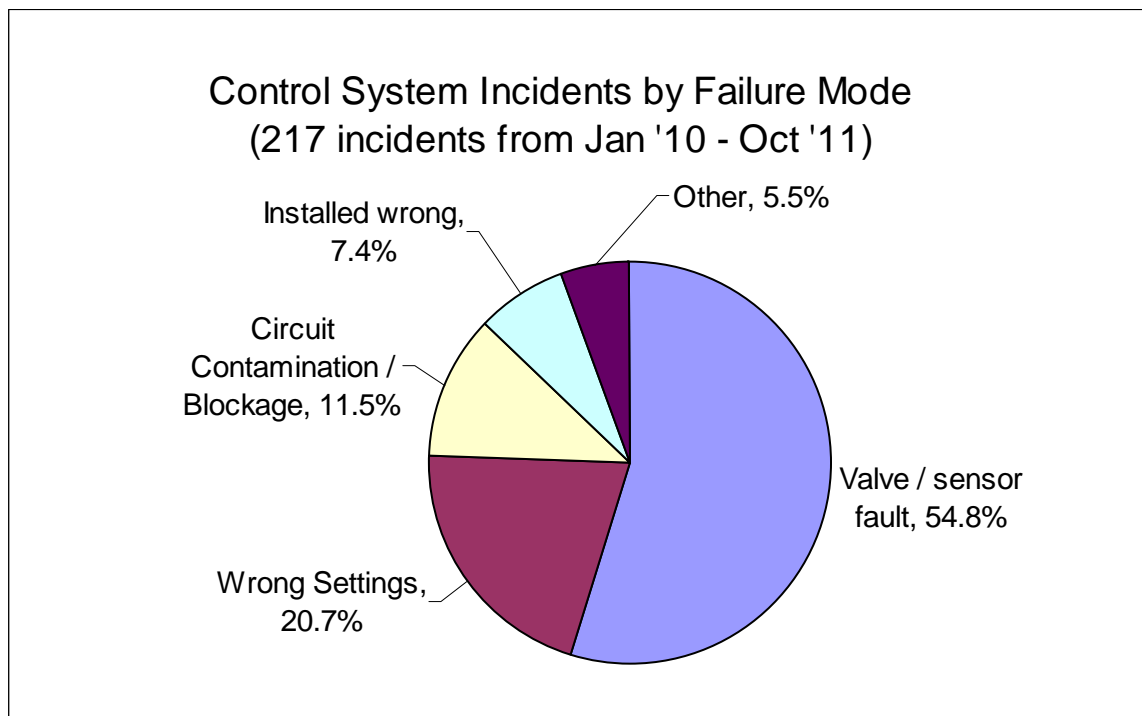
**Figure 10**

Figure 10 below shows the distribution of failure modes experienced by the same set of control system components:

The data suggests that the most significant mode of failure in the pneumatic/hydraulic control system is valve/sensor reliability, accounting for 54.8% of control system failures. Can DES manufacturers control this?

Wrong settings came in next at 20.7% of reported failures. These included both accidental and deliberate deviations from the correct settings, although this was not usually identified in the incident report.

Circuit contamination caused 11.5% of control system failures. Can maintenance or overhaul procedures control this?

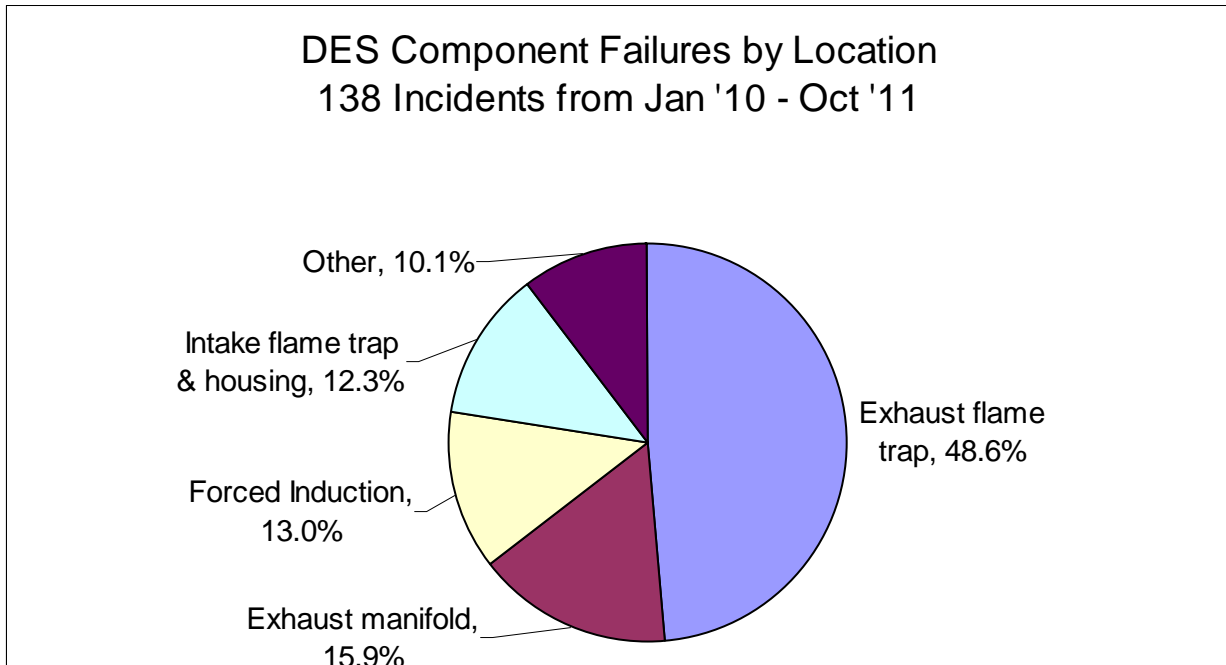
**Figure 11**

Figure 11 below shows which engine components are more prone to failure.

Second to the control system, the next source of failure of diesel engine systems was the exhaust flame trap, contributing 48.6% of non-control-system failures. Most of these were in the wet scrubber.

Lesser contributions were made by the exhaust manifold (15.9%)

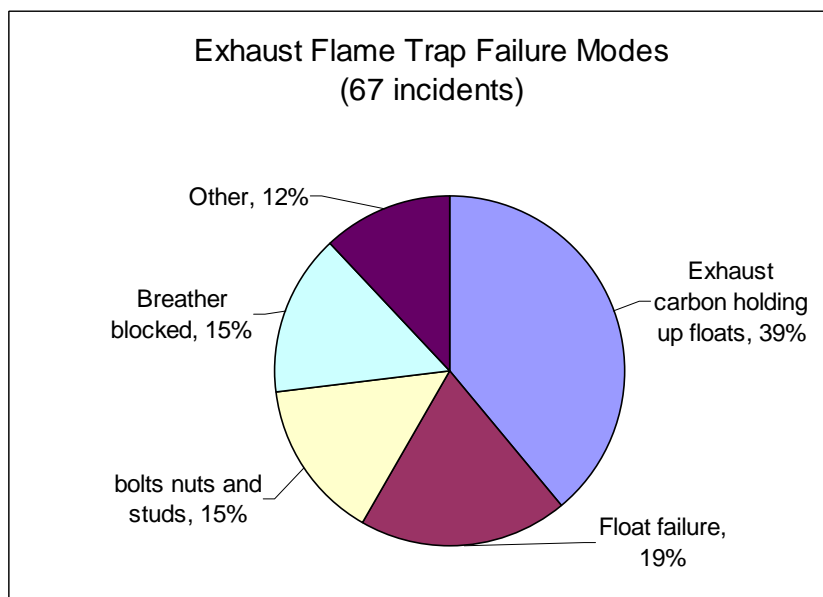
**Figure 12**

Figure 12 below shows the distribution of failure modes of exhaust flame traps.

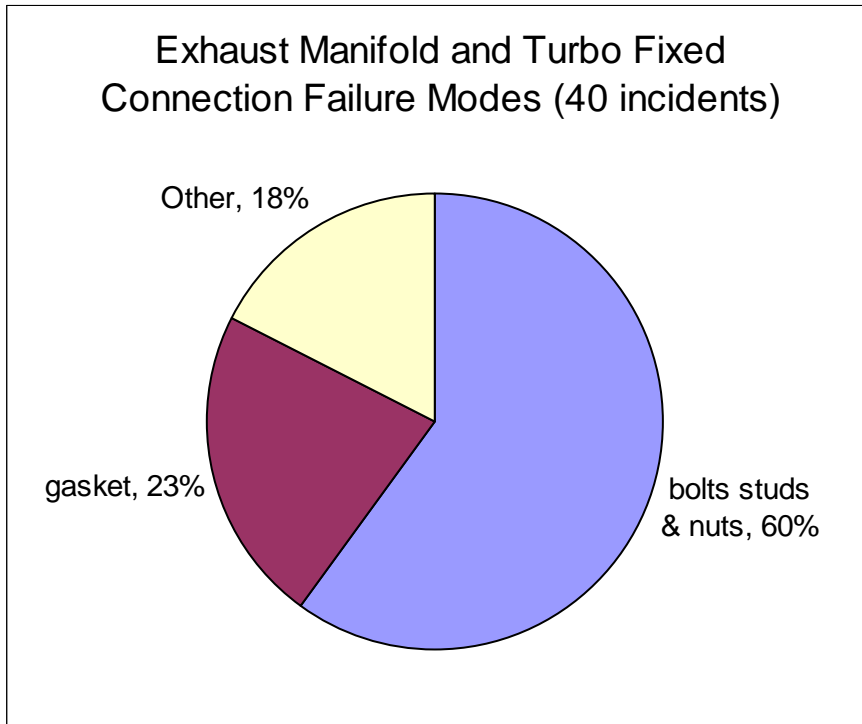
Figure 13

Figure 12 below shows the combined failures modes of the exhaust manifold and turbo:

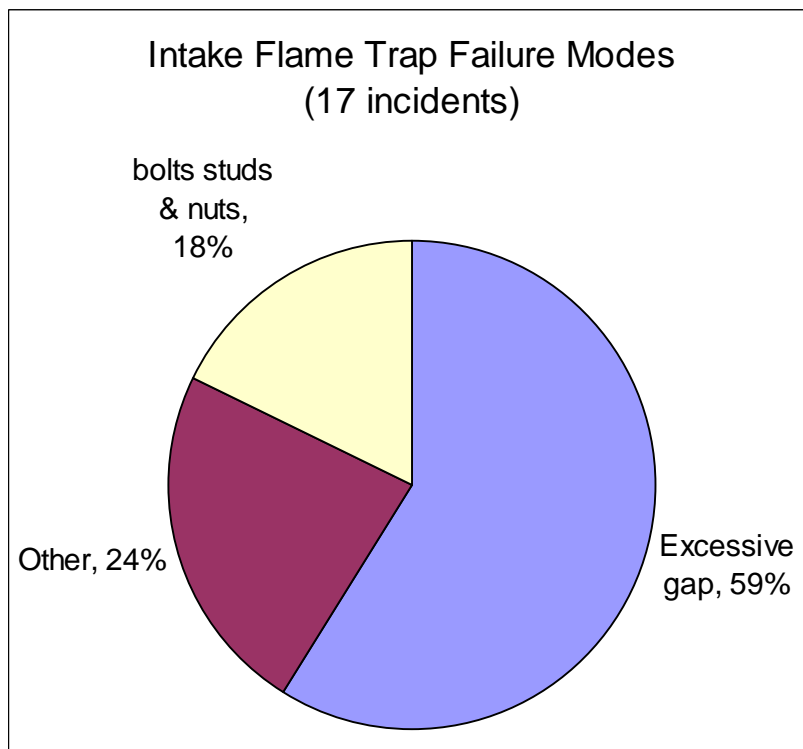
Figure 14 below shows the distribution of failure modes of intake flame traps:

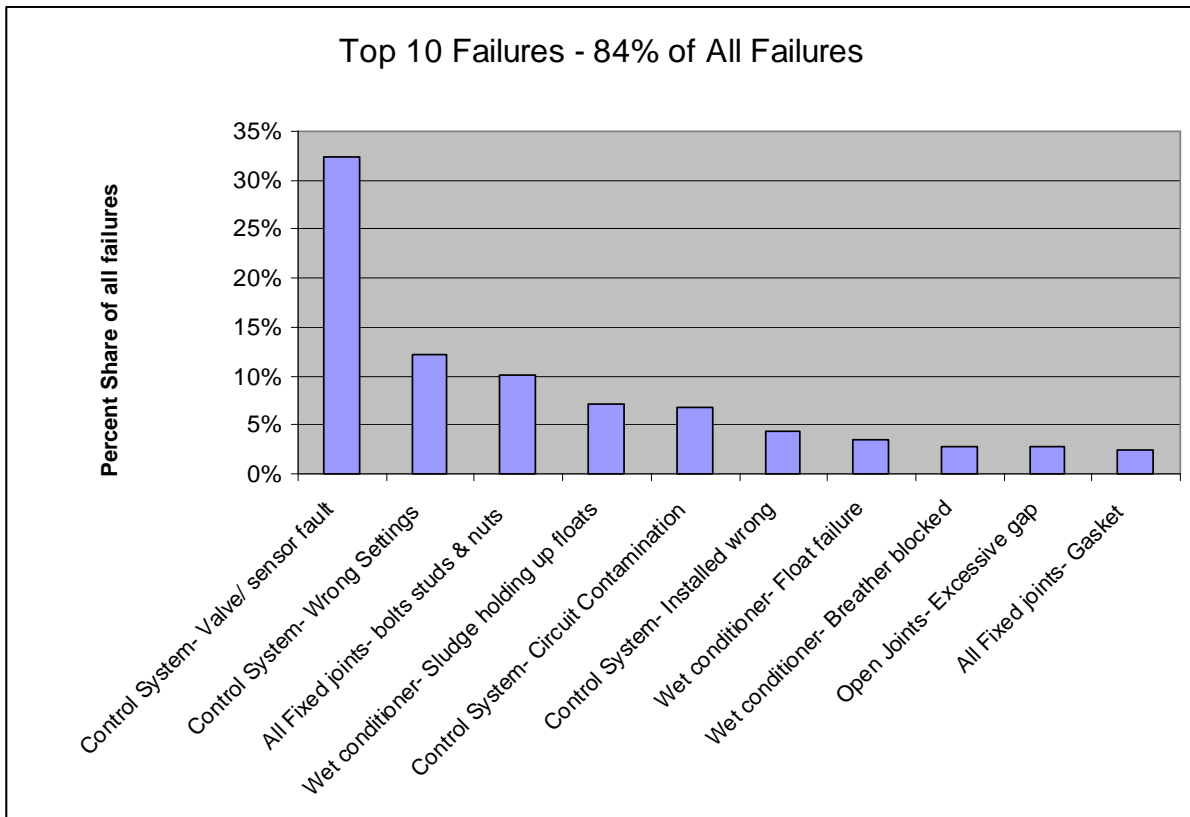
**Figure 15**

Figure 15 below shows the top 10 ways a DES was reported to have failed. The percentages quoted are a proportion of the total number of failures and 84% of all failures are shown.

Valve/sensor reliability seems to be the greatest opportunity for improvement and could be improved by use of an electronic control system. The failures due to wrong settings in the pneumatic/hydraulic control circuit may have been due to either deliberate misuse, or insufficient security of the settings; there is currently insufficient information available to determine the split between the two.

Similarly for security of bolts, studs and nuts – OEM's and users may share responsibility for improvement.
