INVESTIGATION INFORMATION RELEASE

Roof ply rock falls on two workers during pillar extraction

Incident date: 2 November 2021

Location: Clarence Colliery

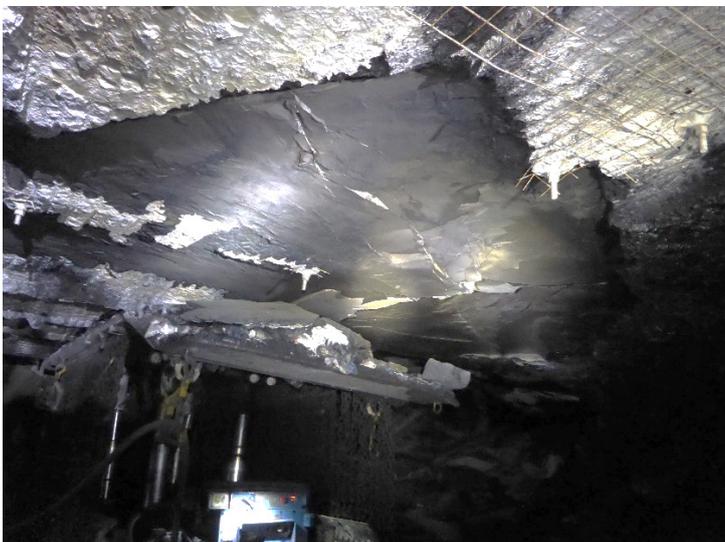
Two workers suffered serious injuries including multiple spinal fractures when they were struck by falling roof ply rock of about 4m² in dimension and weighing about 570kg. The roof ply rock fell from an area in-between a hydraulic breaker line roof support (BLS) and existing primary support roof bolts and mesh during pillar extraction operations (see Figure 1). A third worker was near the two workers.

Figure 1: Photograph looking towards the extracted area (goaf) showing the area from which the roof ply rock fell in-between the BLS, existing roof bolts and mesh (NSW Resources Regulator).

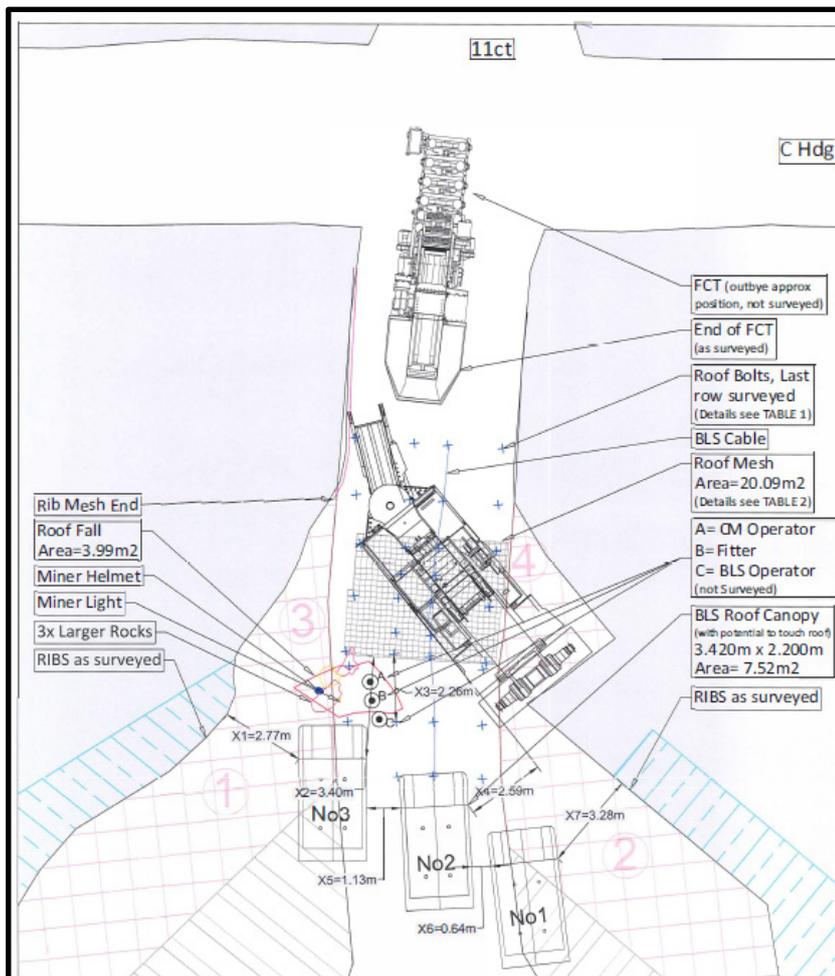
Figure 2: Extract of the incident scene plan (by Clarence Colliery).

At about 3.25am on Tuesday, 2 November 2021, three workers, a continuous miner (CM) operator (using a remote control), a mechanical tradesperson (fitter) and a BLS operator, were standing in the control zone in front of one of three BLS (see Figure 2). They were extracting coal using the CM at the time of the incident. A cracking sound was heard from the roof above immediately after which the roof ply rock fell and struck the CM operator and fitter. The BLS operator was moving towards BLS No 2 and was not hit. The two injured workers were transported by helicopter to Sydney hospitals. The CM operator required emergency surgery for multiple spinal fractures. The fitter also suffered spinal fractures.

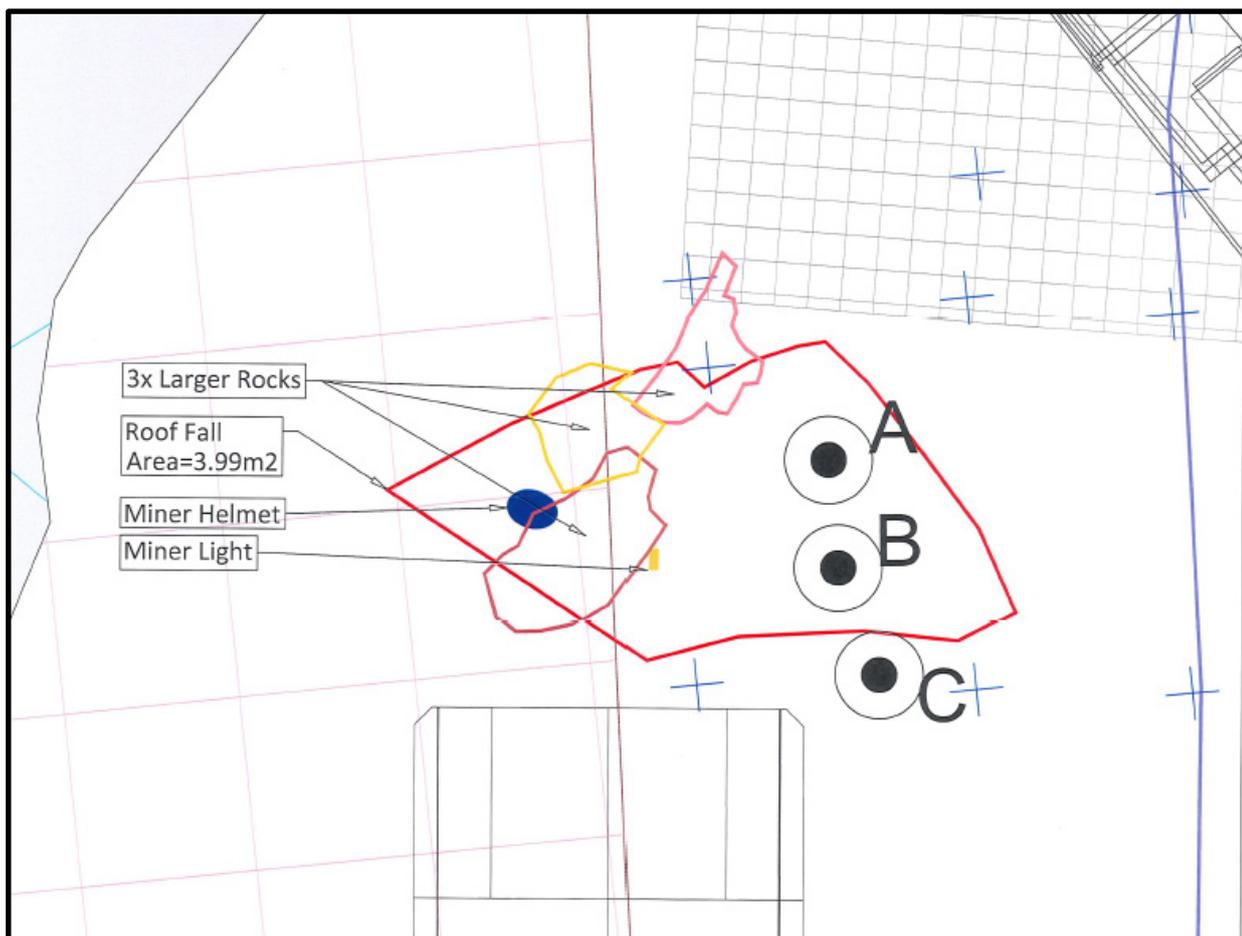
- The coal seam thickness was 2.83m in the extraction area.
- Adjacent to the roof fall area were two sheets of mesh covering 20m². The mesh was installed during primary support development in January 2021. The primary roof support bolts were 1.8 m long with chemical resin anchors.
- The distance between the primary roof bolts supporting the zone where the roof fell was up to 2.26m.

Figure 3: The incident scene plan depicting the area of the roof ply fall (thick red line), approximate location of the three workers (A, B and C), position of roof bolts (blue crosses) and position of roof mesh (blue cross hatch).

1. Conduct a review of the mine's Ground or strata failure principal hazard management plan and implement any additional control measures as necessary.
2. Review the systems of work that govern pre-extraction strata audits and who was accountable to complete the audits.
3. Conduct a review of the adequacy and suitability of existing primary support in extraction panel 818A and rectify any defects identified related to ground and strata support compliance.

1. Engaging an independent subject matter expert to assist in the review and conduct a geotechnical investigation as part of the review of controls measures.
2. How the coal tops, that were not being extracted during development activities, affected the density and type of roof support in areas that would be exposed to secondary extraction.
3. How development CM operators maintain reasonable control to manage full seam extraction during a plunge depth of up to 18m.
4. The density and style of support required to be installed before secondary extraction.

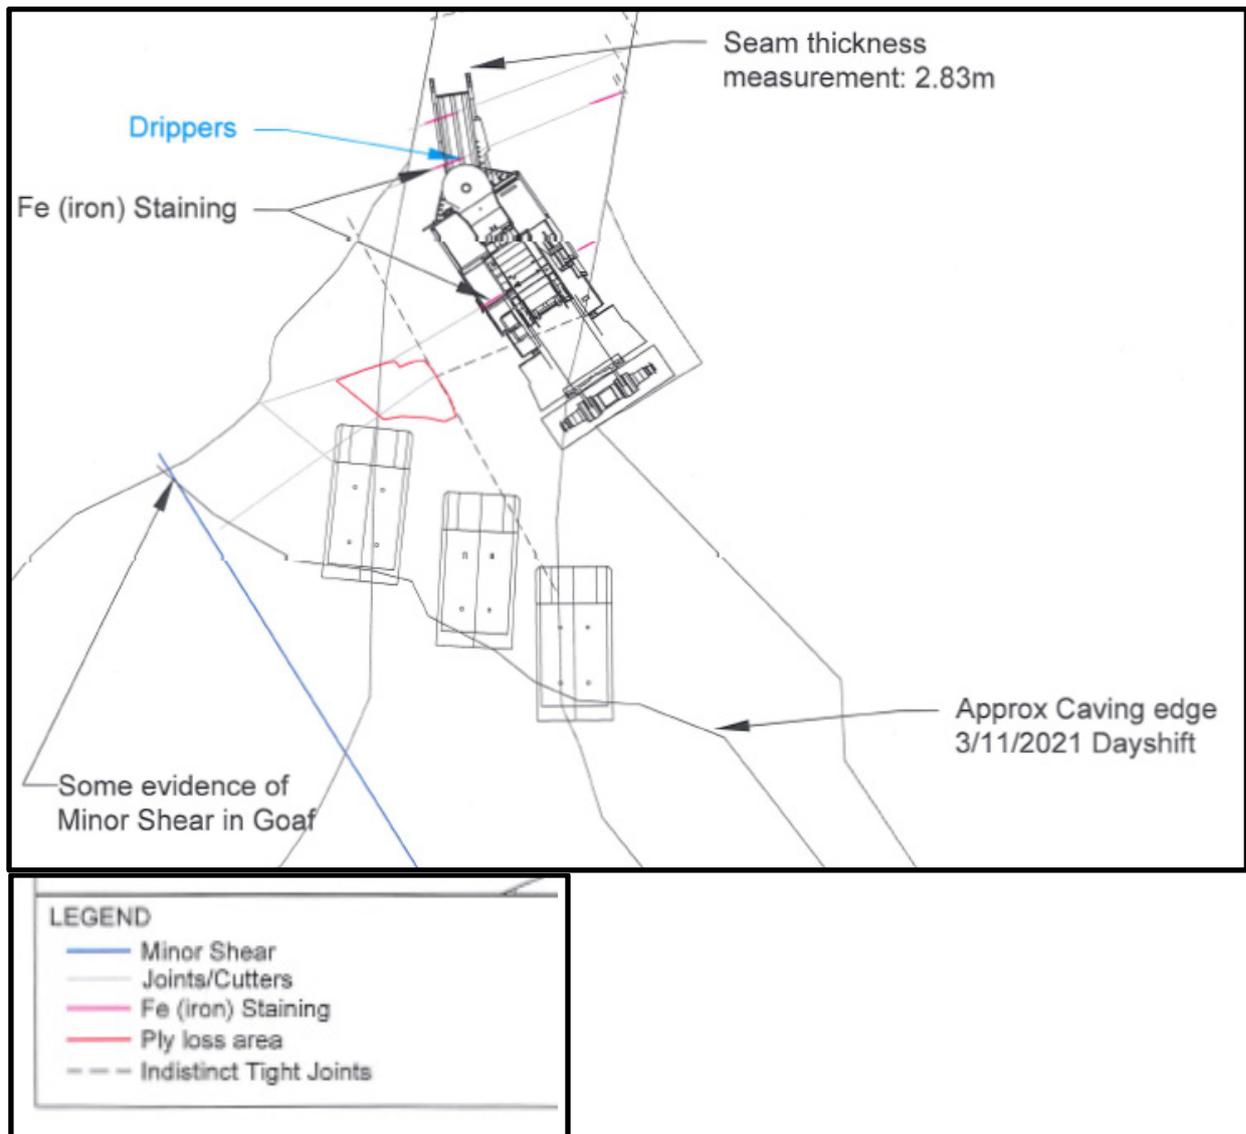
Figure 4: Extract of the geological structure mapping plan (by Clarence Colliery).

- The fallen roof ply rock consisted of carbonaceous siltstone with a gradational base to dull stony coal with an estimated area of fallen material of about 4m².
- Five lumps of broken roof rock were found on the ground after the incident with the largest piece of rock measuring about 1m (length) x 0.6m (width) x 0.2m (thick) with an estimated weight of about 280kg. The total weight of fallen rock was estimated to be about 570kg.
- There was some evidence of minor shear in the goaf adjacent to the fall. Roof joints and cutters were observed in the fallen roof zone. The fallen roof zone was bounded on one side by an indistinct tight joint. There were several iron (Fe) stains and water drippers observed in the roof above the CM (see Figure 4).
