INVESTIGATION INFORMATION RELEASE

Rear dump truck narrowly avoids collision with light vehicle

Incident date: 6 December 2021

Location: Maules Creek Mine, near Boggabri NSW

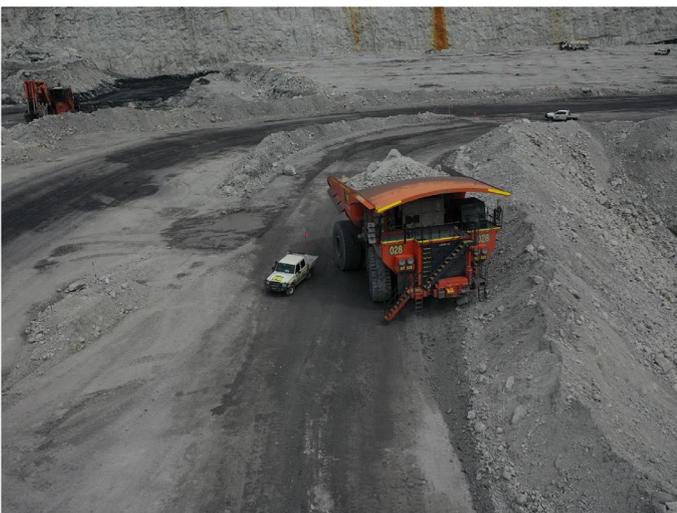
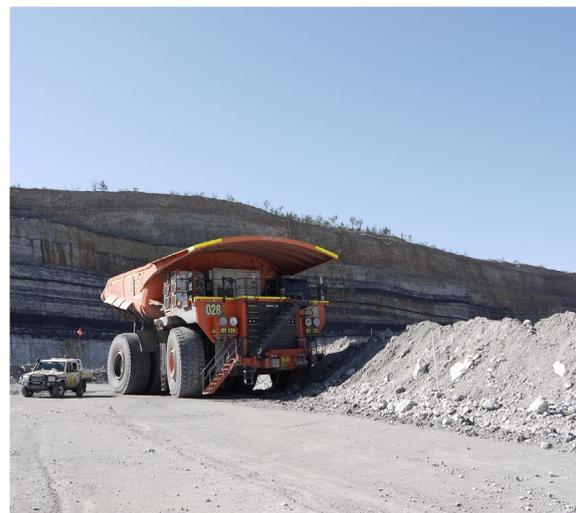
Figure 1 and 2: Location of Hitachi and light vehicle after near collision

The Hitachi's front right-side wheel missed the light vehicle by less than one metre with the two vehicles coming to rest about 1.65 m apart.

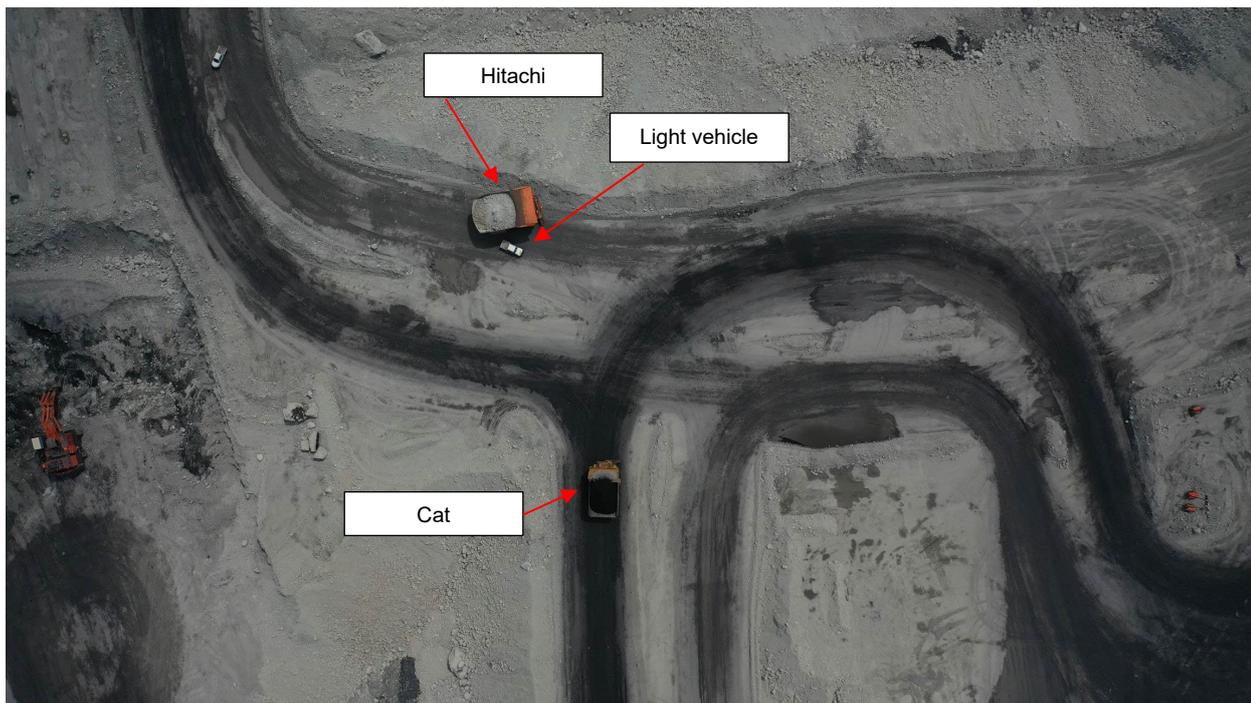
The incident occurred at a T-intersection between multiple excavator loading areas and an in-pit dump.

Figure 3: Aerial view of incident

As the Hitachi operator continued to the in-pit dump he noticed the Cat further ahead to his right but did not notice the light vehicle at the intersection over the windrow of the left-hand bend in the road. On that basis the Hitachi operator assumed the right of way as haul trucks are required to give way to other haul trucks on their left as their cabs are positioned on the left side.

The Hitachi operator continued to focus his attention on the Cat. The windrow height ranged from 2.8 m to 3.8 m on the bend and the Hitachi operator estimated he was travelling around 30 km/h.
