INVESTIGATION INFORMATION RELEASE

Worker suffers serious burns in underground loader fire

Incident date: 25 October 2021

Location: Cadia Valley Operations, Cadia East Underground Mine, Orange NSW

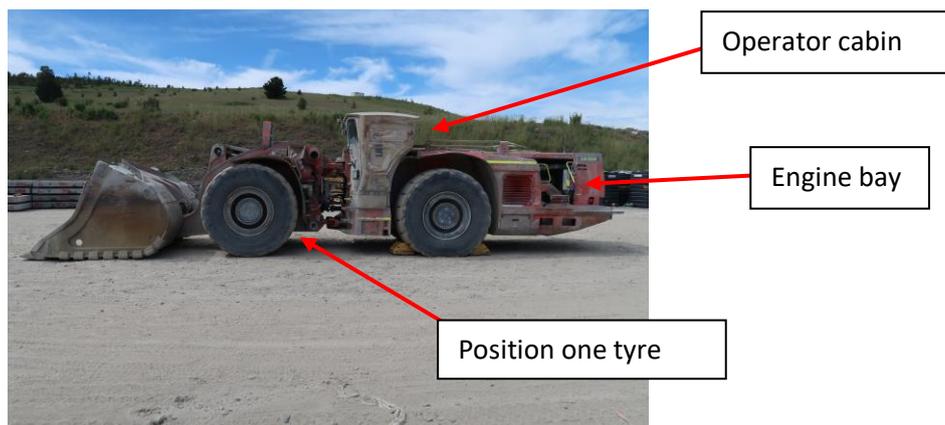
Figure1: Example of LH621 Sandvik loader model involved in the incident

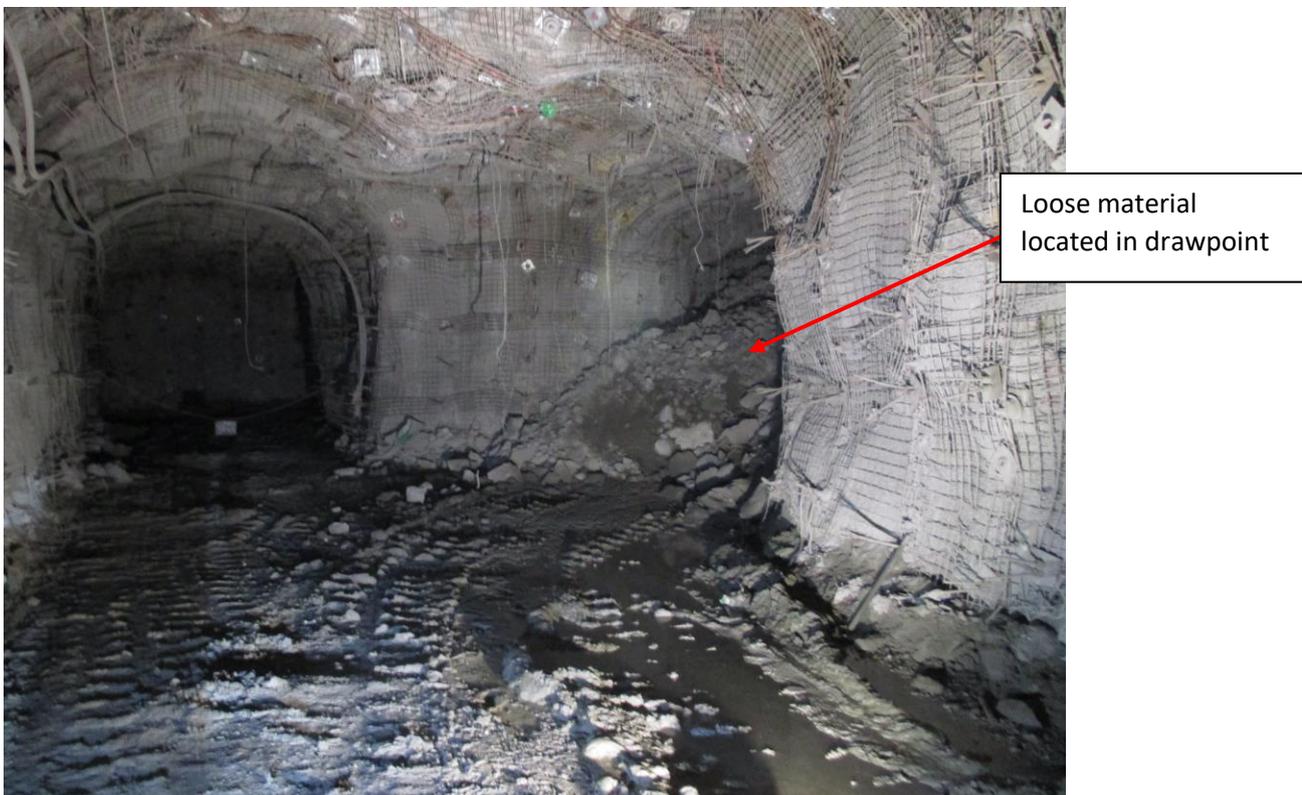
The incident occurred adjacent to a drawpoint in the Cadia East underground mine workings. A drawpoint is a location underground where loose material is extracted by loaders.

Figure 2: Drawpoint located in front of the loader

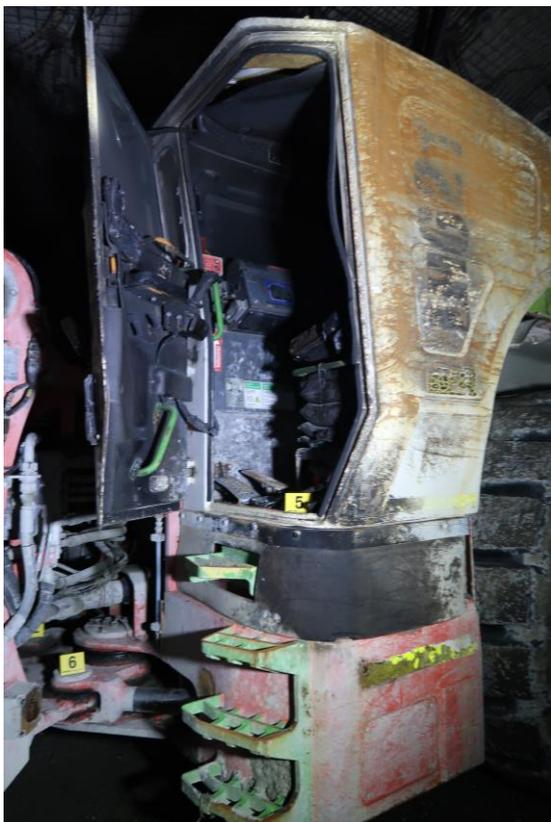
Figure 3: Cabin door of the loader

- the fire had a relatively short-lived duration resulting in minimal damage to the loader
- while burn indicators on the loader suggest the fire was contained to the front left hand side (see figures 3 and 4), when interviewed the worker stated that he in fact sustained burn injuries while running past the rear left hand side of the loader in the vicinity of the engine bay
- the fuel source and ignition point for the fire has not yet been determined.

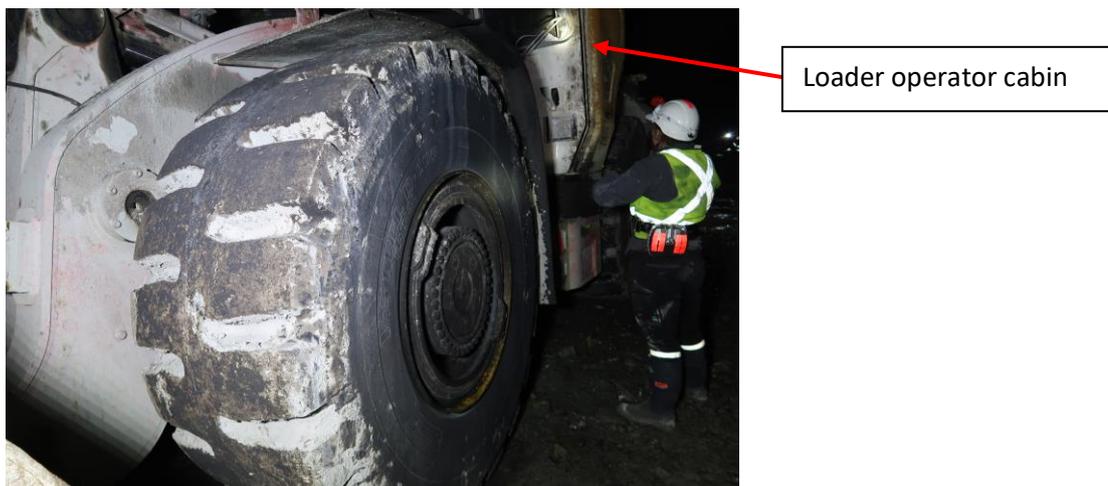
At the time of the incident, the worker was operating the loader to remove material from the drawpoint. While undertaking this task the worker observed a fire near the loader's position one tyre, (see figure 1) with flames travelling between the tyre and its mud guard flowing towards the ground. The worker turned off the loader, activated the fire suppression system and assessed the fire's location, size and flame path to identify the best route of escape. The worker exited the machine via the cabin door and ran past the rear of the loader (in the vicinity of the engine bay) sustaining burn injuries in the process. Once clear of the loader the worker immediately rolled on the ground to extinguish his clothing

Figure 4: Fire affected position one tyre of loader

- ensure they have identified and assessed all hazards that may give rise to the risk of fire on vehicles and equipment used underground
- assess the flammability of fluids used in the hydraulic and braking systems of heavy equipment that operates underground and potential ignition sources
- ensure all hydraulic, braking and fuel systems on heavy equipment are inspected and maintained regularly to identify and prevent system failures that have the potential to produce high pressure leaks.
