# WEEKLY INCIDENT SUMMARY

Week ending Friday 17 December 2021

**CM9 reference** DOC21/1121877

**Mine safety reference** ISR21-50

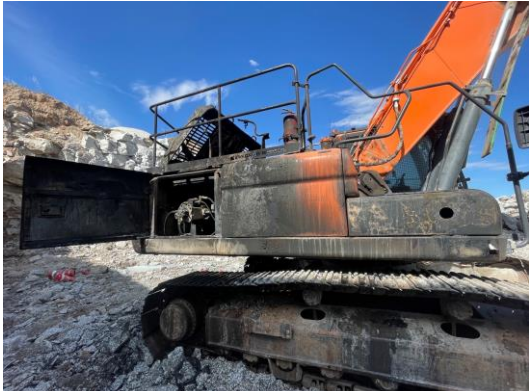
INCIDENT TYPE	SUMMARY	COMMENTS TO INDUSTRY
Dangerous incident IncNot0041304 Construction materials Fire or explosion

<p>A fire started in the battery box on a 30 tonne excavator in a quarry. Workers attempted to extinguish the blaze using two extinguishers. Their attempt failed and emergency services were called. The excavator was destroyed. The incident was not reported to the Resources Regulator until several days later.</p>

<p>Dangerous incidents must be reported directly to the Resources Regulator on 1300 814 609. Quarries and mines should review their emergency response capabilities to ensure adequate firefighting equipment is available. Workers should understand when to escalate an incident to emergency services.</p>

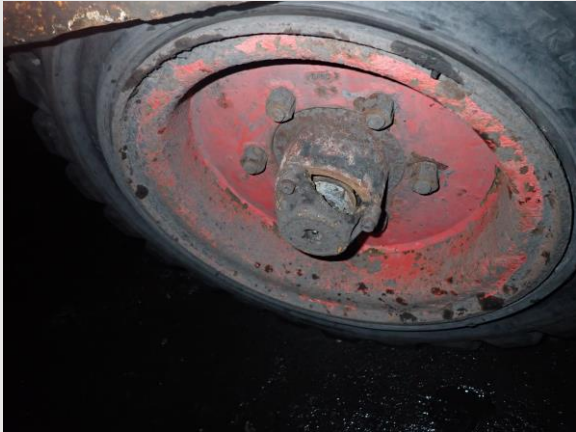
INCIDENT TYPE	SUMMARY	COMMENTS TO INDUSTRY
<p>Dangerous incident IncNot0041297 Underground coal Fire or explosion</p>

<p>A fire occurred in the wheel bearing of a supply trailer in an underground coal mine. The fire was extinguished using a water hose. The investigation identified a damaged bearing cover that had failed to protect the bearing from contamination.</p>

<p>Ancillary equipment such as trailers, attachments and supply pods should have suitable maintenance schedules to manage the plant through its lifecycle. This should consider the environmental conditions and the frequency of use.</p> <p>Workers must always inspect plant for damage that may affect the safe use of the plant before commencing work.</p>
