**NSW
Resources
Regulator**

INVESTIGATION REPORT

REPORT INTO THE DEATH OF BRIAN BRYANT

Grawin Opal Fields, 14 October 2020

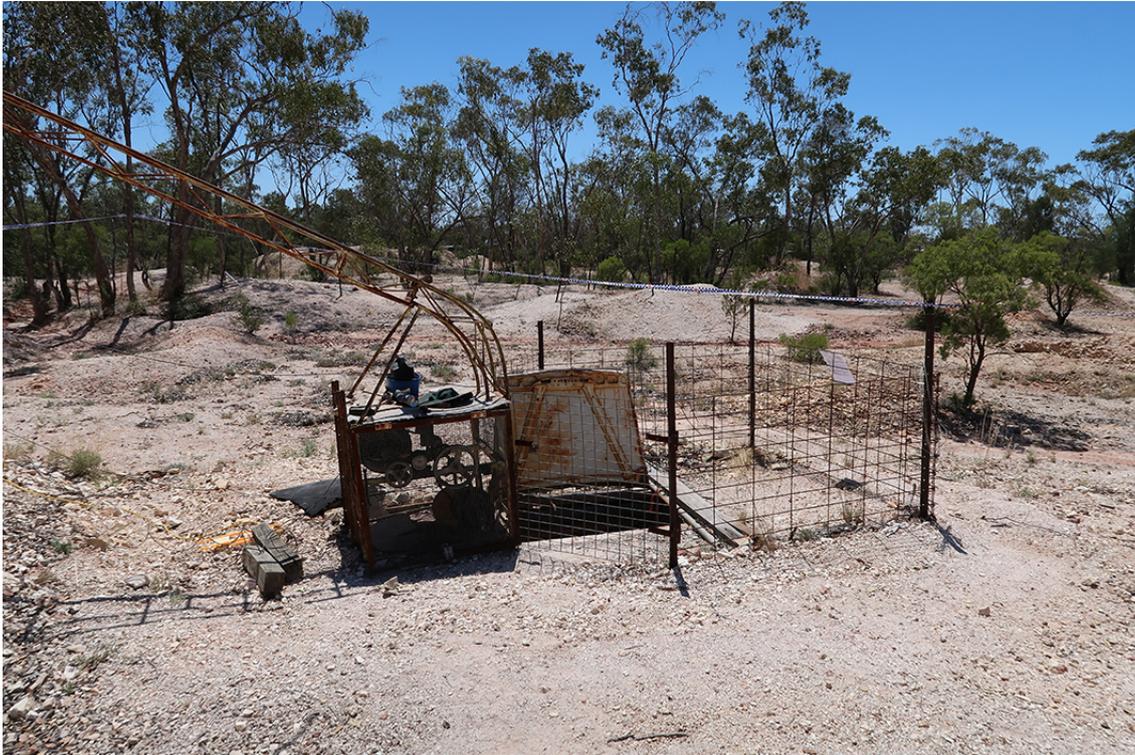
The main shaft, within which the hoist was located, was approximately seven metres from the sump to the surface and was fitted with an access ladder. The shaft opening was enclosed by a perimeter fence and was provided with an improvised cover (a vehicle bonnet) (Figures [4](#), [5](#) and [6](#)).

Figure 4: Hoist machinery cage and perimeter fencing around the hoist shaft

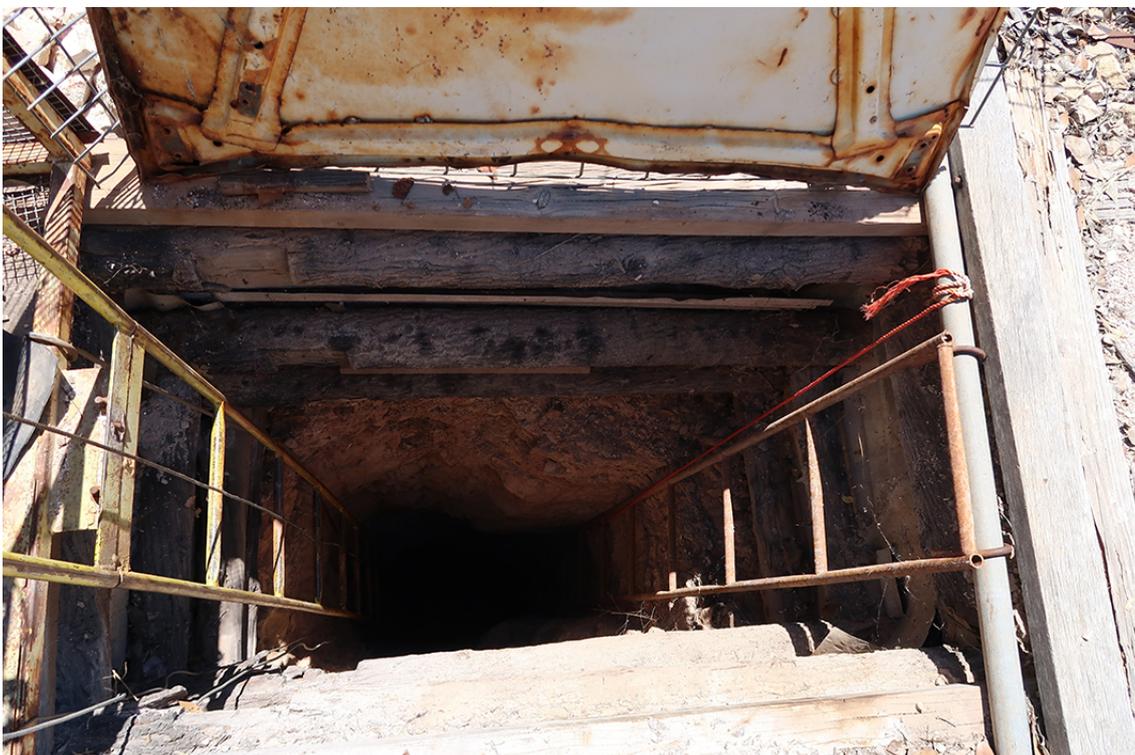
Figure 5: The entrance to the hoist shaft

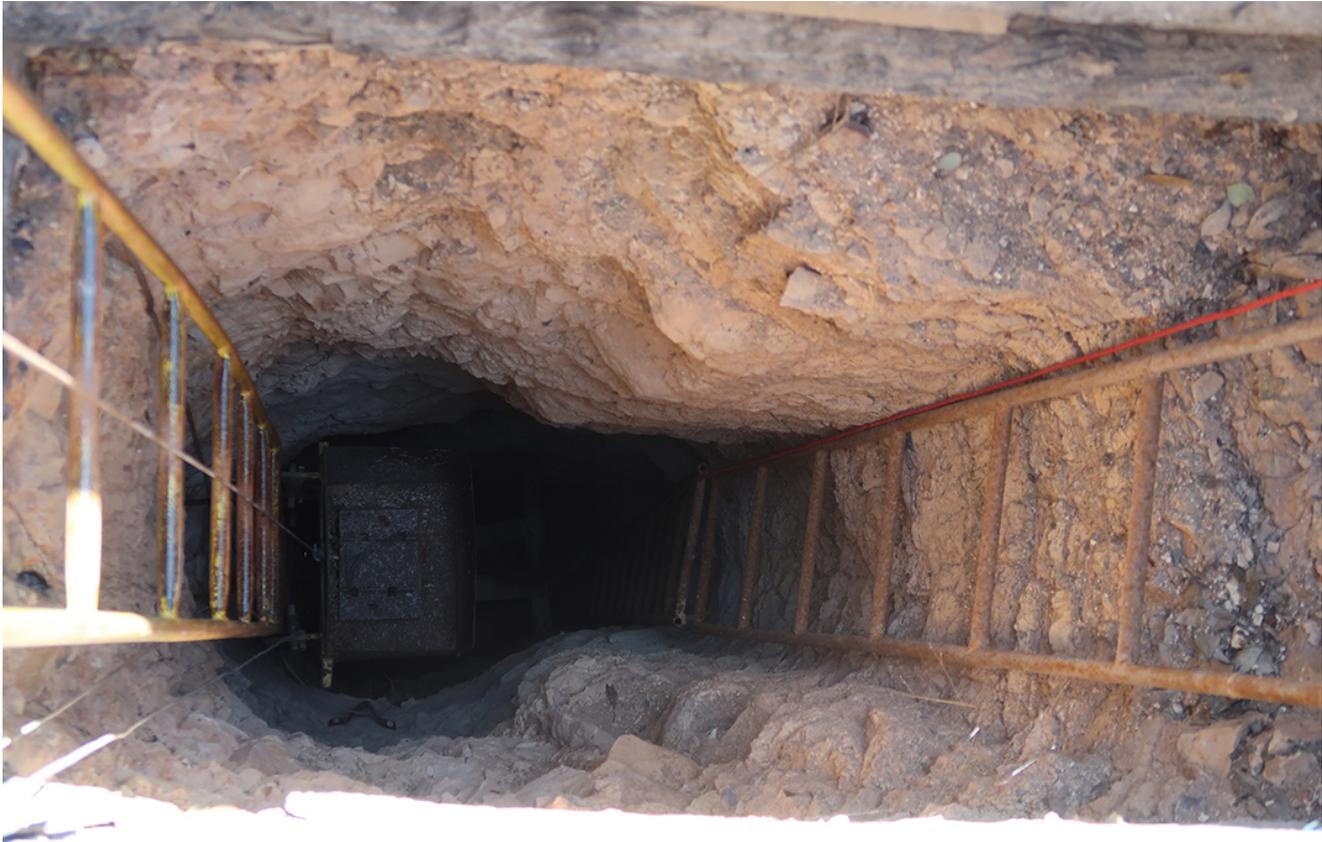
Figure 6: The steel bucket inside the hoist shaft

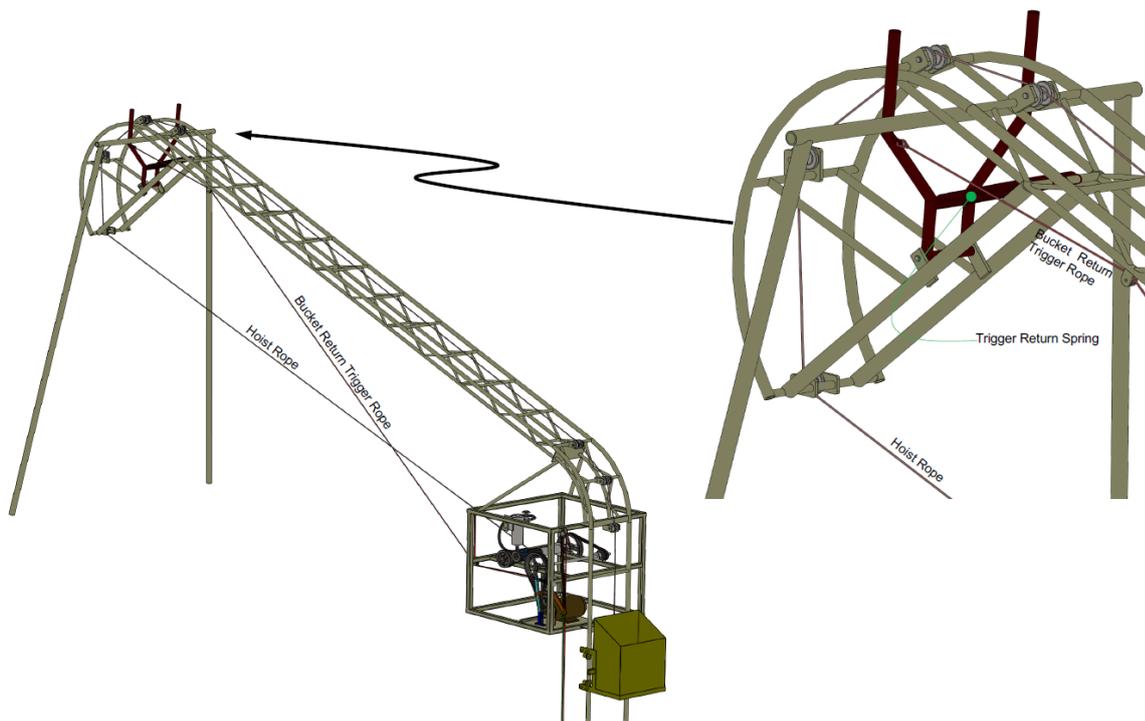
Lugs protruding from each side of the bucket would come into contact with a bucket return trigger lever when the bucket neared the crest of the frame above the dumping point. Once dumping was complete, the hoist rope drum would disengage from the electric motor allowing the bucket to descend along the guide rails under its own weight (Figure 11).

Figure 11: Bucket return trigger on hoist frame

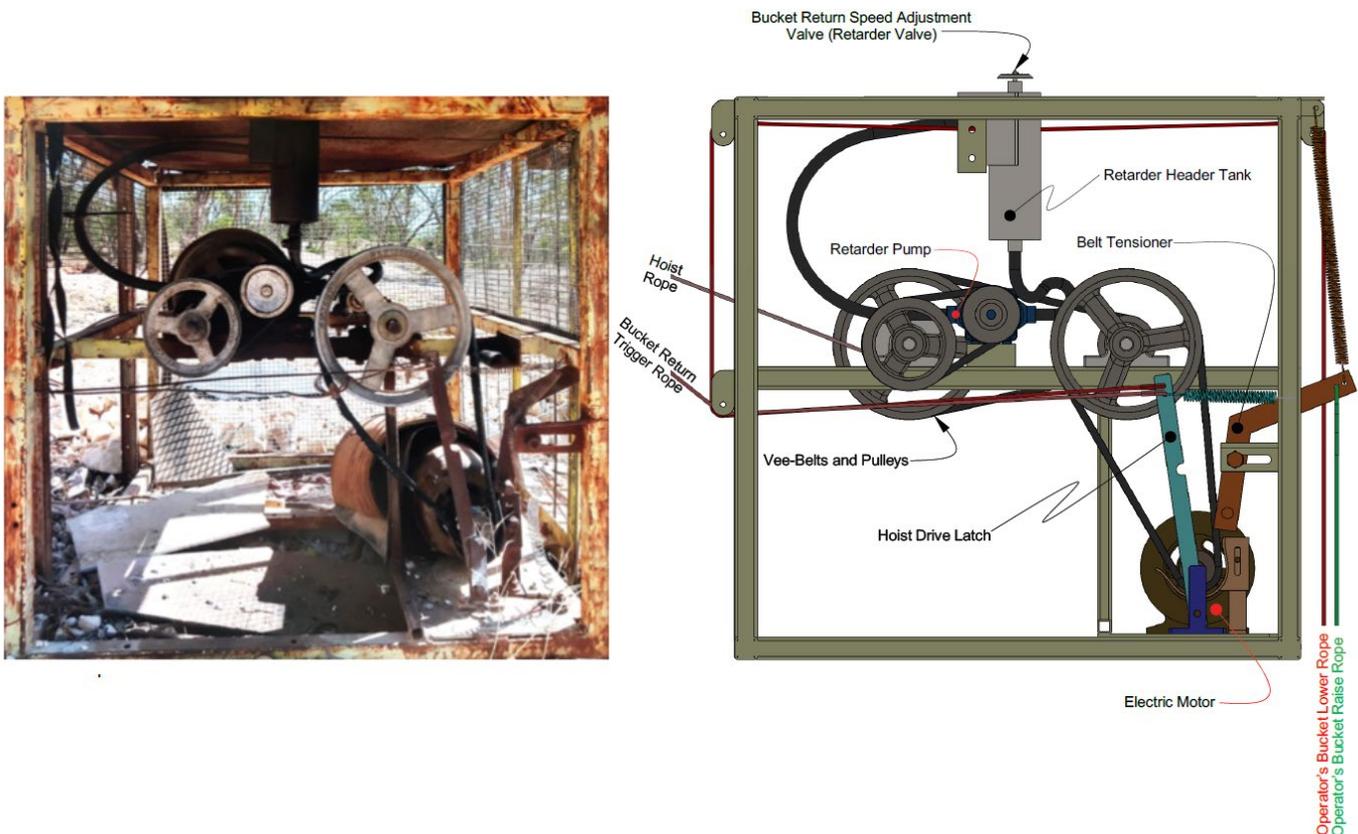
Figure 12: Hoist machinery components

Initial observations of the hoist revealed that the bucket engagement lever was in an upward position and the belts within the machinery cage were not engaged, indicating the hoist was in descent mode (i.e. the electric motor was not supplying power to the belt and pulley system to raise the bucket to the surface). The hoist bucket was empty, which is consistent with the hoist having dumped the contents of the bucket on to the opal dirt pile prior to it failing to return to the base of the sump.

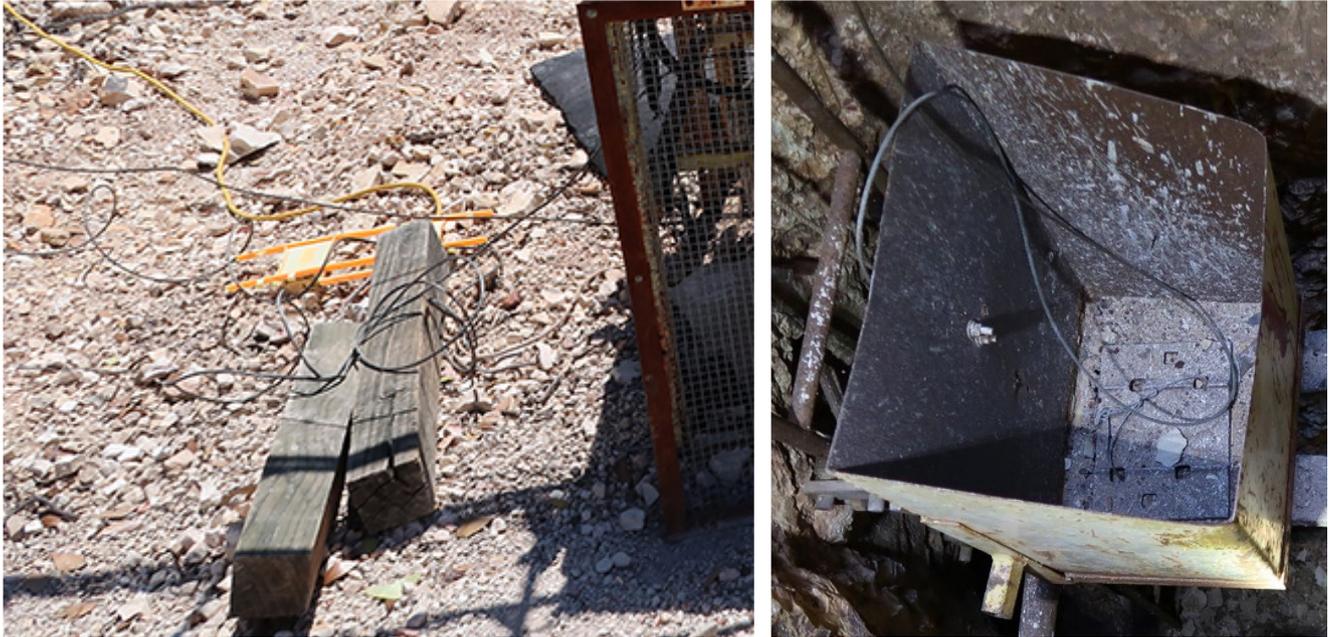
Excess rope was found on the surface adjacent to the hoist machinery cage and in the bucket at the base of the shaft. It is possible that the rope spooled in this manner after mis-tracking off the rope path guide rollers towards the end of the incident ([Figure 13](#)).

Figure 13: Excess wire spooling at the surface and in the bucket

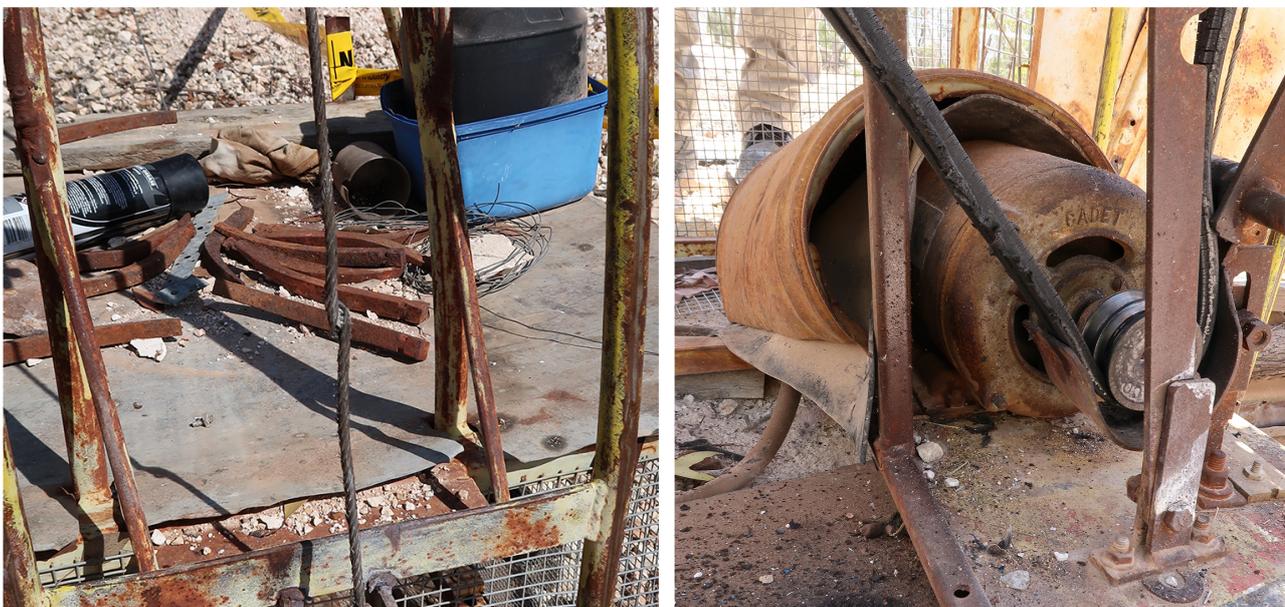
Signs of wear and tear were evident on the wire cable and the vee belts within and near to the hoist machinery cage (Figure 14). Despite their poor condition, they did not impede the overall functionality of the hoist during post incident testing.

Figure 14: Wear and tear observed on wire cable and vee belt

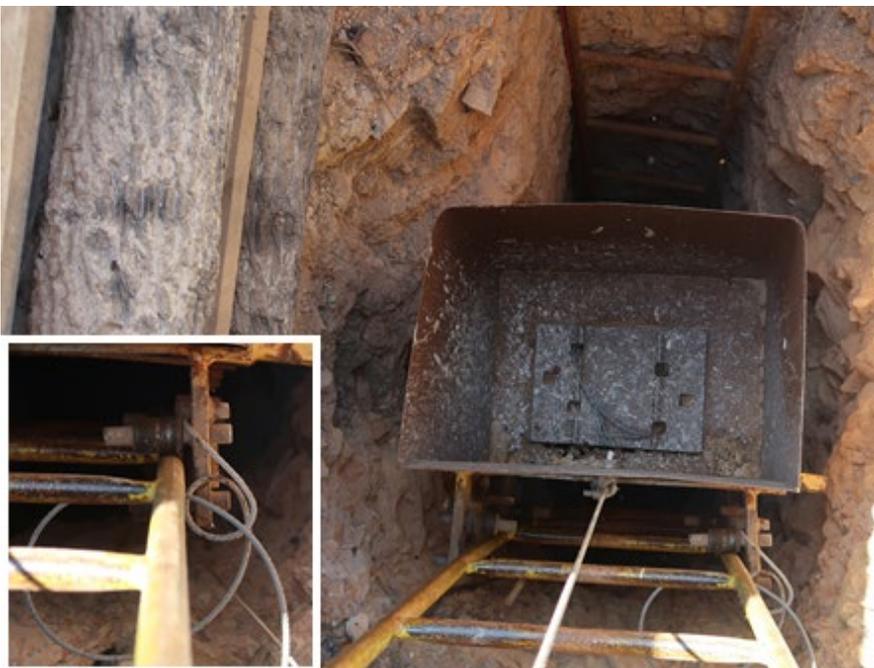
3. Entanglement of the bucket guide wheel with the engagement lever wire caused the bucket to become jammed on the guide rails approximately half-way down the shaft ([Figure 15](#)). The bucket was manually lifted to the surface by inspectors using the hoisting wire cable and the engagement lead wire was untangled from around the bucket guide wheel. The bucket was then loaded with opal dirt and descended to the base of the sump.

Figure 15: Entanglement of the bucket guide wheel with the engagement lever wire
