SAFETY BULLETIN

Strata failures increase in underground coal mines across the state

Mine safety reference SB22-02

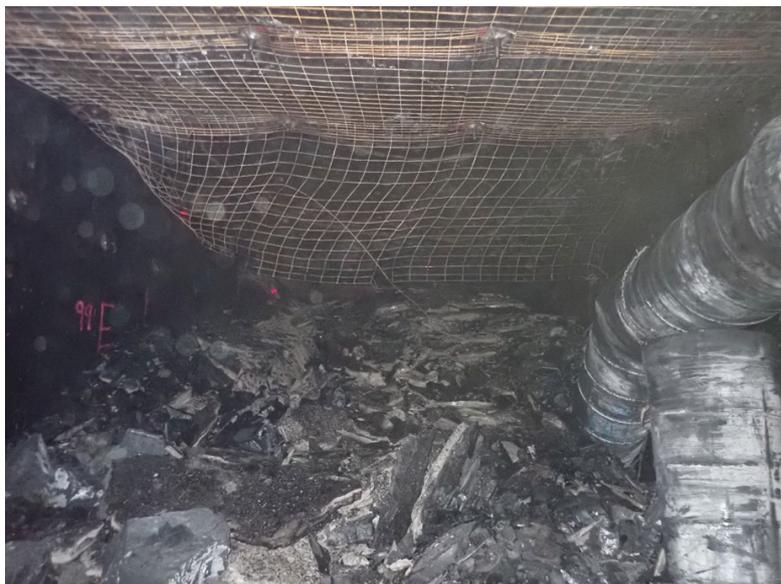
1. Workers were performing maintenance on a continuous miner and noticed roof flaking and immediately evacuated the face area just before a rib-to-rib strata failure.

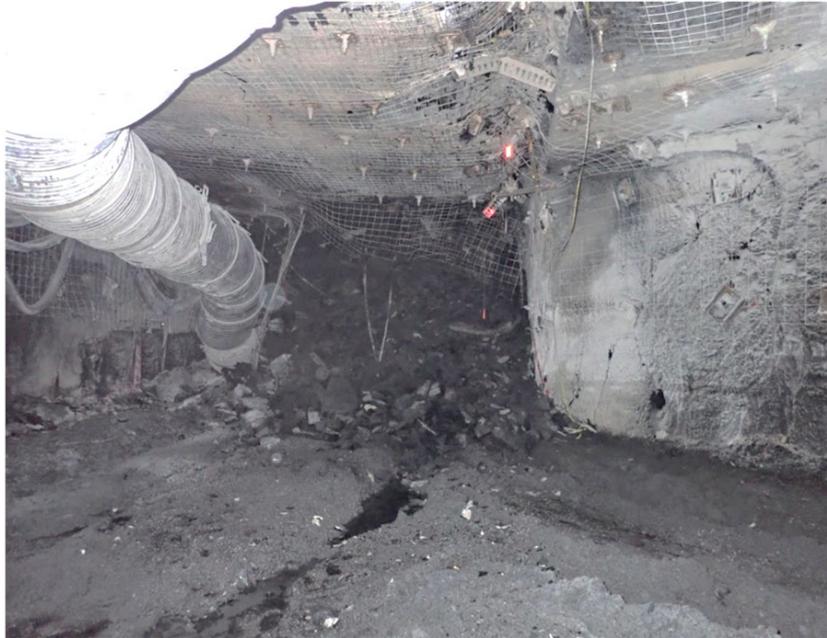
2. Workers were in the crib room at the start of their shift when a rib-to-rib strata failure occurred behind the continuous miner.

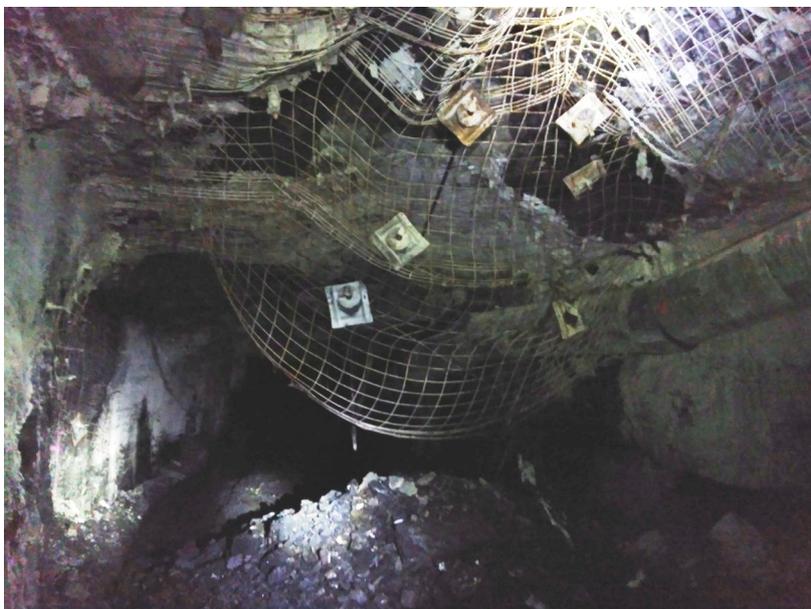
3. In a development roadway, a strata failure occurred 60 metres behind a continuous miner moments after a shuttle car passed through the area where the fall occurred.
