FIRES ON MOBILE PLANT

July – September 2021

Published by NSW Resources Regulator

Title: Fires on mobile plant, July – September 2021

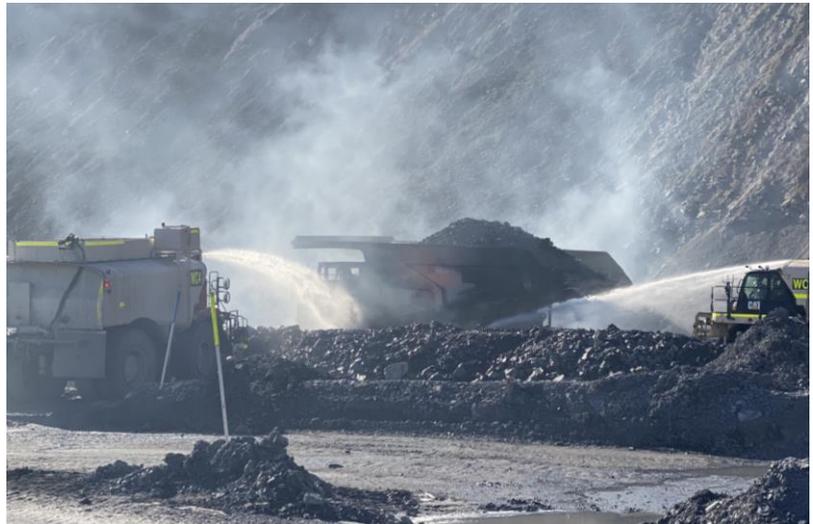
Figure 1: Haul truck fire

This incident is a reminder of how quickly a fire can propagate and the importance of fit-for-purpose access systems and operator training for emergency situations. Training should include the use of primary and secondary access systems.

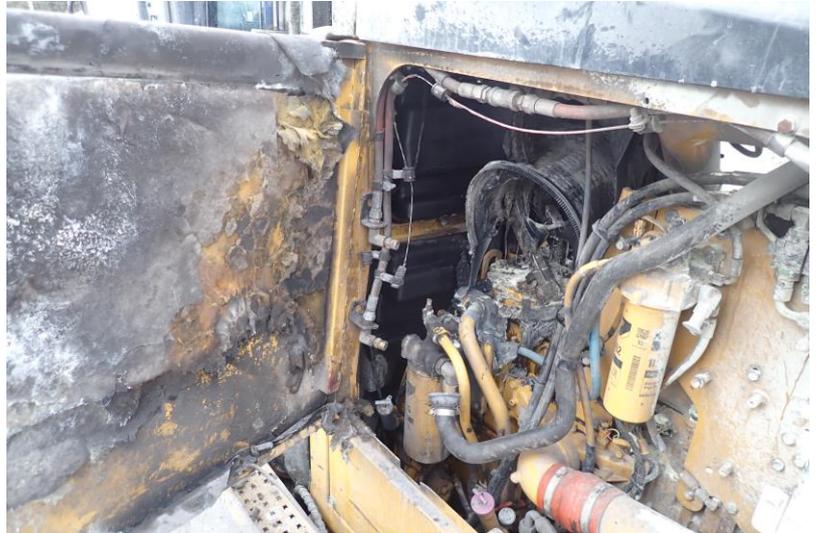
Figure 2: Grader fire damage and location

This incident is a reminder of the importance of quality maintenance and fit for purpose replacement parts.
