WEEKLY INCIDENT SUMMARY

Week ending Friday 4 March 2022

Mine safety reference ISR22-09

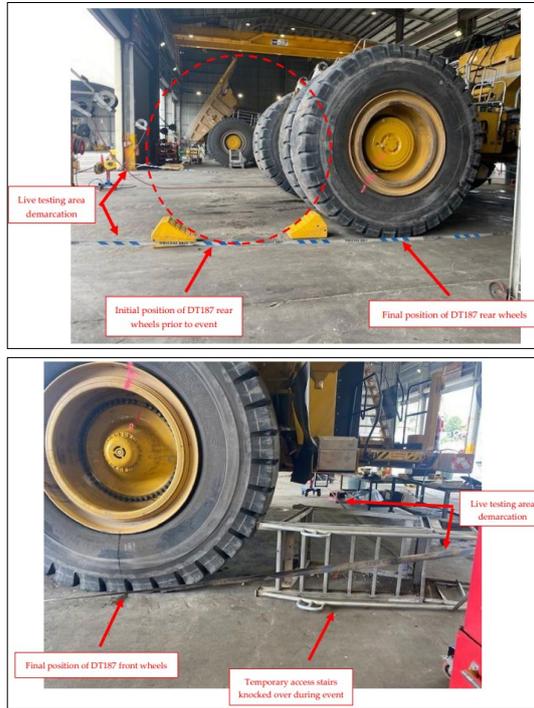
INCIDENT TYPE	SUMMARY	COMMENTS TO INDUSTRY
Dangerous incident IncNot0041698 Surface coal	A Caterpillar 789C was being commissioned after a rebuild. Four workers were investigating a transmission fault when the transmission engaged unintentionally propelling the truck forward about 1.5 metres. The truck stopped when one of the workers applied the service brake. Live testing protocols were in place and all workers on the task were onboard the truck.	This incident demonstrates the need for a safe system of work to be in place when conducting function testing. This system should limit workers to a bare minimum required for the testing. Additionally, no-go zones and barriers must be in place and enforced to prevent other workers from entering the work area.
