SAFETY BULLETIN

Crane incidents on the rise

This safety bulletin provides safety advice for the NSW mining industry.

Mine safety reference SB22-04

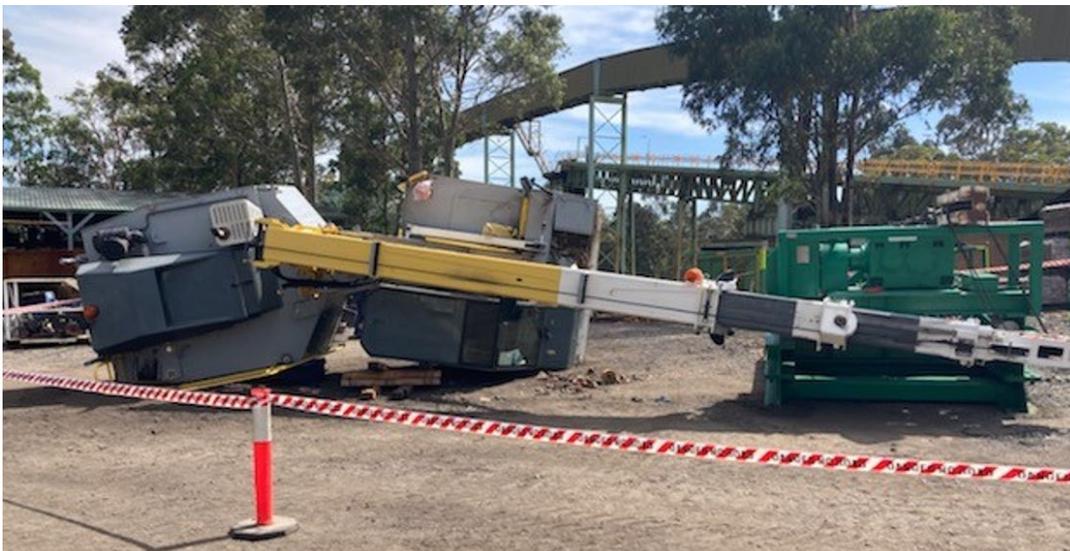
A 25 tonne Franna crane (see figure 1) was being used to relocate a belt winder that weighed approximately seven tonnes. During the relocation, the crane was articulated and slowly rolled onto its side. The operator was uninjured and was able to exit the crane.

Figure 1 – Franna crane overturned - cause still under investigation.

A lift permit and safe work method statement were in place for the lifting operation, which included supervision and spotters. Environmental conditions were good and the ground was relatively flat. Witnesses said the belt winder was rigged level when it was lifted. The crane reversed approximately five metres before articulating and then overturning. An investigation found the crane was not overloaded when it was positioned straight but became overloaded when it was articulated to 21 degrees. At this point, the operator ignored an overload alarm during the move. It was later found that crane scales were also inaccurate, significantly underestimating the true load. The operator said ignoring alarms was not an unusual practice to get jobs done.

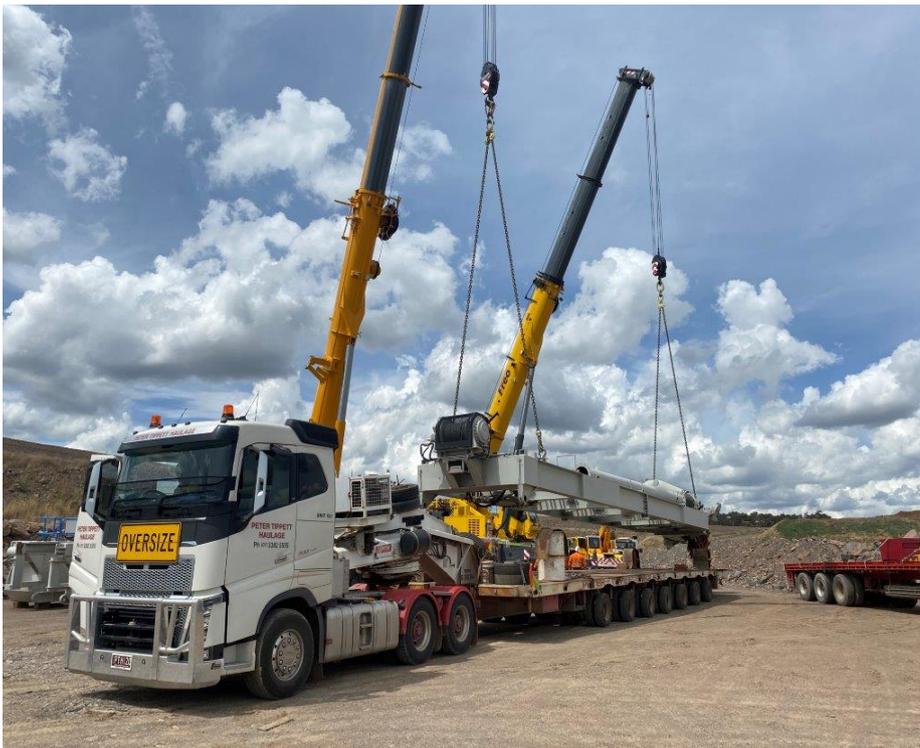
A dredge wheel excavator arm was being loaded onto a heavy transport trailer using two 150 tonne cranes. The operation involved lifting the arm and reversing the trailer under the load. As the weight of the arm transferred to the trailer, rear wheels of the prime mover became unweighted. The truck and trailer then started to roll forward as the rear wheels of the prime mover were the only wheels with a brake applied.

The driver got into the truck and applied the brakes to the trailer after it had rolled approximately three metres. There were no injuries.

Figure 2 - Truck moved on placement of load

Despite these processes, and the lift itself being undertaken successfully, the trailer supplied by the trucking contractor was different to the trailer originally specified for the job. It suited the gross mass of the dredge wheel excavator arm being transported but not its physical size or mass distribution characteristics.

Positioning the support frames on the trailer was left to the experience of the truck operator. Because the centre of gravity was so far rearward on the trailer, the upward force at the king pin lifted the unweighted rear wheels of the truck, which were the only wheels with an applied brake.

Furthermore, due to the hydraulic jacking feature of the trailer, it was common practice to not engage the trailer brakes during loading. Commonly, the trailer is raised to accept the load rather than the load being placed on to the trailer with the use of cranes. The wheels must be free to rotate during the jacking operation to avoid brake damage.

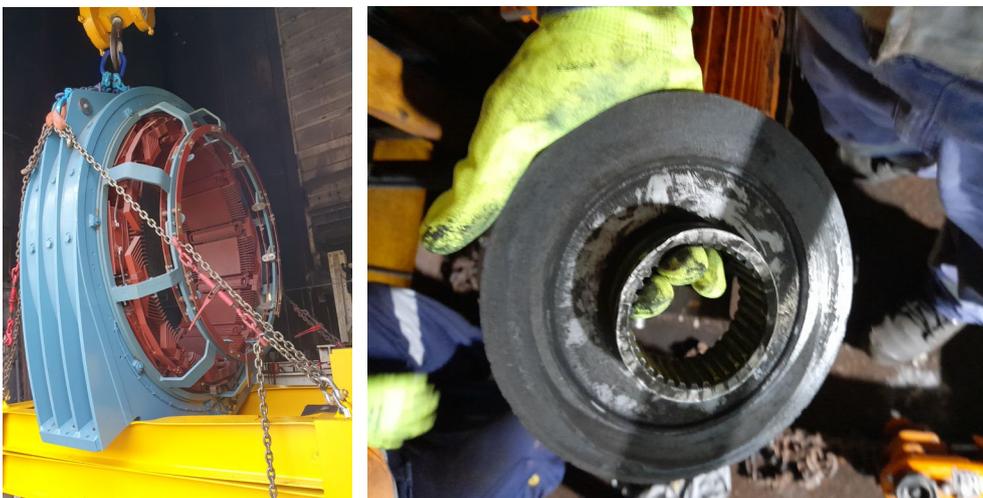
A 20 tonne overhead crane was being used to lift a motor stator weighing 18.3 tonne up to the motor room of a powered winding system. Approximately 10 metres off the ground the crane stopped without input from the operator and the load descended, landing on the transport frame it was lifted from. The crane brake that applied automatically failed to hold the load but did slow its descent.

Figure 3 - Motor stator (left) - restrained after fall and brake disc (right)

Inspections by the crane subcontractor in the month before the incident found the brake was in good condition. Damage to the brake was therefore attributed to have occurred as a result of the incident. Visual inspections confirmed no damage or failure of the crane electric motor, gearbox, shafts, drum or ropes.

Post-incident load testing with a 15 tonne load tripped mid lift and the load dropped a few centimetres. The raise full current limit switch (CRL) was found to have inadvertently activated. Analysis of the circuit shows uncoupling of two of the three phases when the CRL trips. The remaining single phase caused the motor to reverse and prevented the brake from applying. The drum brake was unable to stop the load due to the momentum developed by the descending load and the time delay in brake application.

Ultimately the root cause was attributed to the rope pressing against the rings of the CRL and causing it to activate prematurely. The electrical circuit was upgraded in 2013, however this limit switch was not replaced.

Following the incident, the electrical circuit was altered to include three phase isolation when the CRL trips, an additional brake contact was introduced to ensure faster brake application, a new start button inhibits auto-start after reset of the E-Stop and the mechanical assembly of the CRL altered to prevent inadvertent activation.
