WEEKLY INCIDENT SUMMARY

Week ending Friday 1 April 2022

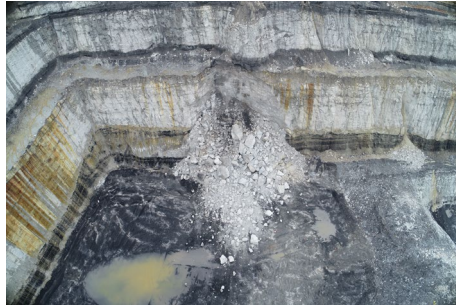
INCIDENT TYPE	SUMMARY	COMMENTS TO INDUSTRY
Dangerous incident IncNot0041908 Open cut coal Ground or strata

A highwall failed and material breached the exclusion control zone in a known geotechnical hazard area. A grader was operating in the area at the time. The operator felt a vibration, noticed dust and quickly drove away from the highwall. The worker was clear of the falling material.	Recent highwall failures in NSW mines have resulted in material overwhelming catchment bunds and exclusion zones. Mine operators should ensure an adequate exclusion zone is established based upon the maximum reasonable potential of a failure occurring, including the potential for a failure to extend through to adjacent jointing/faults. Mine operators should also ensure water egress is minimised to highwall crests to reduce the potential of a failure occurring.

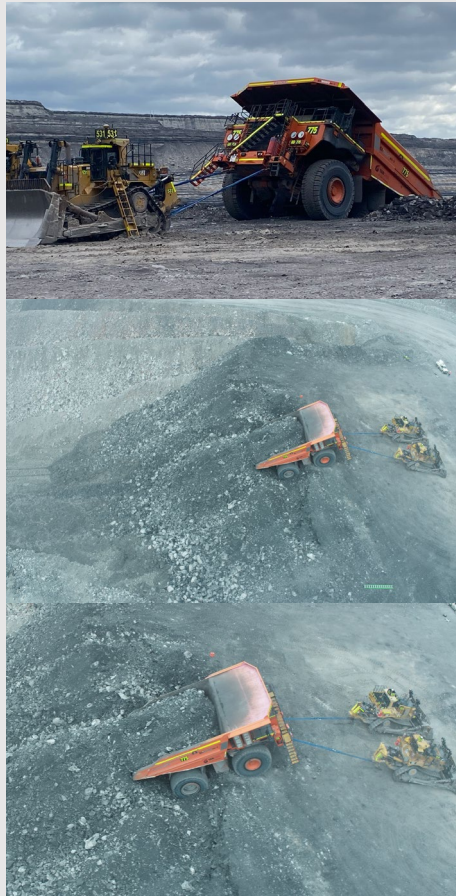
Dangerous incident
IncNot0041937
Open cut coal
Ground or strata

A dump truck was tipping a load when the ground failed, causing the rear of the truck to sink. The operator was assisted from the truck without injury.

Tip heads and dumps must have suitable inspection regimes in place. Changes in conditions, such as wet weather, should trigger a change in inspection frequency.

Design of dumps and catch bunds should consider areas where water can accumulate.

When dumping near bodies of water or mud, strict controls should be implemented based on robust risk assessment processes.
