# WEEKLY INCIDENT SUMMARY

Week ending Friday 15 April February 2022

This incident summary provides information on reportable incidents and safety advice for the NSW mining industry. To report an incident to the NSW Resources Regulator: phone 1300 814 609 24 hours a day, 7 days a week.

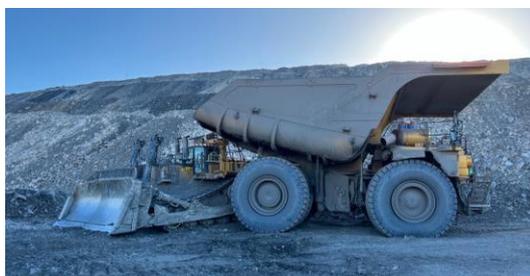
INCIDENT TYPE	SUMMARY	COMMENTS TO INDUSTRY
Dangerous incident IncNot0041984 Open cut coal mine Roads or other vehicle operating areas	A dozer was pushing material in the north-west corner of the dump. A haul truck arrived and started to reverse into the north-east corner of the dump. The dozer operator started reversing across the dump to allow the truck to unload in the north-west corner. The truck and dozer collided. There was no communication between the truck and dozer.	Mine operators must have robust systems in place for supervisors to verify that identified controls such as positive communication are implemented, used correctly and are appropriate.  Workers have a legislative responsibility to follow procedures such as positive communications.

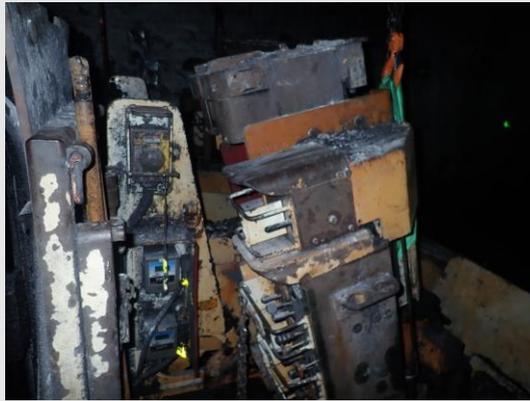
Dangerous incident  
IncNot0041985  
Underground coal  
mine

A roof bolting rig was being removed from a continuous miner. The rig was supported by a chain block attached to a roof bolt. When the last bolt was removed the rig swung, pinning a worker to the rib protection. The bolting rig was pushed off the worker, who then walked to the crib room. The worker was driven out of the mine and transferred to hospital. The worker suffered 2 broken ribs and a lacerated lung.

During tasks involving lifting, workers must assess the potential for the load to shift as it is moved. When the potential for load-shifting exists, controls such as no-go zones must be defined and communicated to all workers involved in the task.

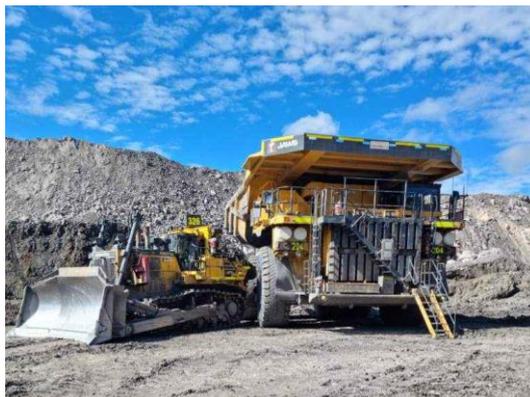
Dangerous incident  
IncNot0041991  
Open cut coal mine  
Roads or other  
vehicle operating  
areas

A dozer was cleaning up material on the dig bench and repairing the floor. A dump truck arrived on the dig bench and parked on the low-wall side, waiting to be called to load. The dozer finished cleaning up and reversed 40 m to the low-wall side where the dump truck was parked. The dozer hit the off-side of the dump truck, damaging the fuel tank.

Vehicle collisions on mine sites continue to be a source of concern. As technology evolves and develops, mine operators should routinely review proximity detection and collision avoidance systems to determine if they are suitable for their operation. Workers should use all aids such as mirrors, cameras and awareness systems that are fitted when operating plant, particularly when reversing.

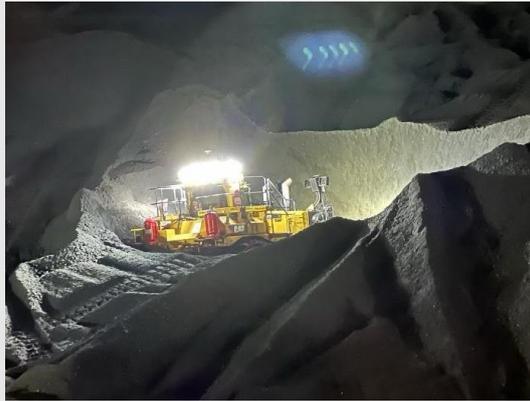
Dangerous incident  
IncNot0042002  
Open cut coal mine  
Ground or strata  
failure

A dozer was working on a clean coal stockpile when there was a slumping of coal into the valve. The dozer sunk about 2 m but remained level. The operator remained in the dozer while 2 other dozers cleared coal so the dozer could walk out of the slump.

Workers must be trained to operate dozers on reclaim stockpiles. This training must include identifying and responding to alarms and managing the hazards associated with draw down valves.

Additionally, workers must be familiar with different coal properties and how this impacts material behaviour on stockpiles.

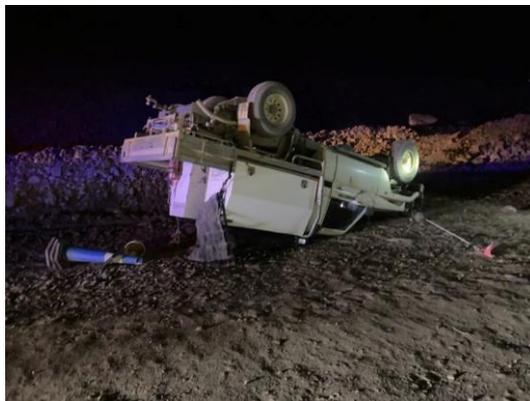
Dangerous incident  
IncNot0042016  
Open cut coal mine  
Roads or other  
vehicle operating  
areas

A light vehicle was travelling along a haul road. The operator was distracted by an open lid on a toolbox and has driven up a windrow and rolled onto the roof. The driver exited the cab of the vehicle with no injuries.

Workers must always remain focused on controlling their vehicle. If a situation develops that requires their attention, such as an open toolbox, operators should safely stop the vehicle before addressing the issue.
