**NSW
Resources
Regulator**

Quarterly safety report

January to March 2022

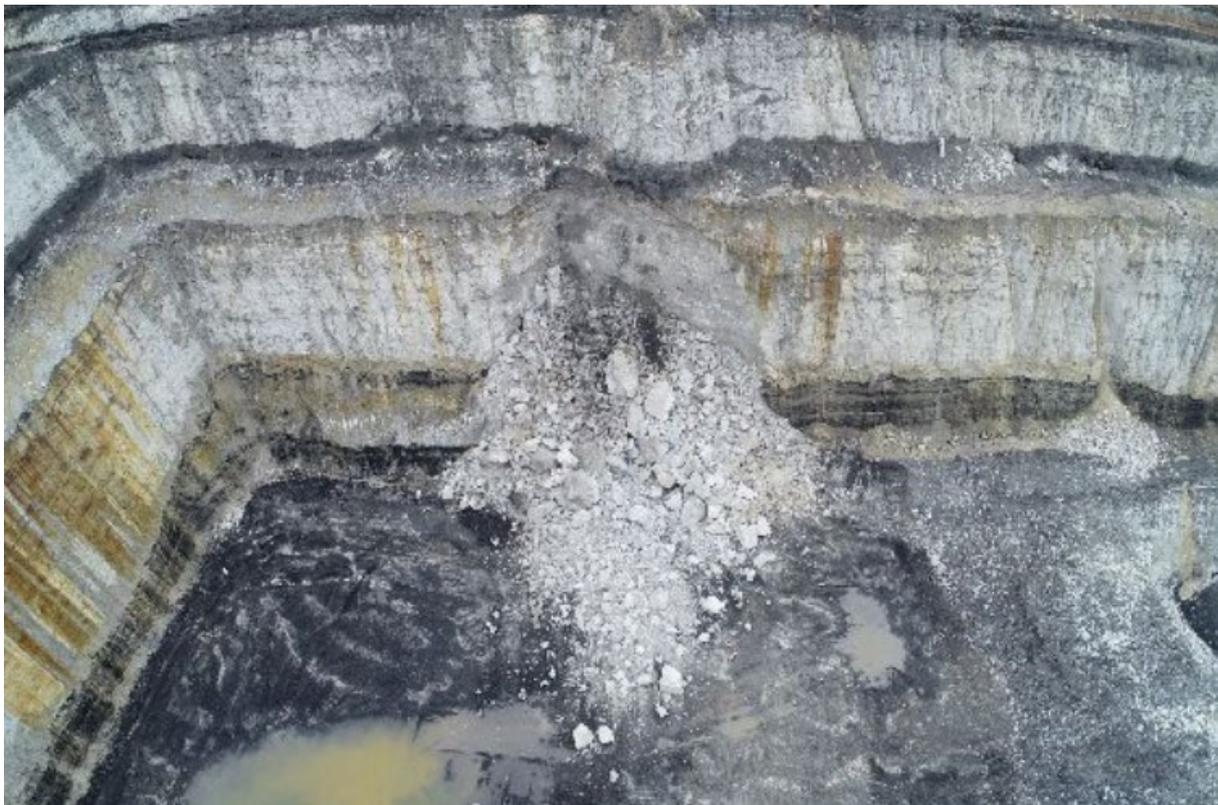
DANGEROUS INCIDENT - HIGHWALL FAILURE NEAR OPERATING GRADER

A highwall failed and material breached the exclusion control zone in a known geotechnical hazard area. A grader was operating in the area at the time. The operator felt a vibration, noticed dust and quickly drove away from the highwall. The worker was clear of the falling material.

Below: Photograph showing the extent of the failure

Recent highwall failures in NSW mines have resulted in material overwhelming catchment bunds and exclusion zones. Mine operators should ensure an adequate exclusion zone is established based upon the maximum reasonable potential of a failure occurring, including the potential for a failure to extend through to adjacent jointing/faults. Mine operators should also ensure water egress is minimised to highwall crests to reduce the potential of a failure occurring. Refer to [Safety Bulletin: SB20-01 Failure of highwalls, low walls and dumps.](#)

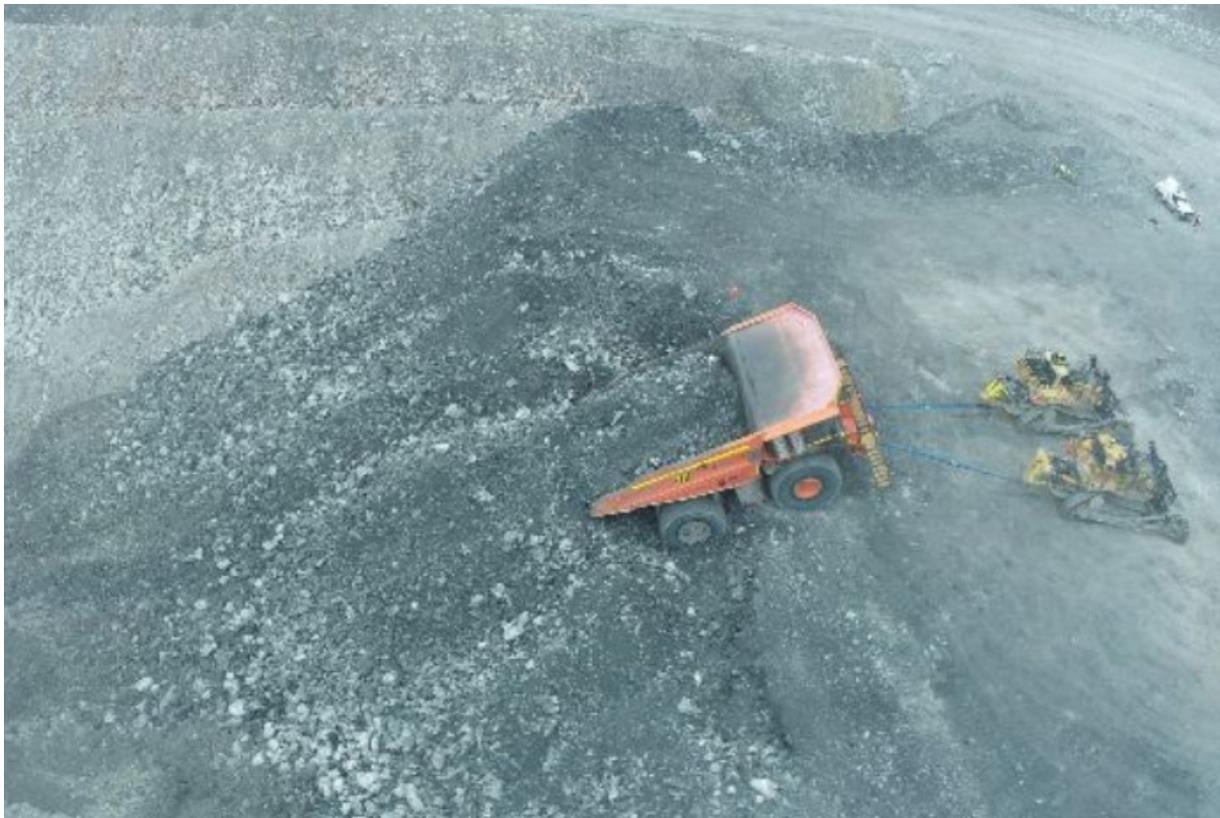
DANGEROUS INCIDENT – OPERATOR ESCAPES FROM SUNKEN DUMP TRUCK

A dump truck was tipping a load when the ground failed, causing the rear of the truck to sink. The operator was assisted from the truck without injury.

Below: The dump truck being stabilised by two dozers.

Tip heads and dumps must have suitable inspection regimes in place. Changes in conditions, such as wet weather, should trigger a change in inspection frequency. Design of dumps and catch bunds should consider areas where water can accumulate. When dumping near bodies of water or mud, strict controls should be implemented based on robust risk assessment processes. Refer to [Safety Bulletin: SB20-01 Failure of highwalls, low walls and dumps](#).

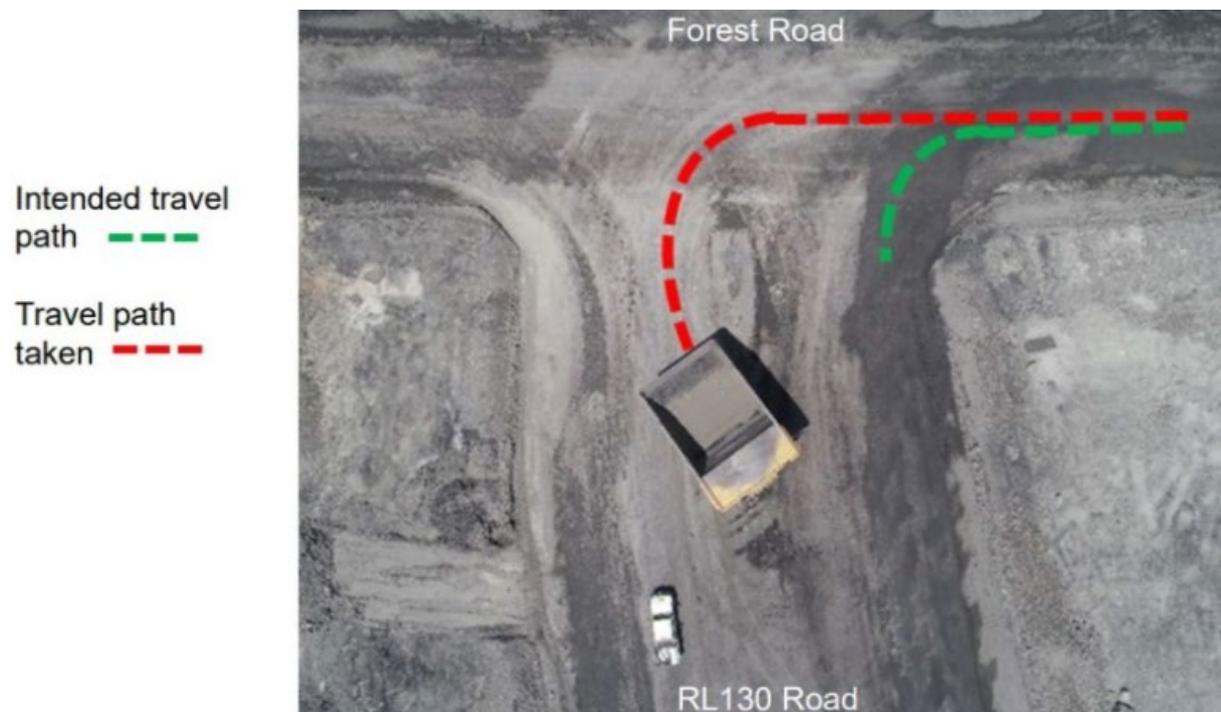
DANGEROUS INCIDENT- HAUL TRUCK MISS TURNS INTO ONCOMING TRAFFIC

A truck hauling reject incorrectly turned left into an outgoing lane intersection. A light vehicle was approaching the intersection. The operator of the vehicle identified the truck and came to a stop before the intersection. The truck identified the vehicle as it began its left-hand turn, at which point the vehicle was about 25 metres away from the intersection.

Below: Aerial view showing the truck's intended and actual travel paths.

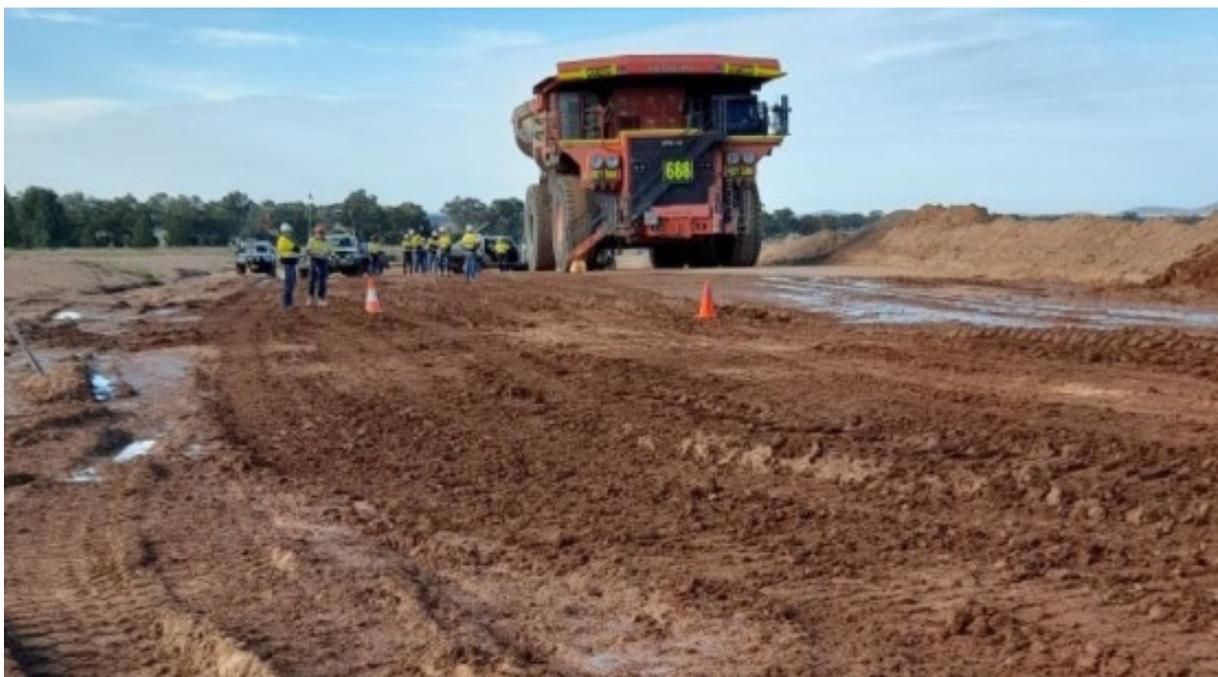
DANGEROUS INCIDENT - HAUL TRUCK LOSS OF CONTROL (LOC) INCIDENT

A haul truck lost control on a wet and muddy area of a roadway and collided with a stationary haul truck. The truck had stopped due to the poor roadway conditions. The ground was wet due to a machine having been washed down in the area.

Below: Area of wet ground and position of haul truck

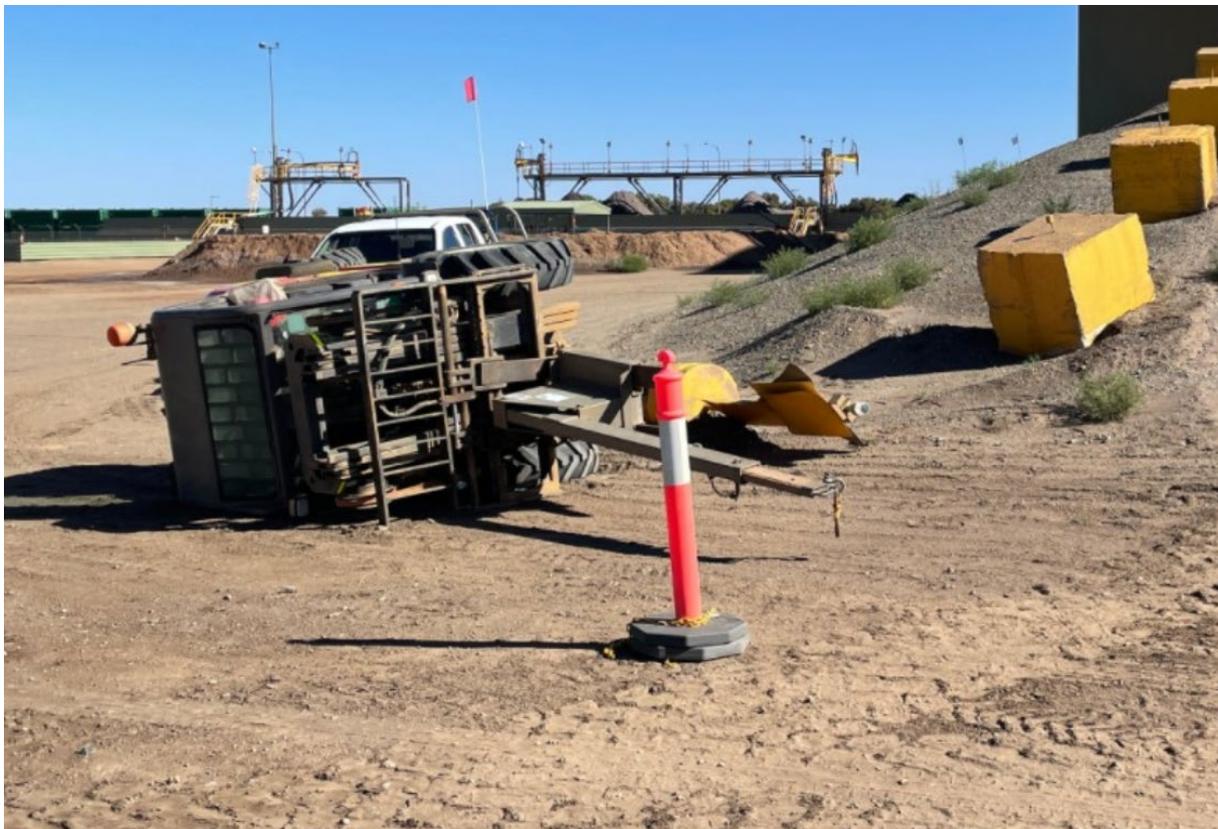
DANGEROUS INCIDENT - FORKLIFT DRIVER HELPED BY SEATBELT

While travelling back to the workshop, a forklift stopped to give way to another vehicle. As the forklift moved off it hit the 'Give Way' sign and overturned. The operator was wearing a seatbelt at the time of the incident and was uninjured.

Below: The forklift on its side after overturning.

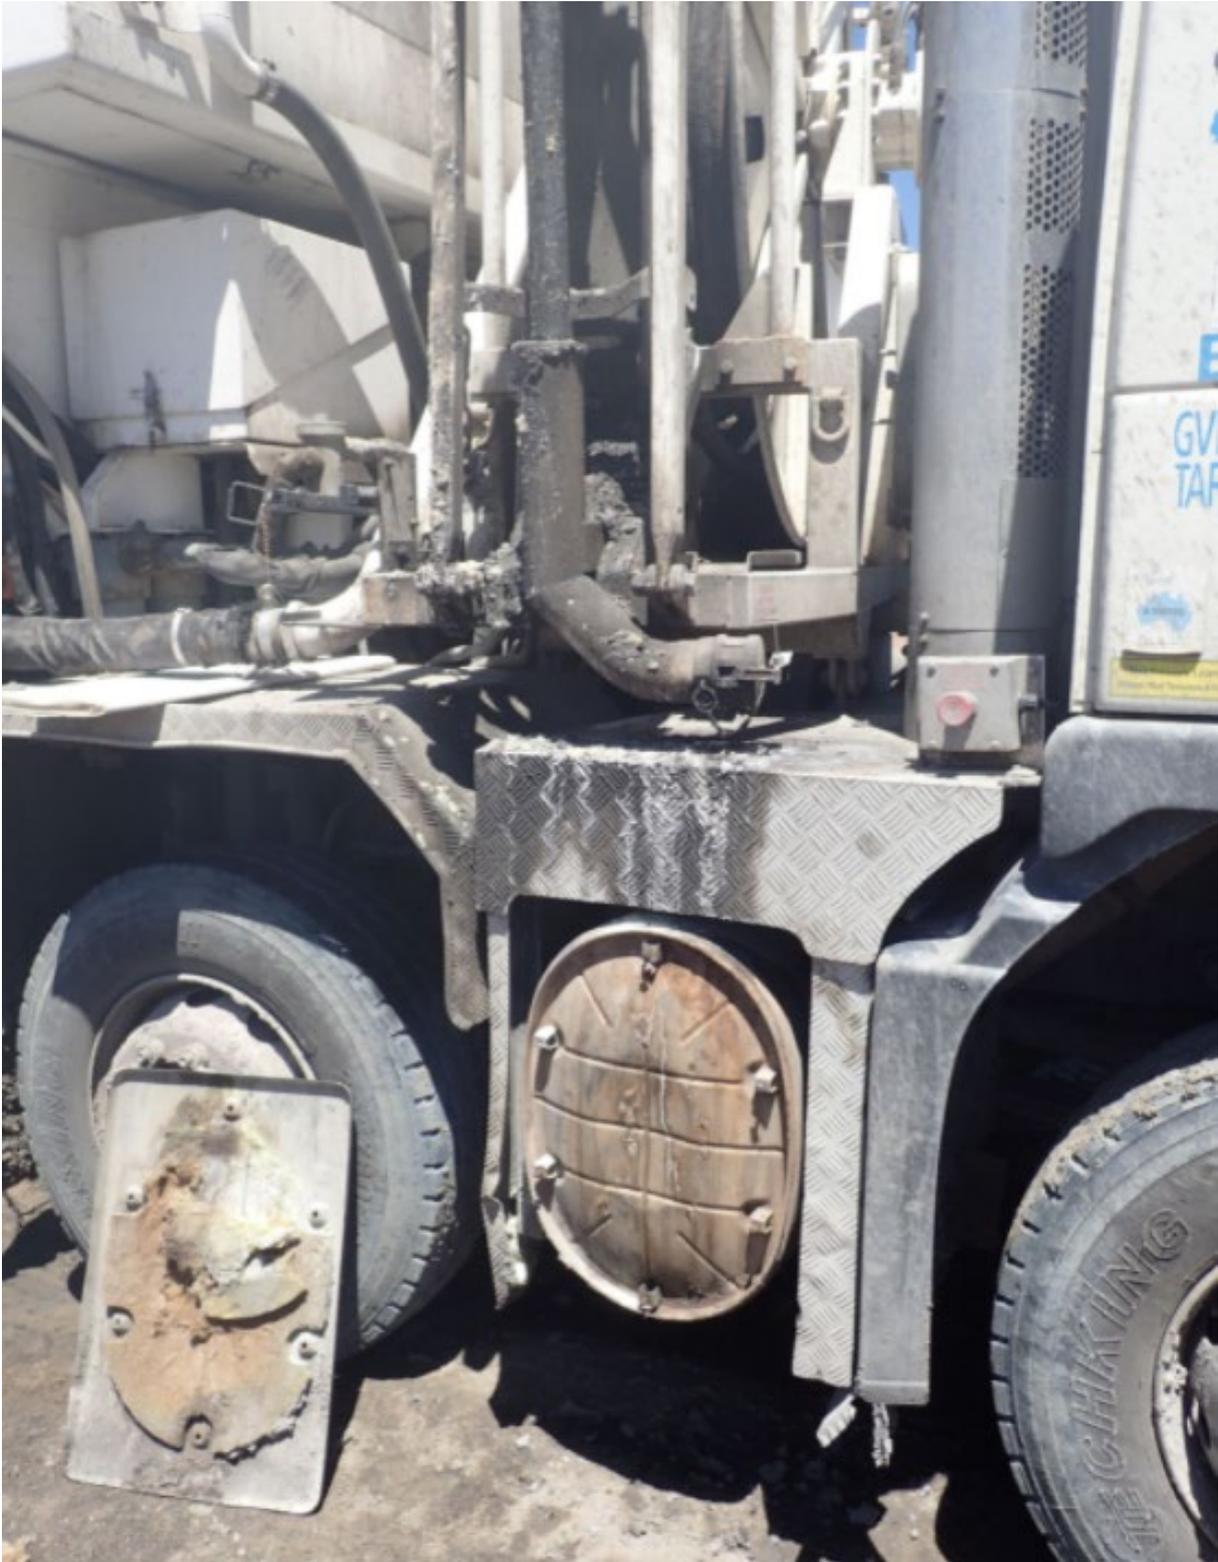
DANGEROUS INCIDENT - MOBILE MANUFACTURING UNIT TRUCK FIRE

A fire occurred on a mobile manufacturing unit truck after it returned empty from the pit. The operator was checking the machine and observed a flame coming from above a cover over exhaust components behind the rear of the cab. Flames were visible about 10 cm high at the top of the cover. He extinguished the flame with a hand-held extinguisher. A preliminary investigation indicated that small amounts of explosive emulsion dripped off the delivery hose and accumulated on top of the cover.

Below: Exhaust components showing area of flames.

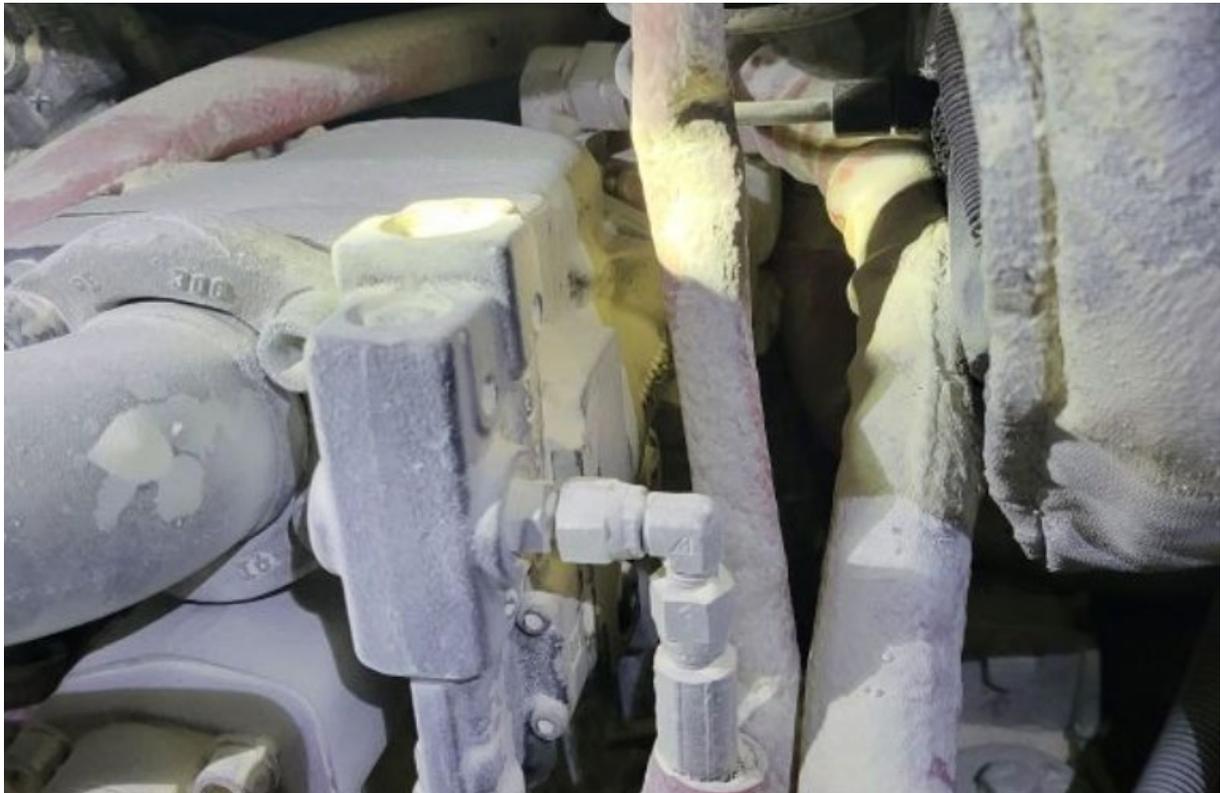
DANGEROUS INCIDENT- FIRE ON SPRAY RIG

A spray rig was being trammed up the decline when it stopped to allow traffic to pass. The operator exited the rig and noticed smoke coming from the offside near the exhaust. The operator extinguished the fire using a hand-held fire extinguisher.

Below: Poor hose standards can lead to fires.

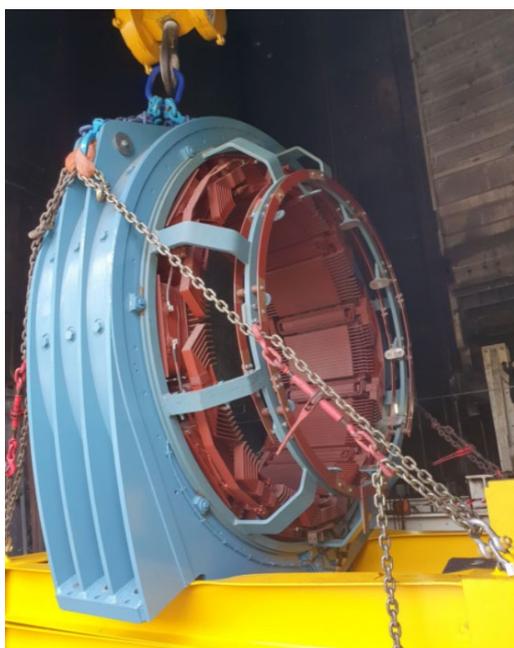
DANGEROUS INCIDENT - LOAD FAILURE UNDER INVESTIGATION

Below: Resting place of the fallen motor section.

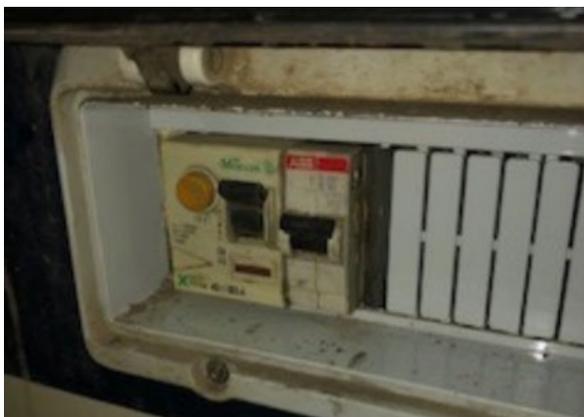
DANGEROUS INCIDENT - JUMBO OPERATOR SHOCKED

Below: Circuit breaker and control cabinet.

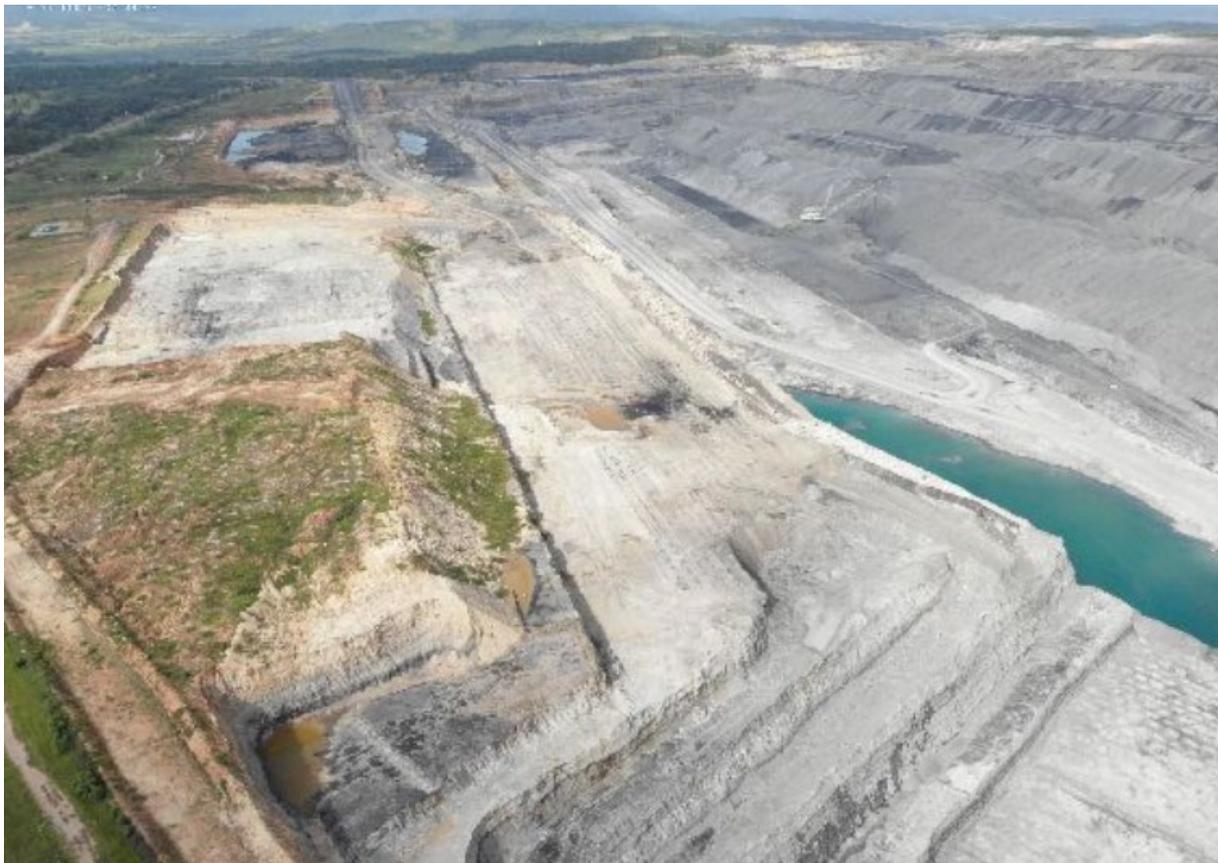
DANGEROUS INCIDENT - PREMATURE DETONATION DURING PLANNED SHOT

Below: Aerial view of shot area.
