INVESTIGATION INFORMATION RELEASE

Two mine workers injured during pipe installation work

Incident date: 17 May 2022

Location: Centennial Mandalong Mine

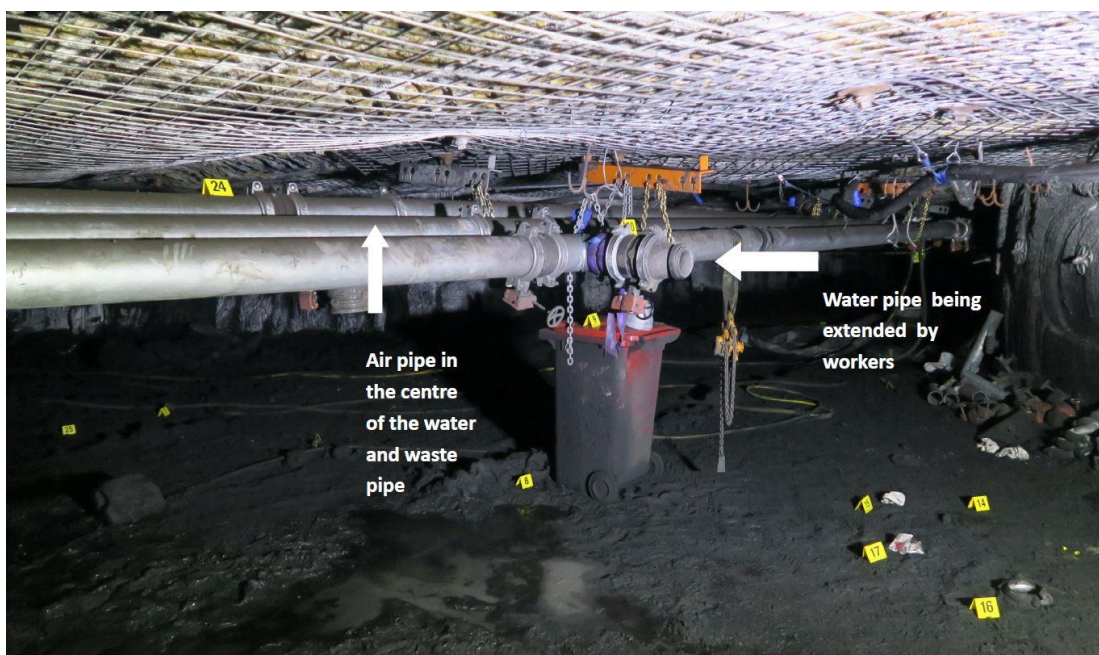
Figure 1: Incident scene photograph taken by investigator

The NSW Resources Regulator has commenced an investigation into the cause and circumstances of the incident which is in its preliminary stages. An examination of the scene, which included an inspection of pipes in the vicinity of the installation work, identified an uncapped T-piece in the air pipe. Several pieces of pipe work fittings, including clamps (couplings) and end caps, were located a short distance away and the investigation will explore whether or not these items are linked to the incident.

- undertake appropriate work area and plant inspections to ensure the risks associated with the installation and commissioning of plant are managed
- ensure that plant is isolated correctly to prevent risk of injury to workers.
