SAFETY BULLETIN

DATE: JUNE 2022

Collisions on overburden dumps

Mine safety reference	SB22-07
------------------------------	---------

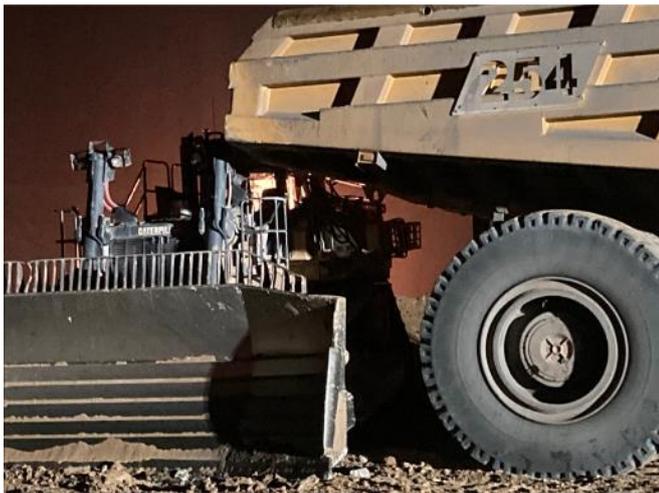
Figure 1 – Haul truck reverses into dozer

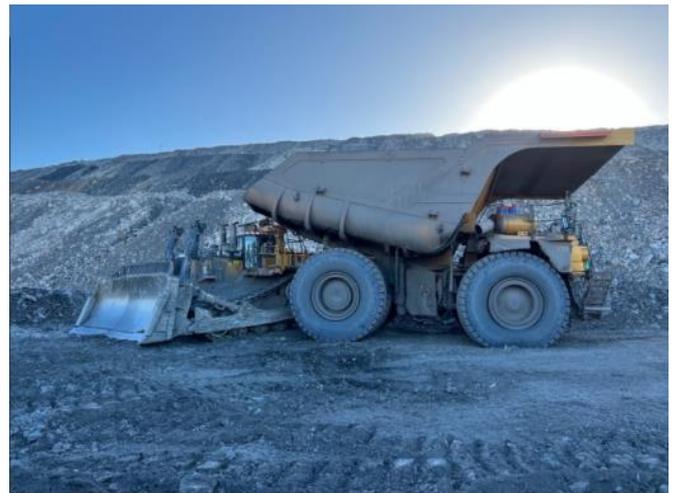
Figure 2 – Haul truck reverses into dozer

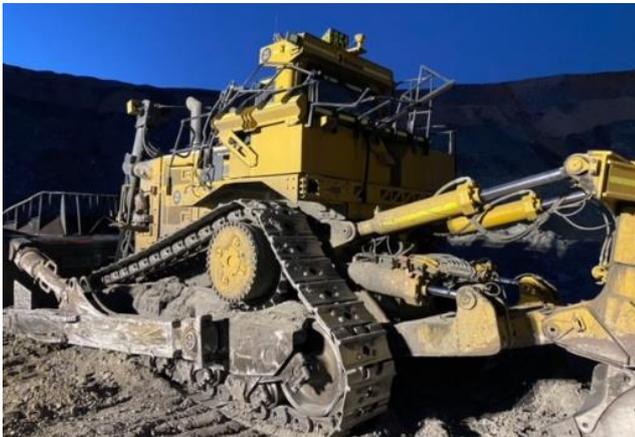
Figure 3 – Dozer reverses into haul truck

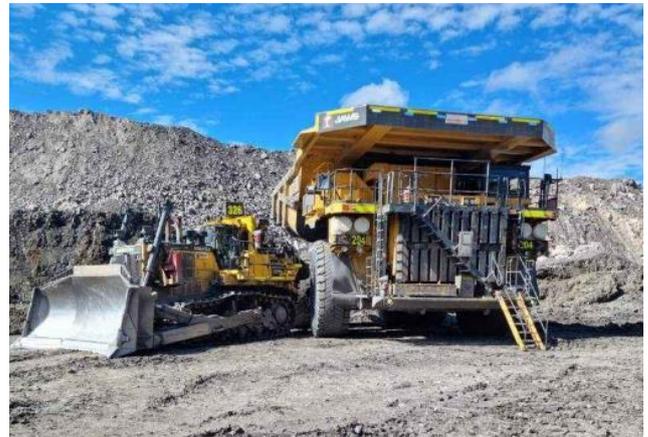
Figure 4 – Equipment damage post contact

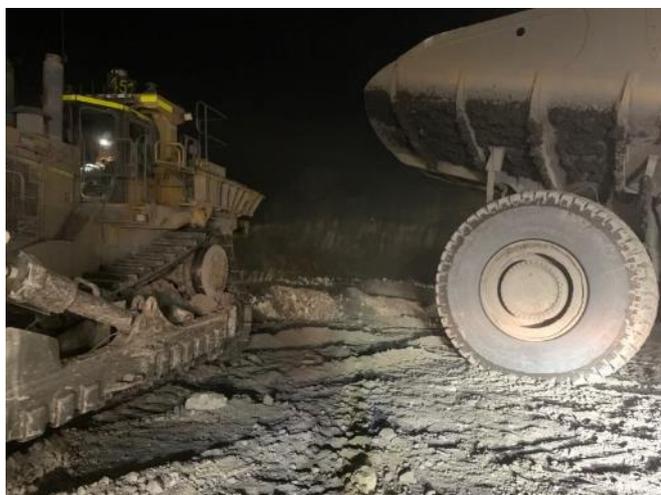
Figure 5 – Haul truck reverses into dozer
