WEEKLY INCIDENT SUMMARY

Week ending Friday 12 August 2022

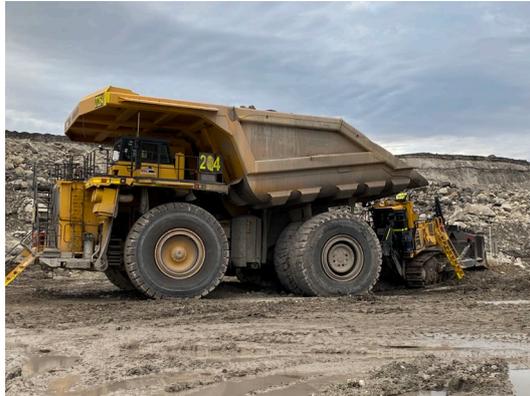
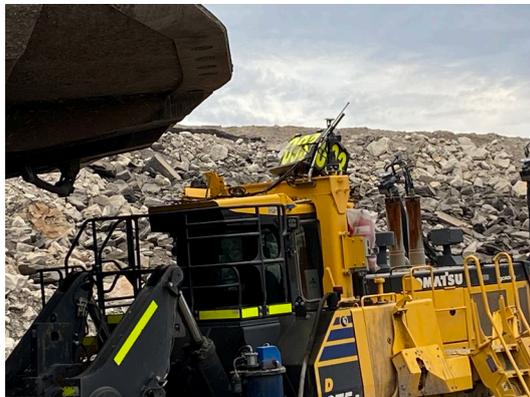
INCIDENT TYPE	SUMMARY	COMMENTS TO INDUSTRY
Dangerous incident IncNot0042774 Open cut coal Roads or other vehicle operating areas	<p>Two dozers were working to repair a haul road. A haul truck arrived to deliver fresh material. The haul truck driver made positive communications with one dozer and the truck started to reverse to the dump point. As the truck reversed, it hit the second dozer.</p> <p>The dovetail of the haul truck made contact with the unit number sign on the cabin of the dozer resulting in minor damage. No workers were injured.</p>	<p>When multiple dozers are operating in one area, procedures must address vehicle separation, communication and control of the work area. Supervision arrangements should also be reviewed to confirm the adequacy for the task. A recent Resources Regulator campaign focused on the risk of collisions involving heavy mining equipment.</p> <p>Refer to:</p> <ul style="list-style-type: none"> Vehicle incidents - heading in the wrong direction
