WEEKLY INCIDENT SUMMARY

Week ending Friday 29 July 2022

Mine safety reference ISR22-30

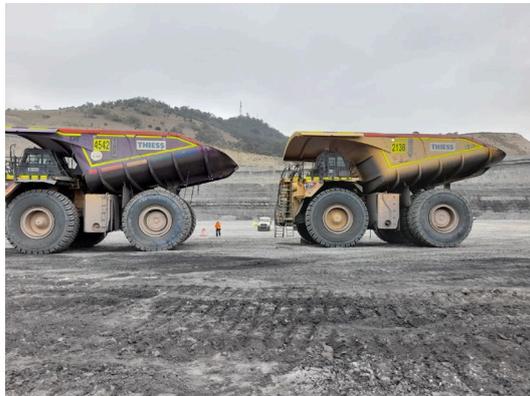
INCIDENT TYPE	SUMMARY	COMMENTS TO INDUSTRY
Dangerous incident IncNot0042669 Open cut coal mine Roads or other vehicle operating areas

<p>A dump truck was queued, waiting to be loaded. The operator put the truck in neutral and began to get something from a bag. The truck started rolling forward. The truck rolled 10 m and collided with the dovetail of another truck. No-one was injured.</p>	<p>Management plans and vehicle operating procedures invariably specify separation distances between mobile plant and require vehicles to be parked fundamentally stable. Vehicle operators must comply with correct queueing and park-up arrangements. Mine operators should consider installing interlocks or warning systems for park brakes on other mobile equipment. Refer to: Safety Bulletin SB13-02 Unplanned movements of vehicles - too many near misses.</p>

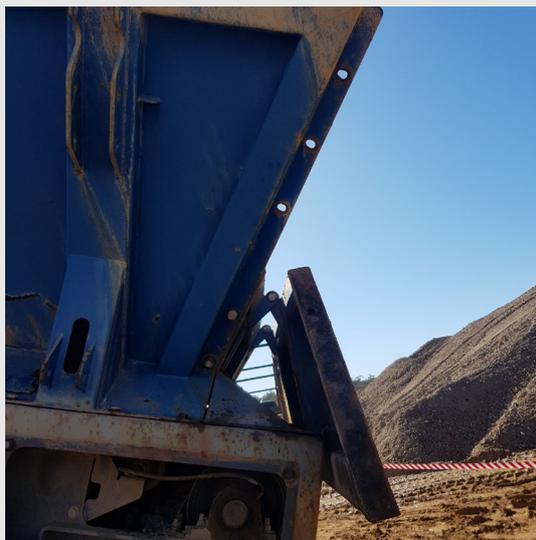
Dangerous incident
IncNot0042705
Construction
materials

A worker was disassembling a hopper from a mobile crusher in a quarry. The worker removed one side and was removing the rear plate that was held in place by 5 bolts. The worker believed that the section would still be held in place by the 2 lower bolts. However, the worker failed to identify that the section was hinged. When the third bolt was removed, the section swung down, hitting the worker's shoulder. The worker suffered soft tissue injuries and a suspected fractured vertebrae.

Supervisors should ensure that workers have access to procedures before commencing tasks and ensure that they understand the risks and controls associated with that task. Workers have a legislative duty to care for their own health and safety and that of others (s28 *Work Health and Safety Act 2011*). One of the duties is to cooperate with any reasonable policy or procedure. Procedures are developed to help protect workers from injuries or illness. Where a procedure exists for a particular task, workers should follow the procedure. Any deviation from a procedure should first be discussed with a supervisor and appropriate risk control measures put in place.
