# WEEKLY INCIDENT SUMMARY

Week ending Friday 19 August 2022

**Mine safety reference** ISR22/33

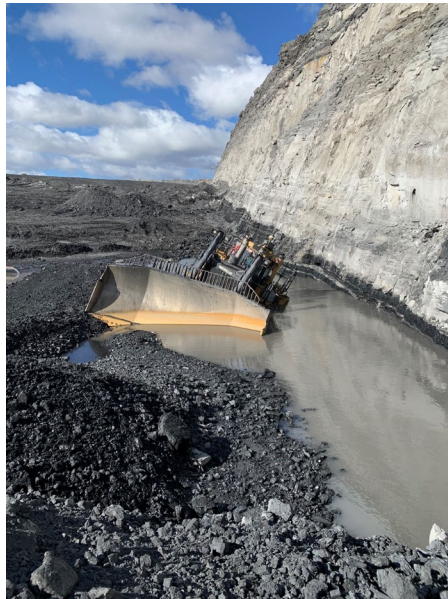
INCIDENT TYPE	SUMMARY	COMMENTS TO INDUSTRY
Dangerous incident IncNot0042791 Open cut coal mine Roads or other vehicle operating areas	A dozer was cleaning up around an excavator when it slid off the coal floor into a body of water and dropped a track. The water level came up to the level of the tracks. The driver was unharmed in the cabin. Material was used to form a bridge so the operator could exit the vehicle safely.	Mine operators must have controls in place to manage the risks posed by planned and unplanned bodies of water near vehicle operating areas. Shift change-over procedures should include communication about the status of sumps/water particularly after rain.

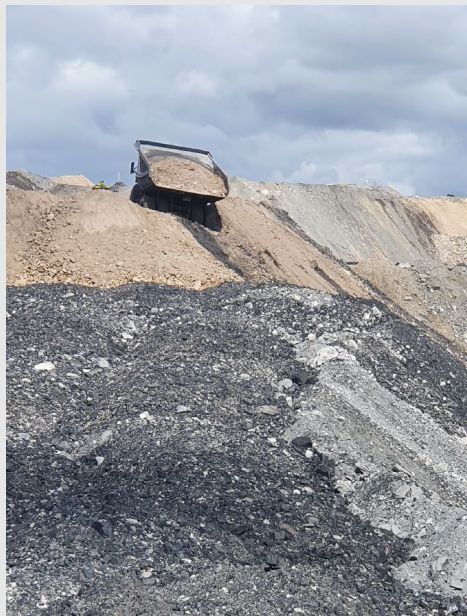
Dangerous incident  
IncNot0042803  
Open cut coal mine  
Ground or strata

When an operator was ready to dump a load of overburden in a haul truck, all 4 rear wheels sunk when the dump slumped. The operator exited the truck safely.

When co-disposing material with different properties, an assessment should be conducted to confirm the suitability of the material for the dump design (e.g. dump height).

A system must be in place to ensure that dump operations are compliant to site standards about material types and design parameters.

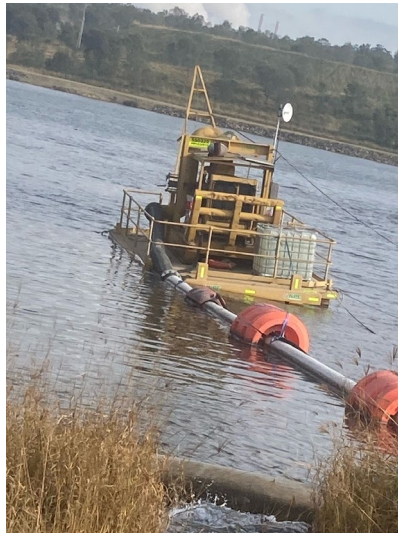
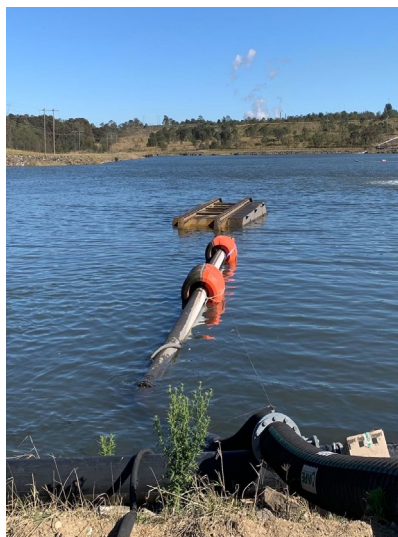
Dangerous incident  
IncNot0042812  
Open cut coal mine

A worker was servicing a pontoon pump when a defect was identified on the primer pump. The faulty primer pump was removed and placed in a boat tethered to the pontoon.

The worker noticed the pontoon tilting and decided to swim to the bank. As the worker swam away, the pontoon sank dragging the boat under the water. The worker was not wearing a life vest.

The pontoon had an IBC filled with water on one side of the pontoon to act as ballast control. When the vacuum pump was removed, the water syphoned out of the IBC. The centre of gravity changed, tipping the pontoon and allowing it to take on water.

When a task changes, workers must stop and reassess the job steps and the risks involved in the task. If appropriate controls can't be put in place, the task must not proceed.

Any worker who is required to work on or access floating plant or involving boats must wear an appropriate life vest.

All floating vessels must be addressed in an emergency plan and workers should routinely practice evacuation drills for a rapidly listing or sinking event. Floating vessels should have a stability and buoyancy assessment with consideration given to critical scenarios where a vessel could rapidly list or sink.

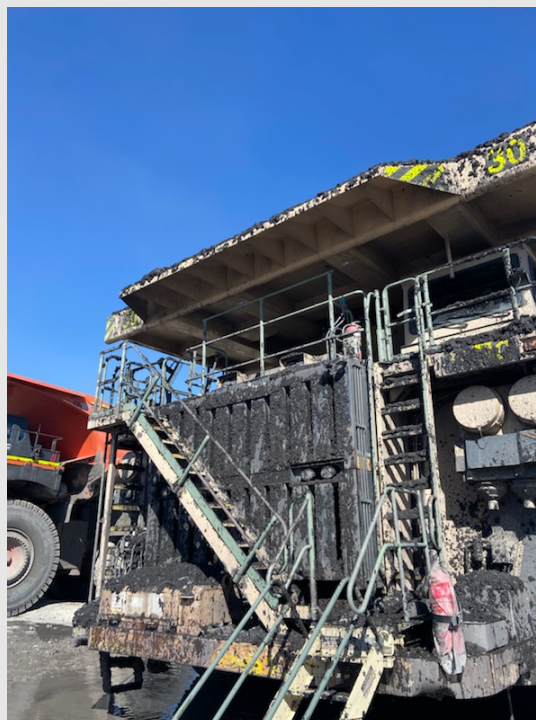
Dangerous incident  
IncNot0042819  
Open cut coal mine

An operator was boarding a reject truck when a clump of reject fell from the headboard and hit the operator on the back of the neck. The operator suffered spinal bruising.

Wet material hanging up on headboards is a hazard that poses a risk to operators entering and exiting vehicles. The method and rate of loading reject should be reviewed to minimise material spraying all over vehicles and infrastructure.

Controls such as hosing down headboards should be implemented to control the risk to operators of falling material.
