Investigation report

Report into the serious injury of a worker at Myuna Colliery

September 2022

Published by the Department of Regional NSW

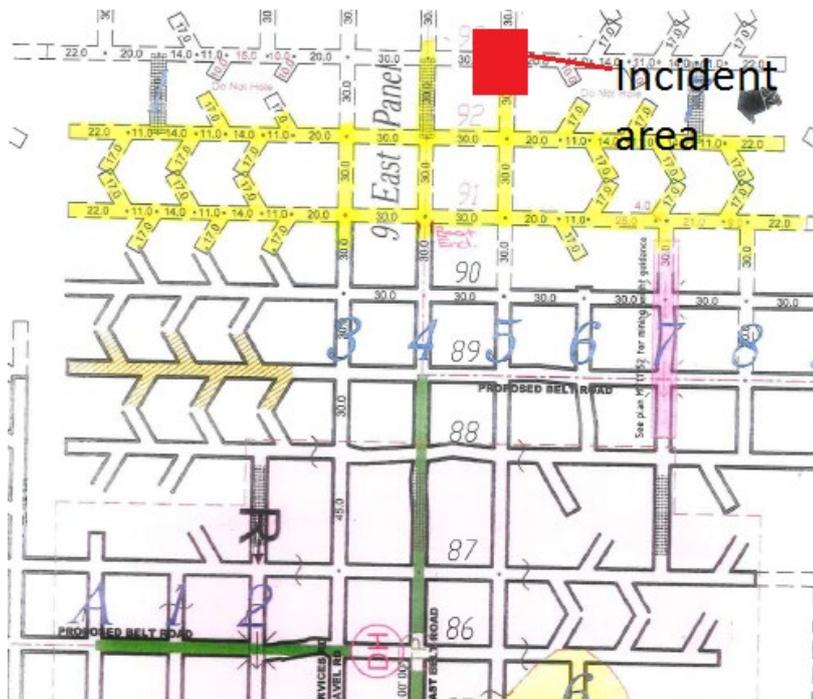
Figure 1 - Excerpt from 9 East Panel Plan

The incident occurred in the Myuna Colliery Fassifern Seam 9 East Panel, Heading 5 cut through 93. An intersection was in the process of being formed at that location when the incident occurred.

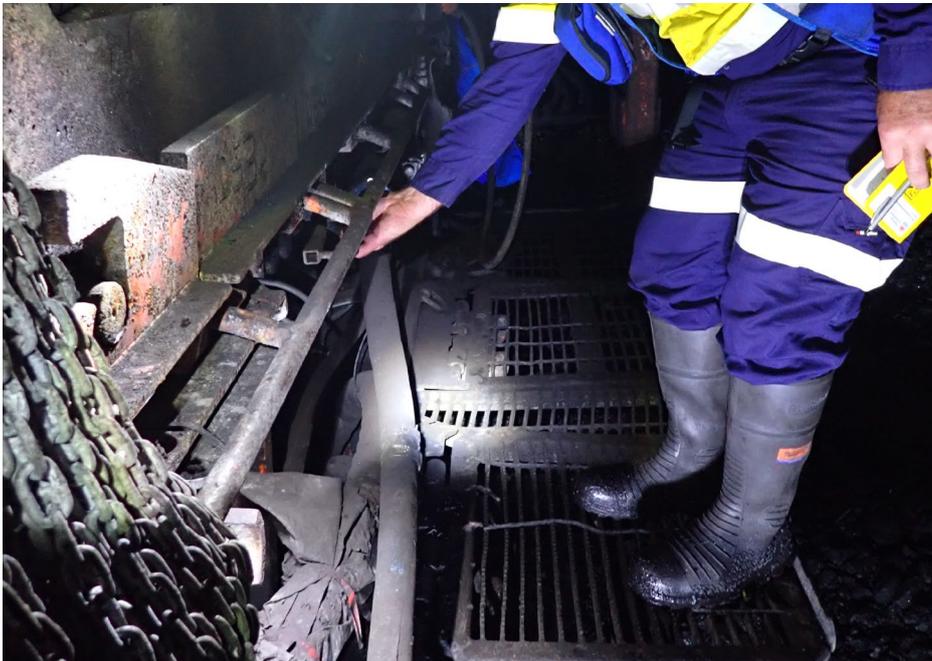
CM313's operator and the other worker lowered CM313's temporary roof supports and retreated the bolting rigs to their stowed positions. CM313's diversion valve was activated by adjusting a lever adjacent to the right side platform of CM313. The activation of the valve resulted in the necessary energy being supplied to CM313's tracks, enabling movement of the continuous miner.

Figure 5 - Location of diversion valve above right side platform on CM313

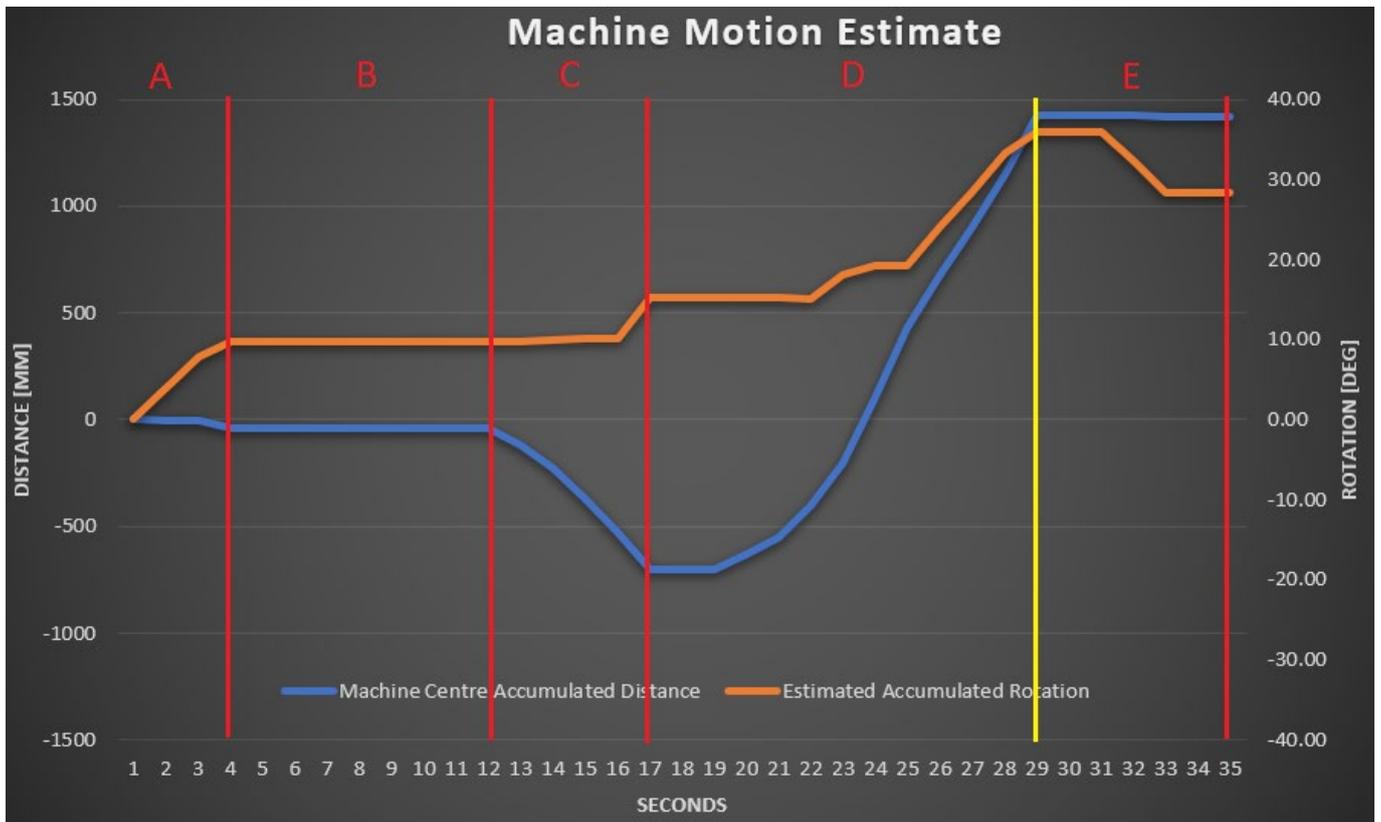
Figure 2 - Machine motion estimate prepared by Komatsu (adapted by the Regulator)

Figure 6 is a graphical representation of the data extrapolated from CM313’s onboard control system. The movement data shown in the graph relates to CM313’s centre mass and is not necessarily representative of the movement of its extremities. The seconds count along the horizontal axis begins at 12.16am. The left axis relates to the movement of CM313, which is shown by the blue line. Decreases in values relate to rearward movement and increases in values relate to forward movement. The right vertical axis relates to the rotation of the machine shown by the orange line. Increases in values represent counter-clockwise rotation and decreases represent clockwise rotation. The vertical lines and lettering on the graph have been added by the Regulator to assist with the description of the incident. The yellow line in Figure 6 shows the point the worker was impacted by the boom.

The injured worker said he did not see CM313 move forward at any stage during the above sequence (i.e. during phases A to E). Investigators found, as shown in Figure 6, any rear movement by CM313 ceased 12 seconds before the incident.

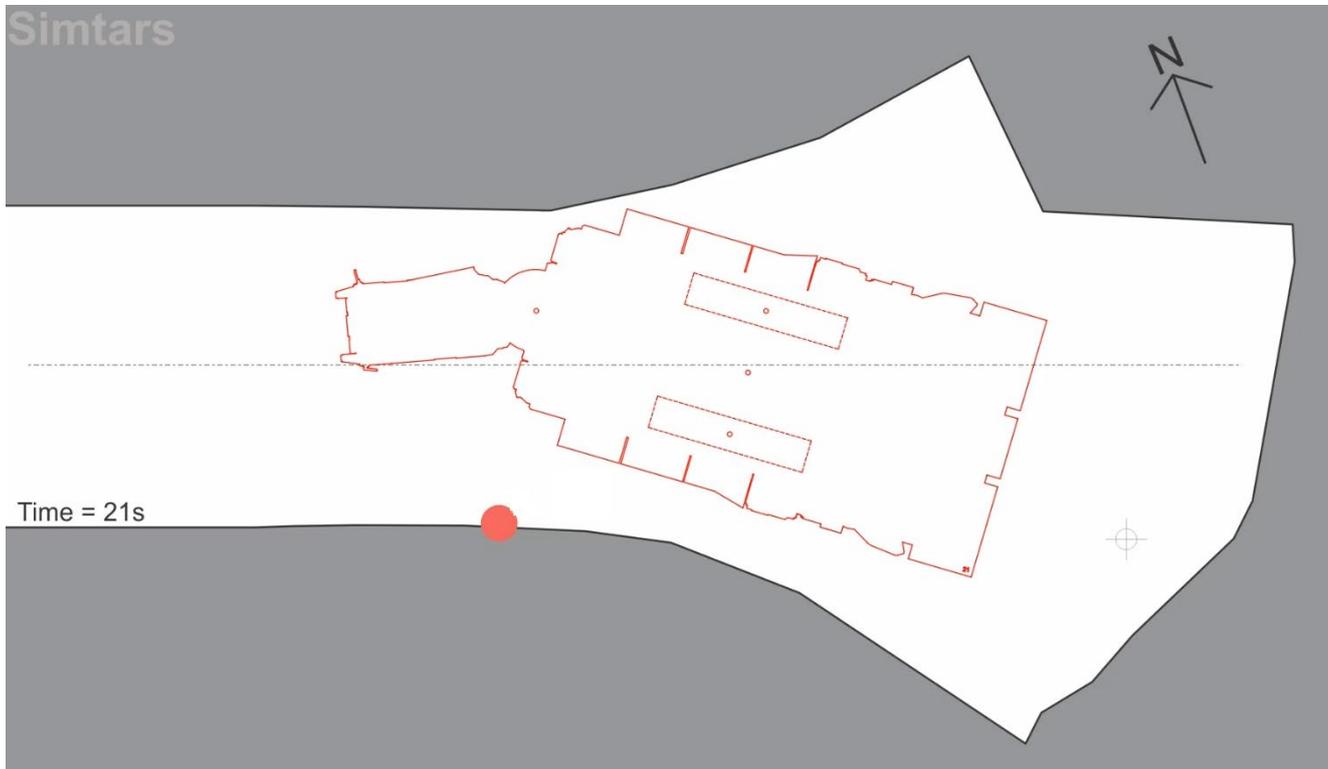
As CM313 moved rearward out of the niche, it moved generally closer to the left rib.

Figure 7 – CM313’s position at the completion of its rearward movement (marker shows position where the (injured) worker became pinned)

The worker said after pulling the first section of the cable back, he walked forward to the location of the red marker shown in Figure 7 in order to take hold of another section of cable. The worker said CM313 was moving rearward when he did this. The investigation did not find any evidence to support this statement, as CM313 retreated for a total of 5 seconds (Phase C).

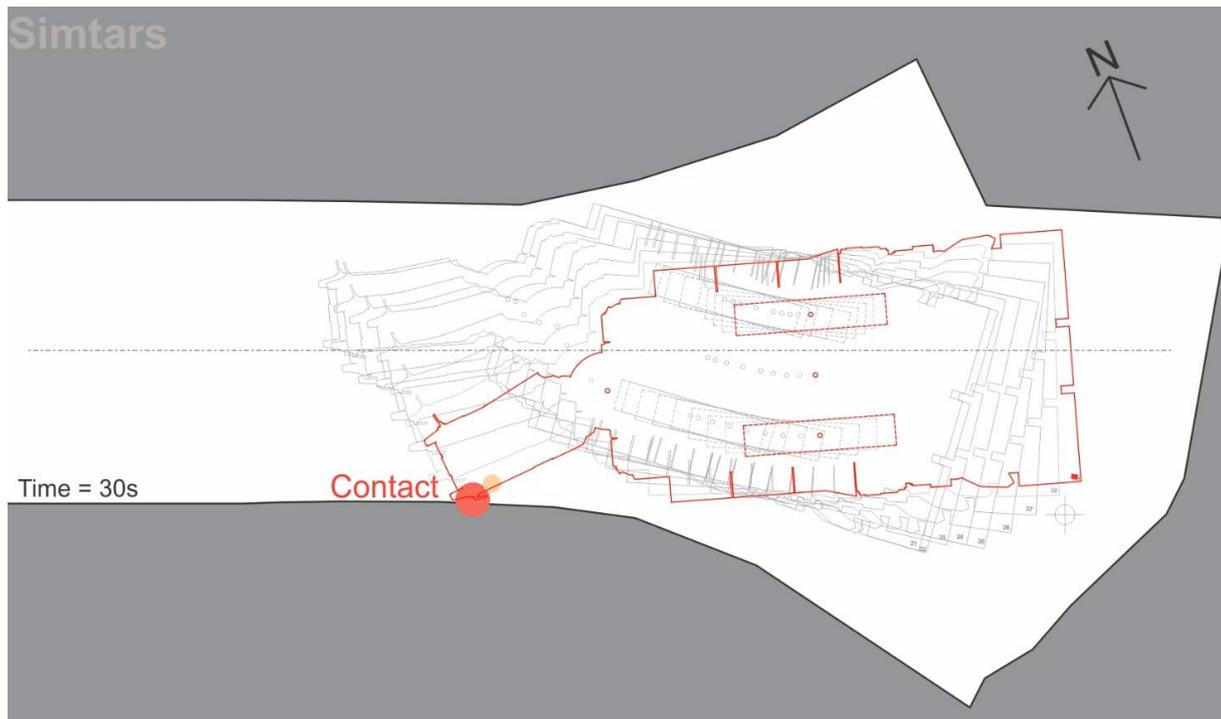
Figure 8 - CM313 forward movement during Phase D

After completing its rear movement, CM313 was stationary for 2 seconds (start of Phase D). CM313’s operator began tramping it forward to further centre the machine. CM313 moved forward and rotated counter-clockwise for about 8 seconds before the incident. As shown in Figure 8 below, there was a considerable lateral movement of CM313’s boom as it moved toward the right rib. In the 5 seconds before the impact, the rear right side of the boom moved laterally by 1853 mm and forward by 2116 mm.

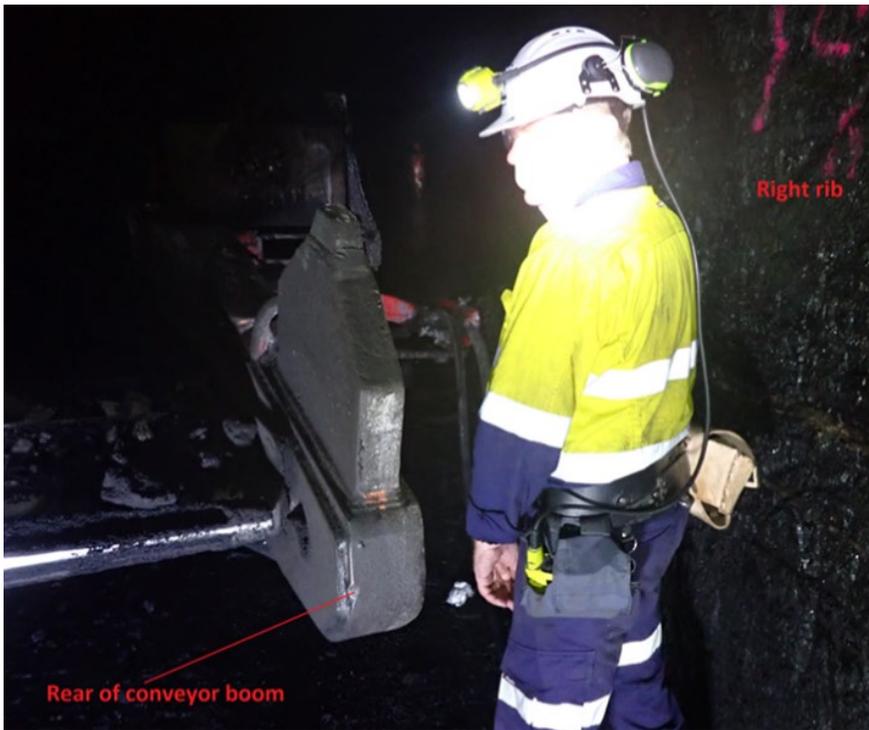
The injured worker was facing slightly inbye and towards the continuous miner when he stood up after bending down. He said he was holding a section of cable at that time. As he stood up, he said he saw the rear right corner of CM313's boom moving towards him and about to hit his upper left side. He moved his left arm across his body to try and protect himself, when the rear right corner of the boom hit his left side and pinned him against the rib.

Figure 10 – A mines inspector standing in the approximate spot where the injured worker just before being hit by boom

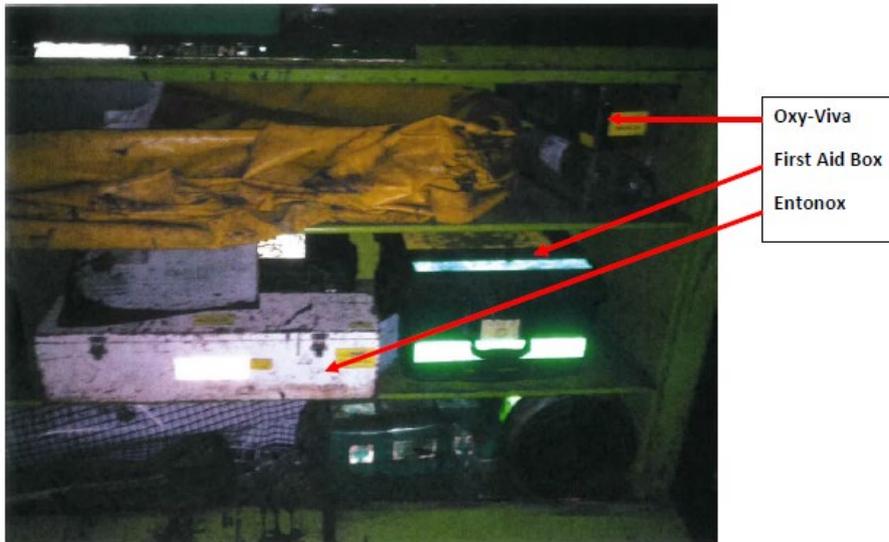
A worker went to the emergency pod in the panel to obtain Entonox; a pain relief gas that is stored in a cylinder and administered through a mask. He reached into the pod and mistakenly took hold of an Oxy-Viva unit instead of an Entonox unit. He returned to the transport vehicle where the injured worker was seated. He handed the Oxy-Viva unit to the other workers providing first aid to the injured worker. Nobody raised any concerns at this time about the fact that Oxy-Viva rather than Entonox had been obtained.

Figure 11 - View of Oxy-Viva and Entonox units in an emergency pod

- The provision of an Oxy-Viva unit to the transport vehicle rather than Entonox unit was based on a human error that arose in an urgent situation. There was no evidence of failings in the mine's systems or training that caused this to occur. The units were quite distinctive in appearance and there was nothing identified in the manner in which the units were stored or labelled which contributed to the error.

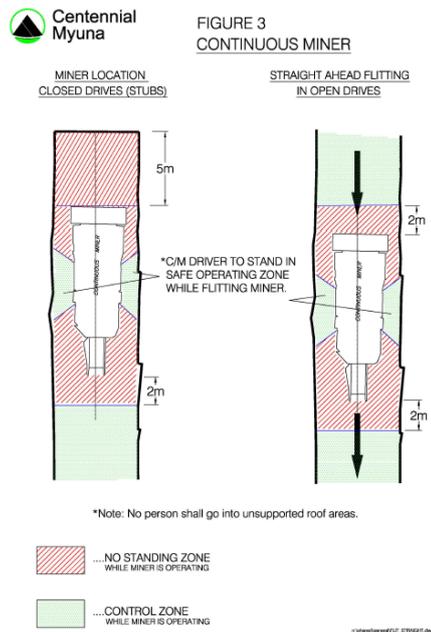
Figure 12 - Excerpt from Centennial Myuna S070 T050 No Standing Zone Procedure

The mine operator stated the following diagram in the NSZ procedure sets out the safe work location zone rules that apply ‘when repositioning a continuous mining machine in a drive’.

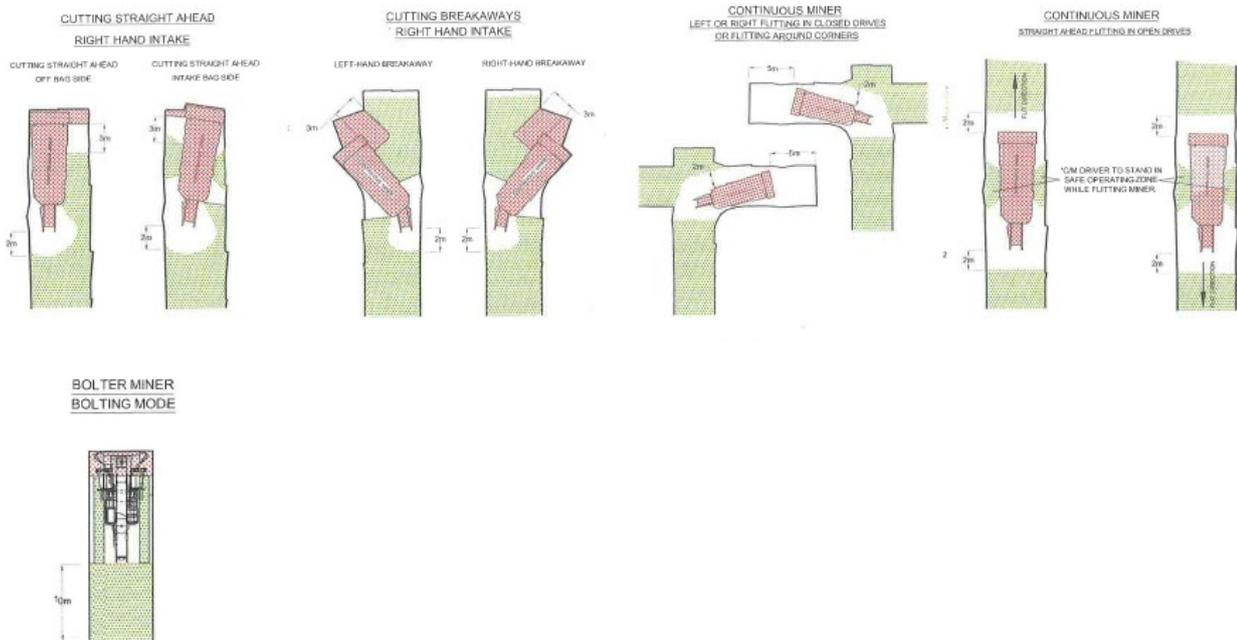
Figure 13 - Excerpt from 'Myuna Collieries - No Standing Zones' plan

There was no corresponding illustration of the above ‘Miner location closed drive stubs’ in the plan. This position existed despite most workers at the mine being familiar with the plan but some not being familiar with the NSZ procedure and whether it was still in effect.

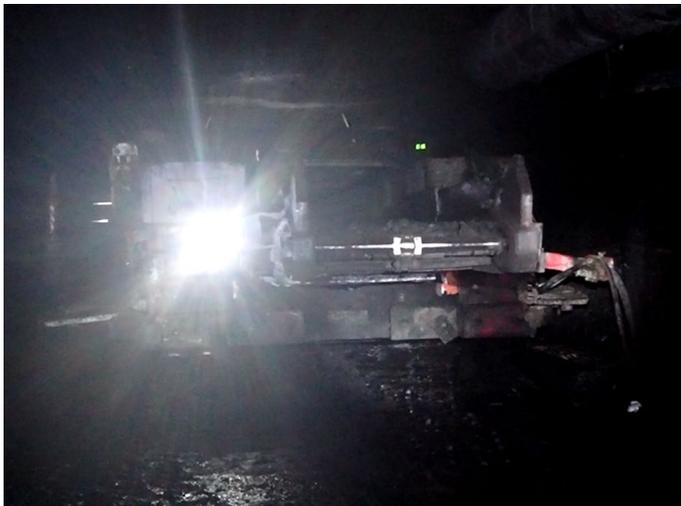
| SAFETY SYSTEM | DESCRIPTION | OBSERVATIONS REGARDING EFFECTIVENESS OF SAFETY SYSTEM |
|---|---|---|
| Reversing light | Bright light that shines rearward when CM313 is moved in a rearward direction. Light was found to be operational during functional testing. | No effect. The injured worker was already aware that CM313 was being repositioned and it was moving forward when the incident occurred. |

Figure 3 - Reversing light on CM313 displayed during functional testing
