Investigation report

Dangerous incident involving a worker at Attunga Limestone Mine

October 2022

Published by the Department of Regional NSW

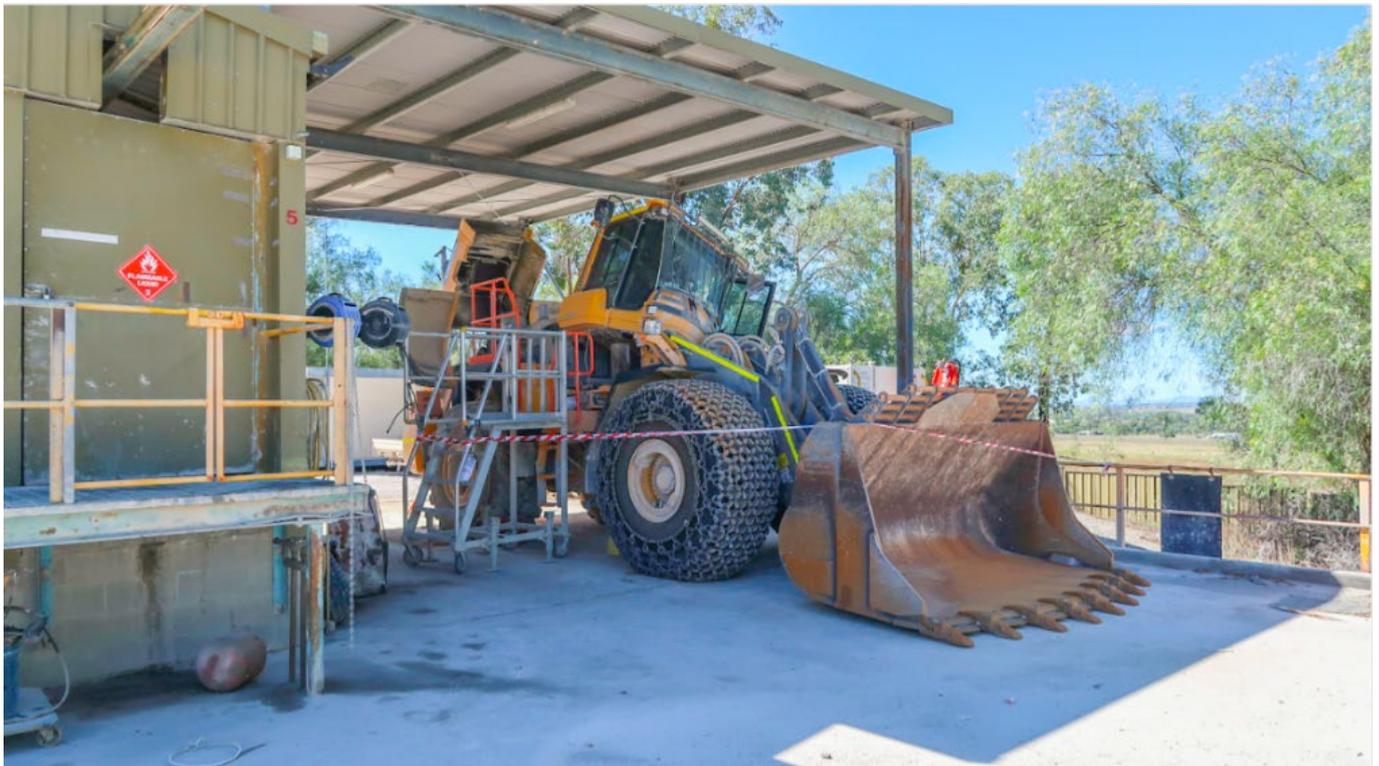
Figure 1 The loader in the Attunga service bay following the incident

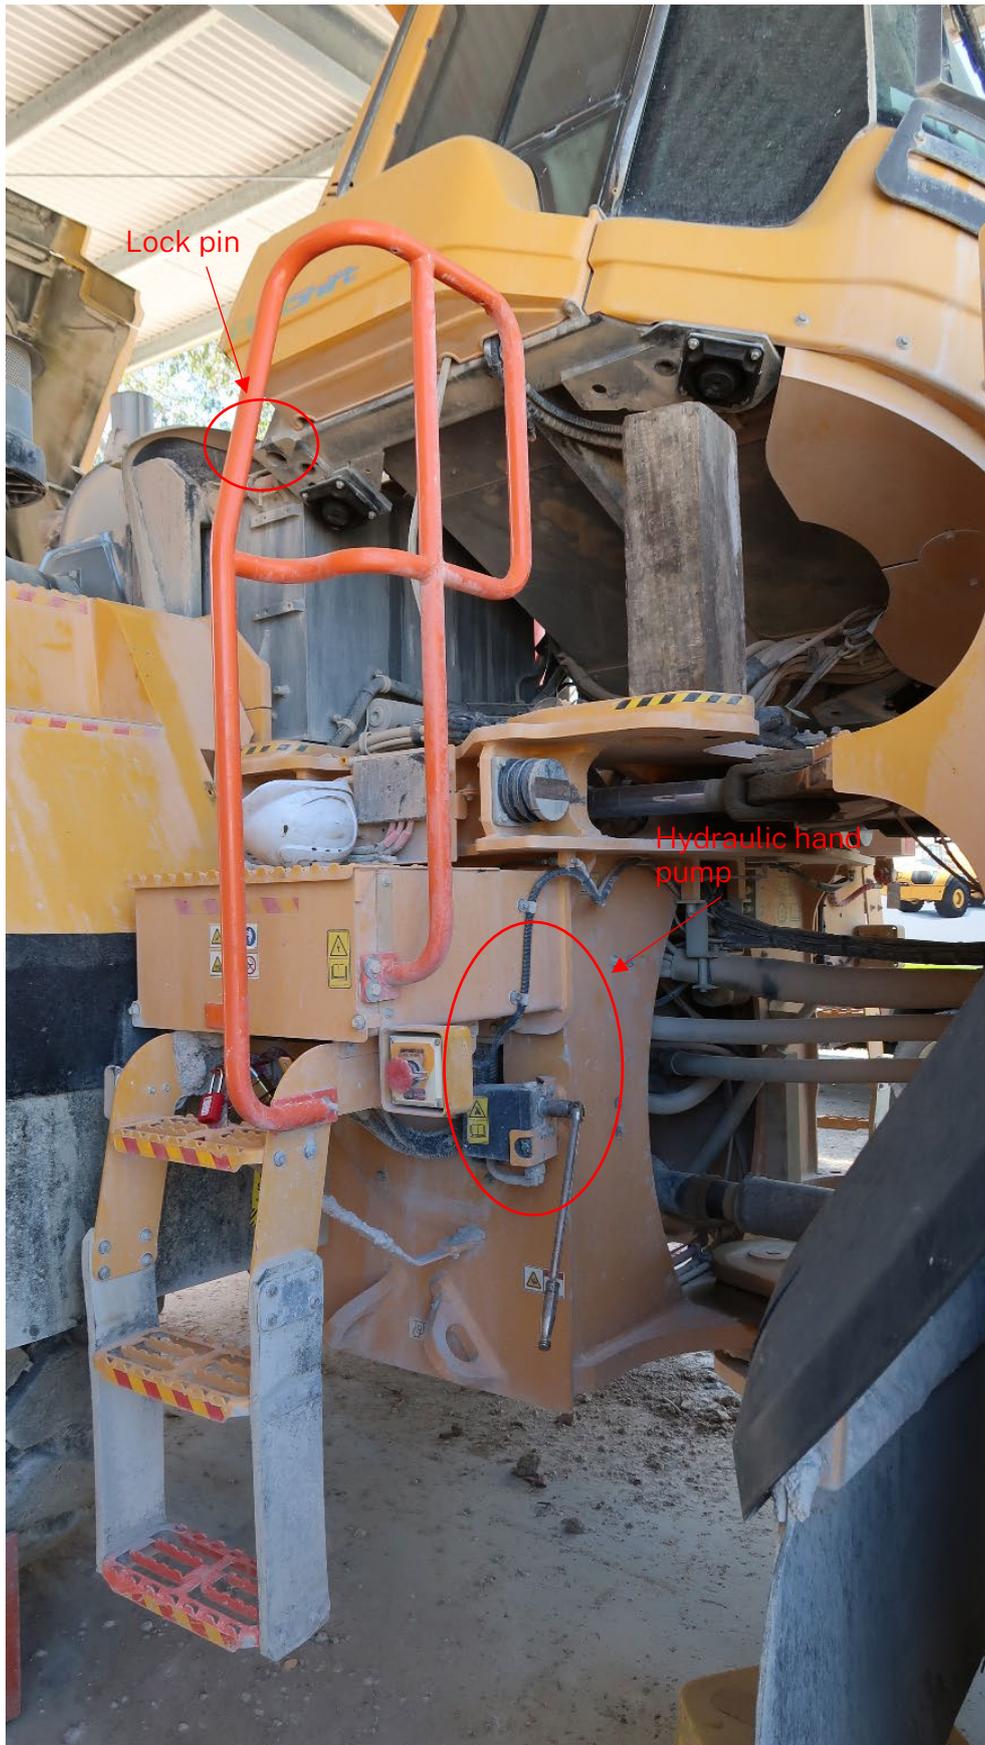
Figure 2 Right-hand side of the loader in the fully elevated position 1 with the lock pin engaged in the Attunga service bay following the incident (Note: the wooden chock was placed following the release of the worker)

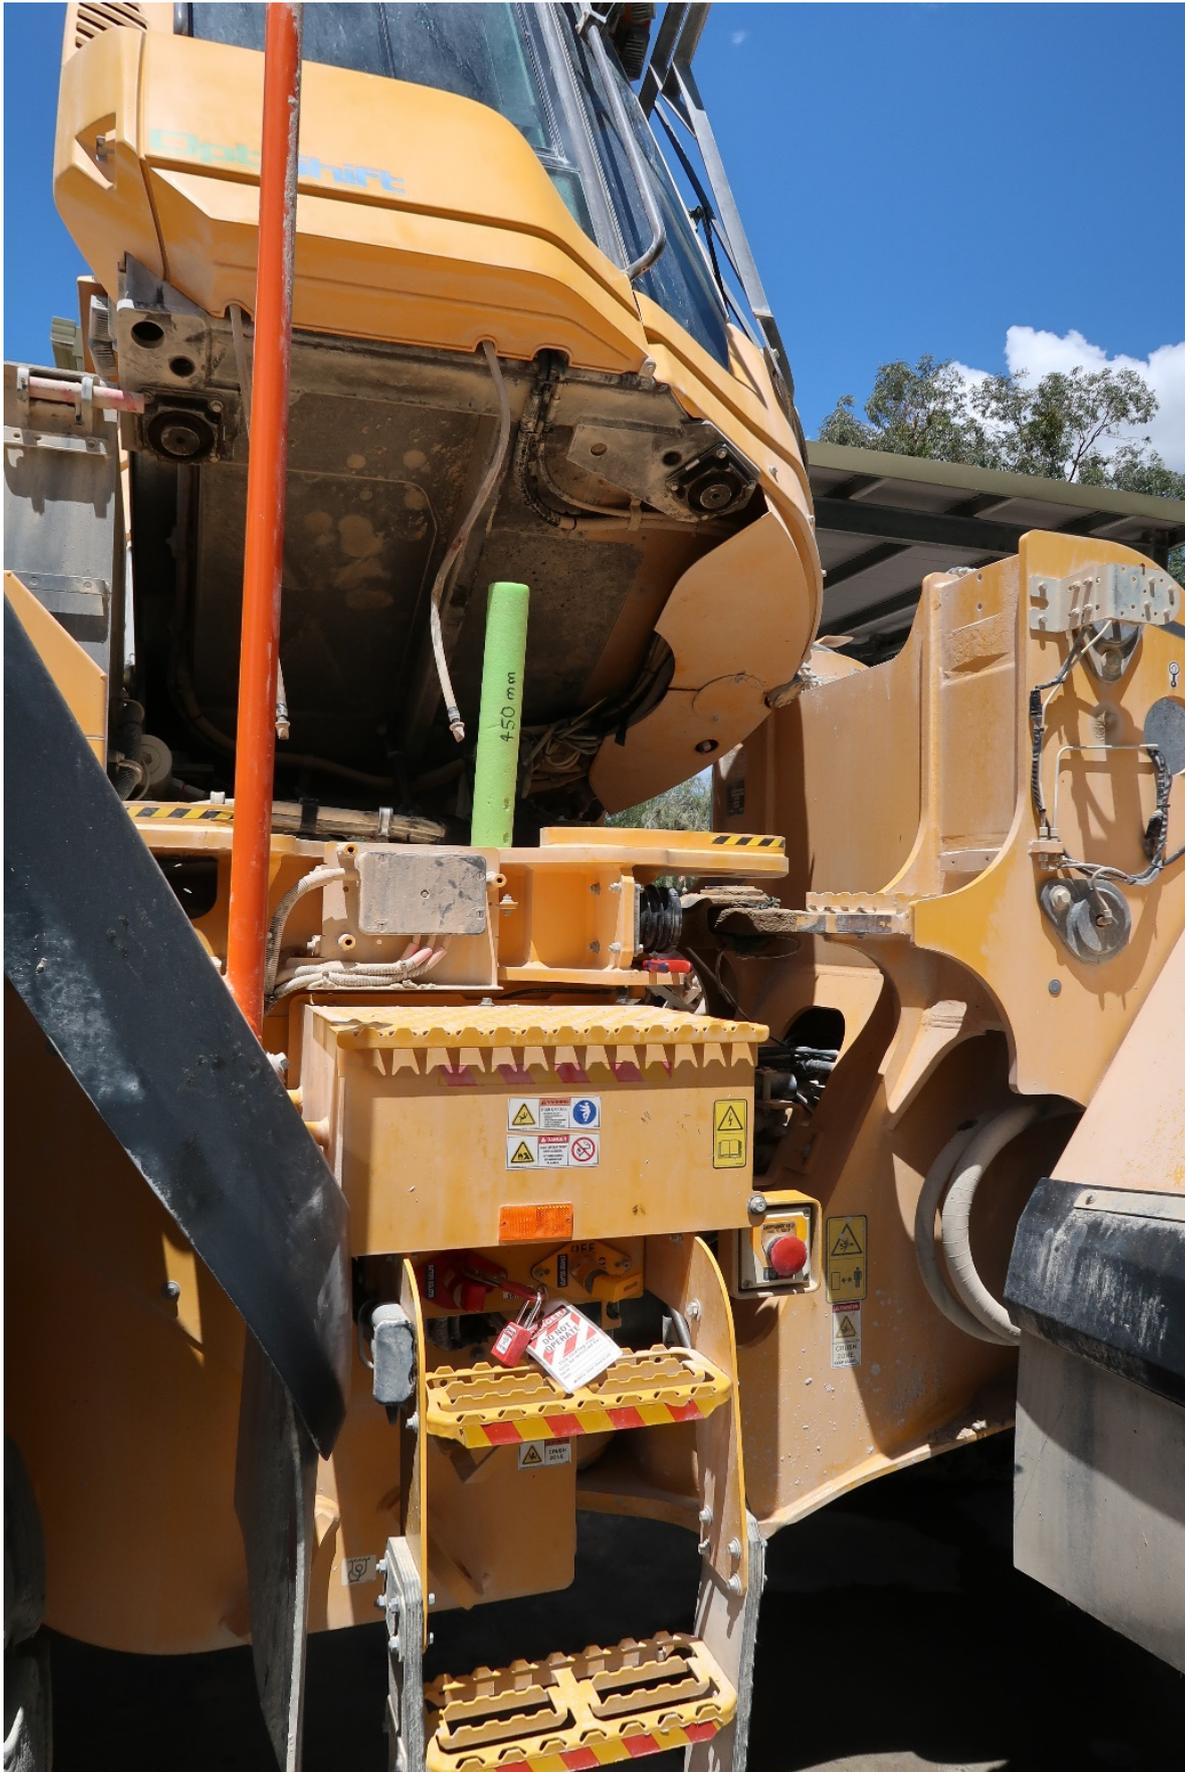
Figure 3 Right-hand side of the loader with cab tilted at position 1 and the lock pin in place to support the cab. A 450 mm green device is placed in the gap between the cab and the chassis for measurement purposes

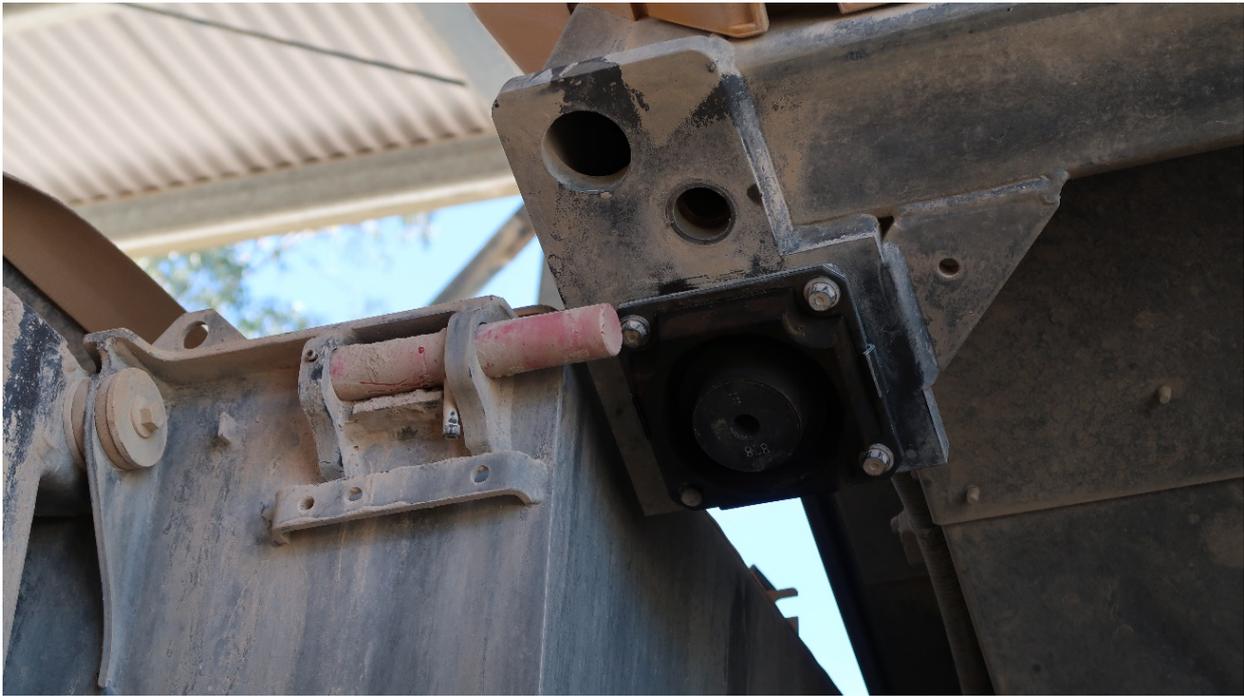
Figure 4 Cab lock pin in locked position 1, supporting the raised cab

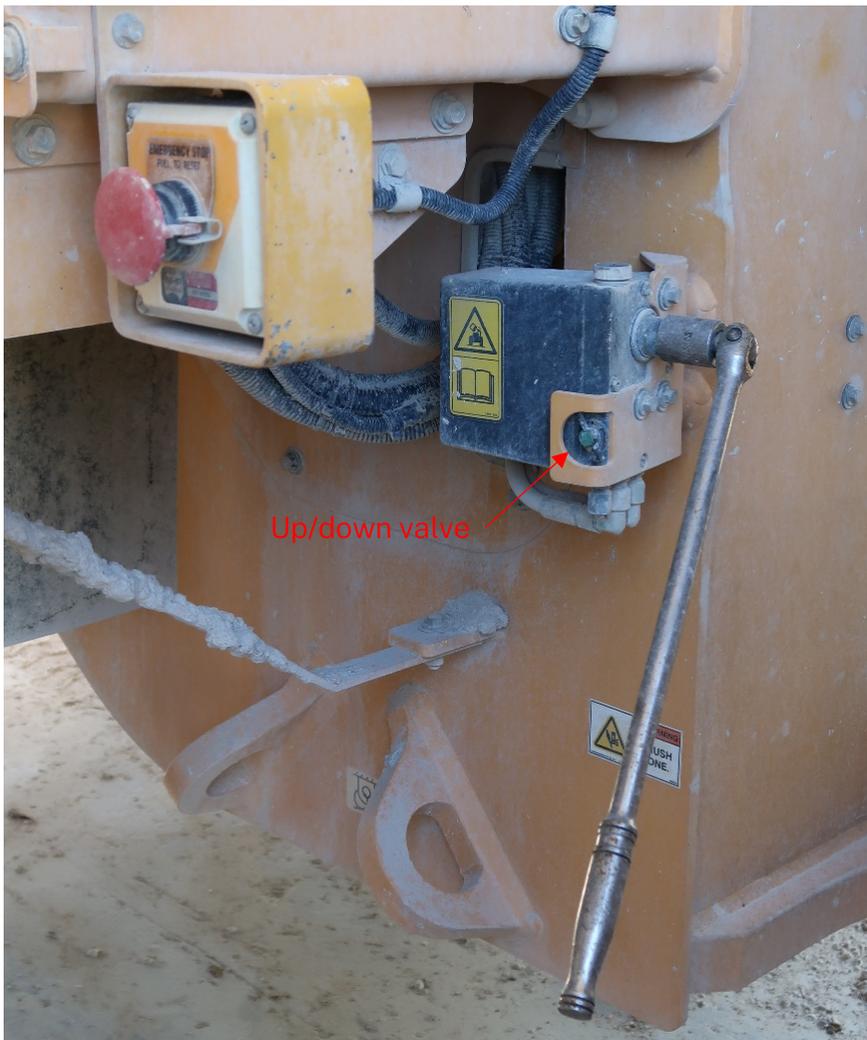
The hydraulic tilt cylinder used to raise the cab had an in-built 'float' function that caused the cab to self-lower without warning at approximately 300–330 mm above the chassis.

Figure 5 Hydraulic pump and handle used to raise and lower cab

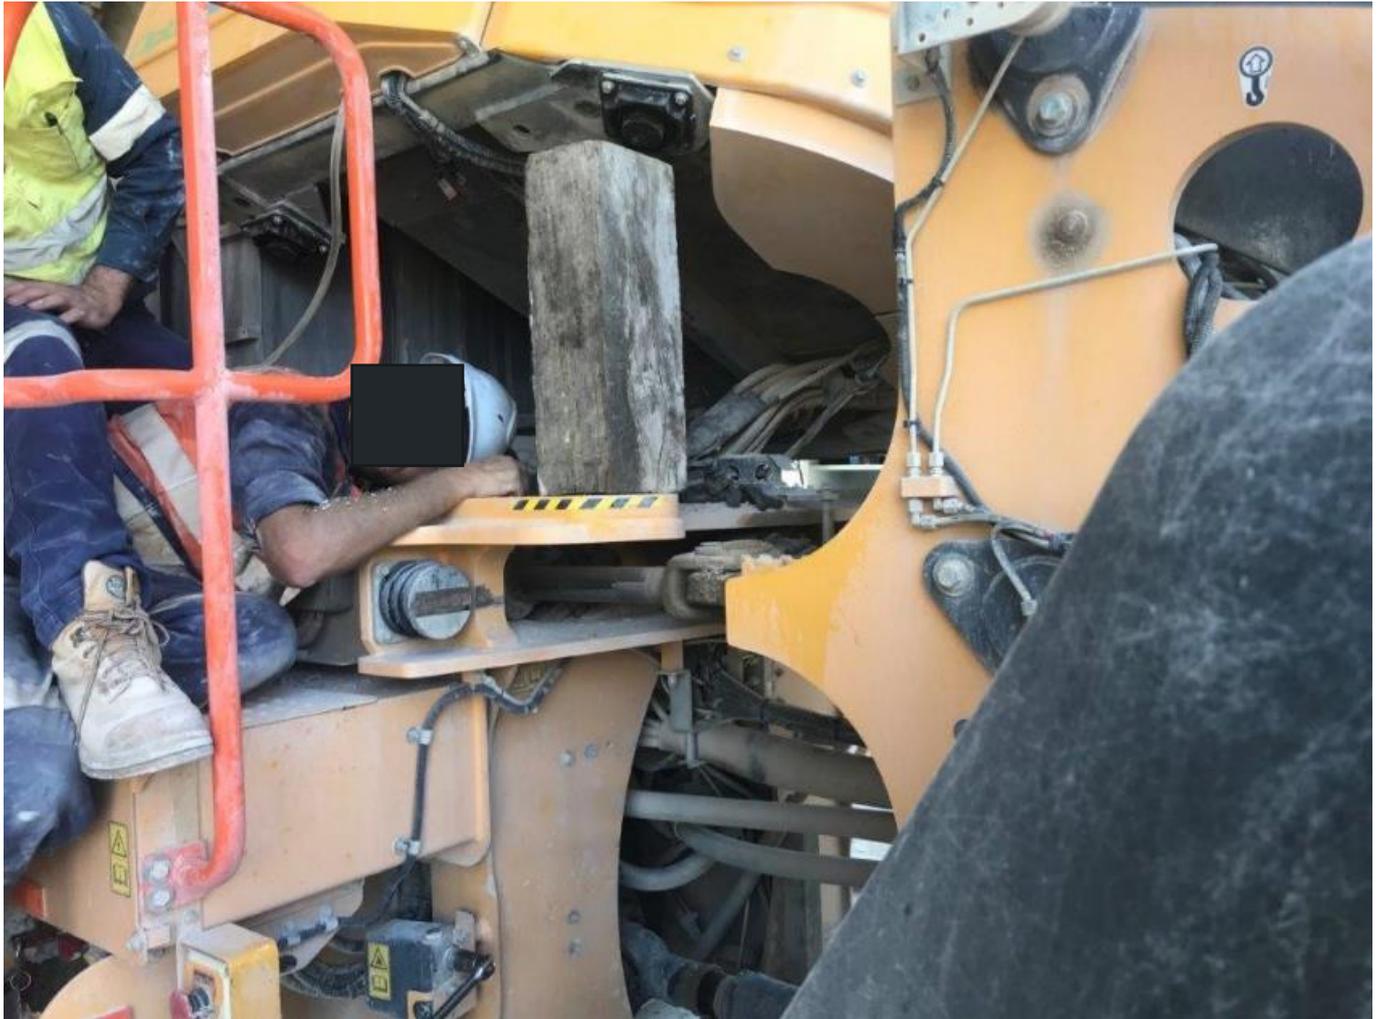
3. There was no evidence of gradual seal leakage of hydraulic fluid.
4. On the basis of post-incident testing it is likely that, at the time of the incident, the cab was positioned just above 300 mm or 330 mm when the worker entered the gap between the raised cab and chassis and shook or bumped the cab or hydraulic cylinder causing the float function to initiate and the cab to descend (as established during testing when the cab was shaken).

Figure 6 Recovery scene photograph showing the position of the worker on his side after the cab was raised and a wood chock placed by mine workers following his release from the crush point

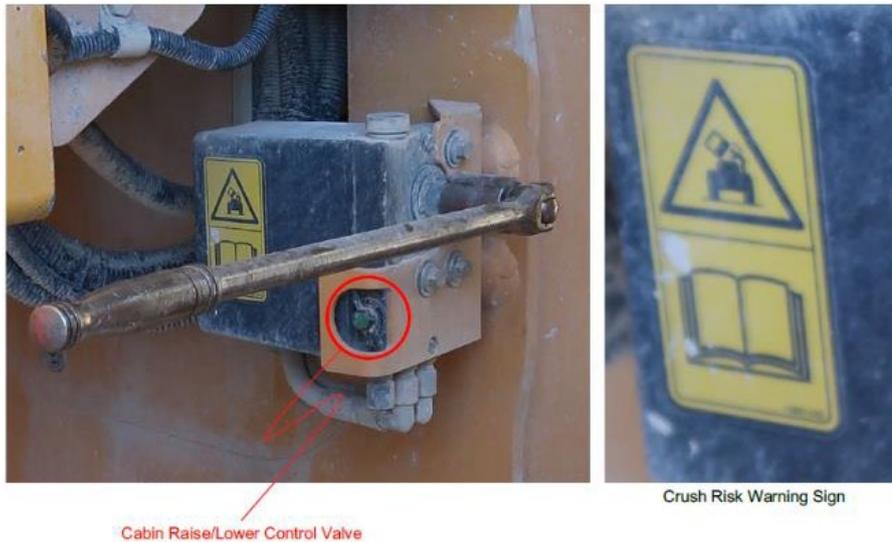
Figure 8 shows the information is affixed in a prominent position on the hydraulic pump and handle used by a technician to raise or lower the cab

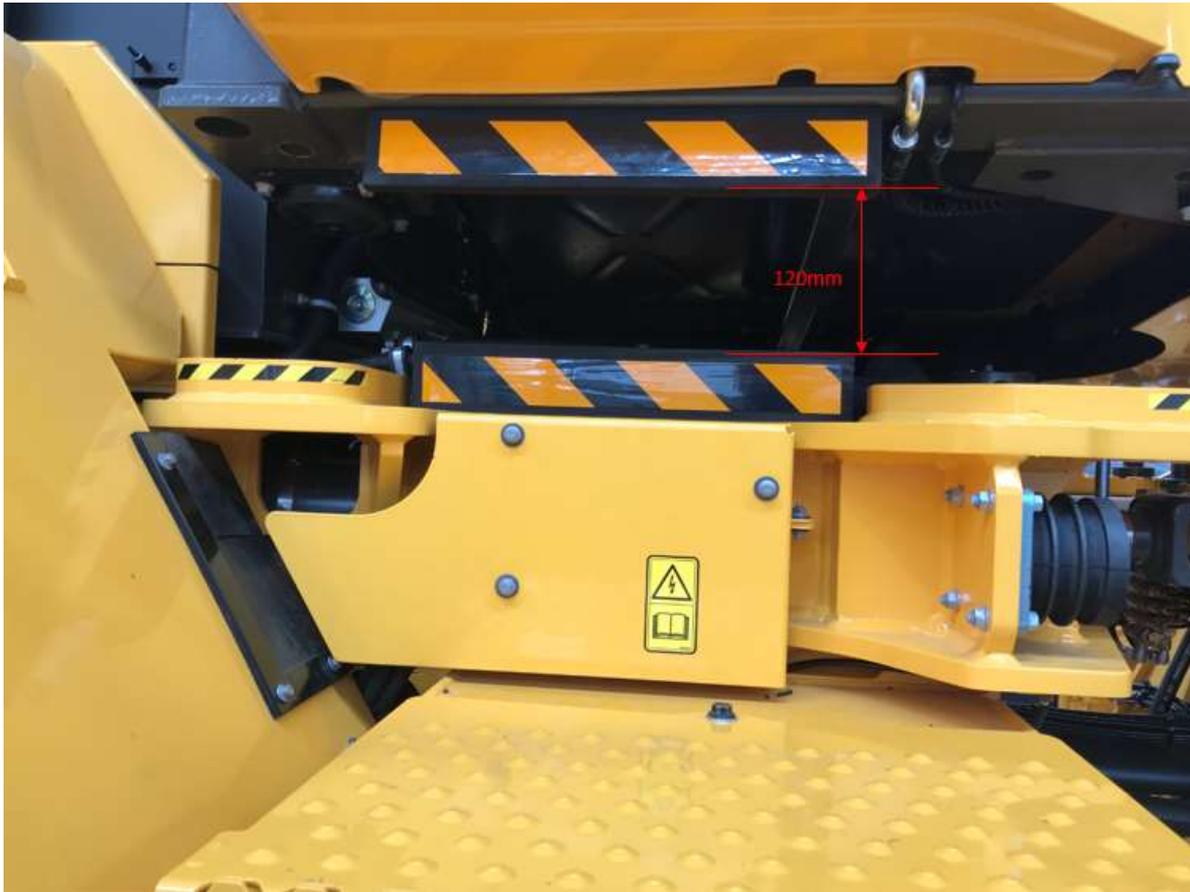
NOTE: This calculation is based on Volvo's assumed measurement of a current float gap of 270 mm but based on measurements made by CJD during post-incident testing, the modified float gap would actually be 145–175 mm.

Figure 9 CJD-supplied photograph of two barriers fitted to the underside of a Volvo loader cab to reduce the float gap
