Safety Alert

Dangers of lifting and pulling activities revealed

This safety alert provides safety advice for the NSW mining industry.

Safety Alert SA22-04

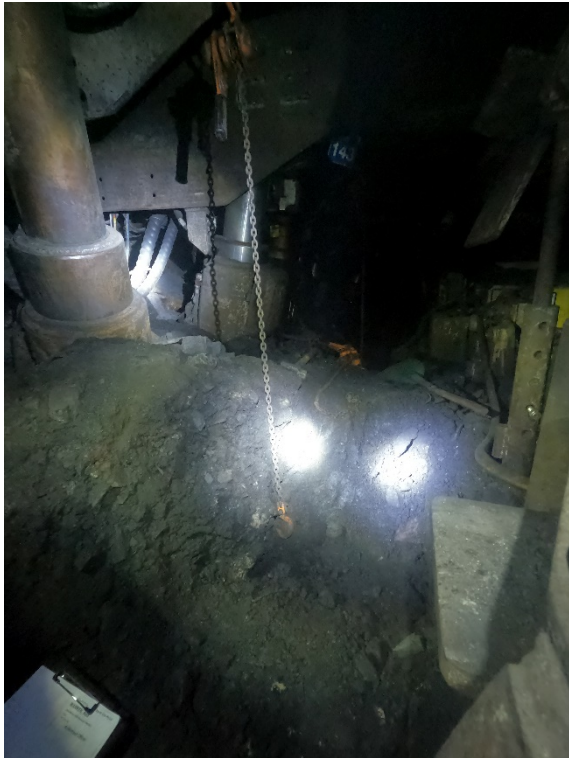
The lug on top of the clevis pin on roof support 144 was damaged but the pin was sitting high in the relay bar. This allowed the worker to wrap the chain of the lever hoist around the pin, attaching the hook back onto the chain (choking the chain around the pin). Load was applied to the lever hoists on both supports but the clevis pins did not move.

As the worker applied additional loaded to the lever hoist, the chain and hook has slipped off the pin and flung upwards, striking the worker on the cheek. The worker was taken to hospital by ambulance.

Figure 1 Set-up of lever hoist over a clevis pin

- provide workers with detailed procedures on the intended method and lifting techniques including identifying the correct lifting equipment when planning lifting tasks
- develop and review safe work procedures for carrying out lifting activities for routine tasks
- train workers to identify the correct attachment points and methods for lifting activities
- create safe work procedures when JHA/JSAs are used repeatedly
- include contract work groups in planned behavioural, workplace and task inspections
- regularly train workers in the triggers when different levels of risk assessment are required
- review shovel float function and the methods used to support the shovel during flitting operations.

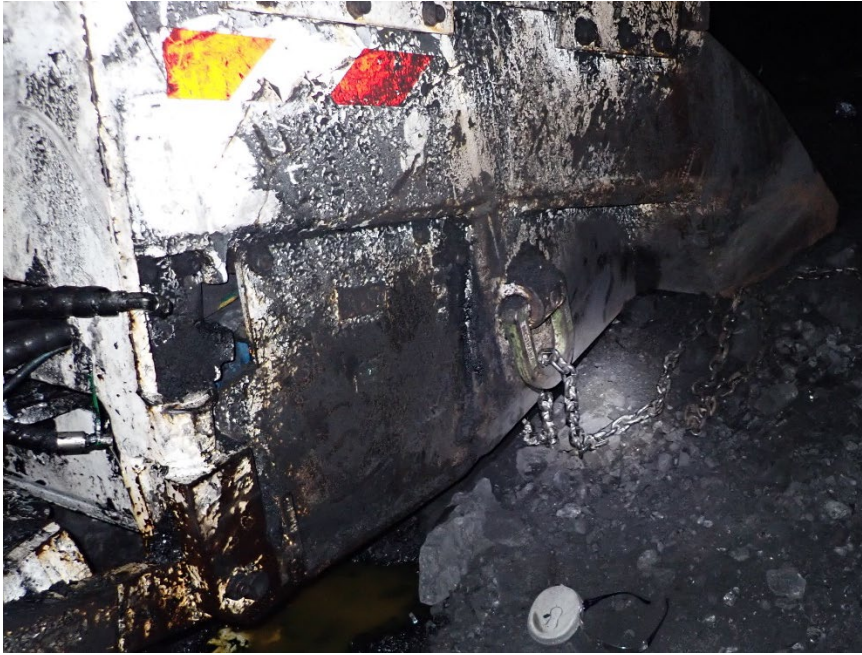
No procedure was provided and a new JHA was not completed. The miner driver, deputy and electrician inspected the travel route. The cutter boom was lowered and a 10 mm chain was connected to RUD lugs on either side of the shovel.

The deputy and electrician moved to a cut through behind the miner. The miner driver powered up the miner and started the hydraulic pumps and moved to what he thought was a safe place to the right-hand side of the miner, clear of the chain on that side. As the cutter boom was raised the chain failed on the left-hand side of the cutter boom and flung in an arc. The chain hit the worker on the face and shoulder.

No controls were in place to prevent the cutter boom from travelling beyond the travel limits of the shovel. The miner driver stated he didn't think he raised the cutter boom beyond this point but there was no control or indication of this.

Figure 2 10 mm chain attached to an RUD lug
