WEEKLY INCIDENT SUMMARY

Week ending Friday 14 October 2022

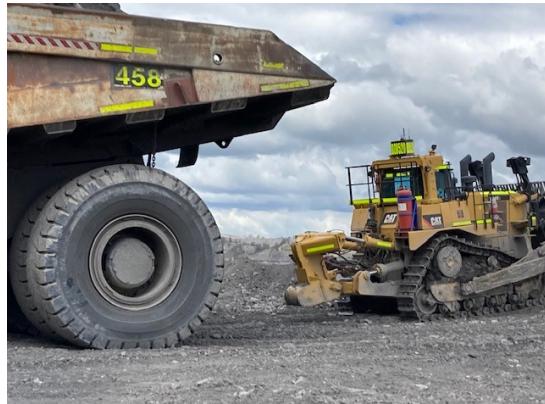
| INCIDENT TYPE | SUMMARY | COMMENTS TO INDUSTRY |
|---|--|---|
| Dangerous incident IncNot0043194 Open cut coal mine | A truck operator reversed a dump truck into a dozer on a dump. The dozer was parked in the correct position next to the windrow waiting for the truck to dump. As the dump truck was reversed, the operator lost sight of the dozer and continued to reverse. The position 6 wheel contacted the dozer's ripper box. | Operators must stop and reassess if they lose vision of other plant and equipment while reversing. They must not proceed placing other workers at risk. |

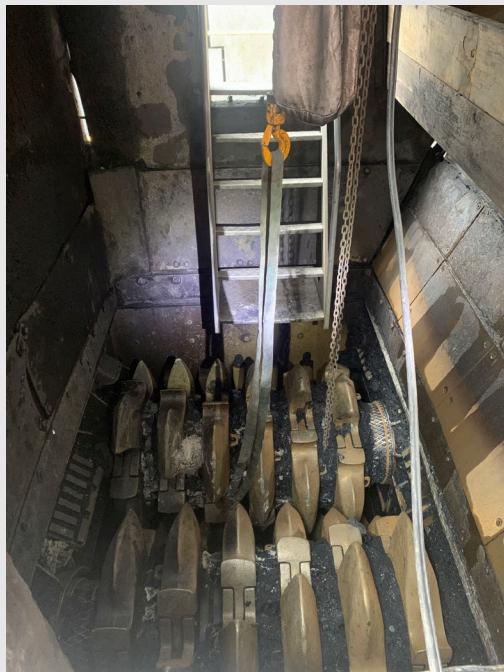
Dangerous incident
IncNot0043194
Open cut coal mine

A worker received an electric shock while working in a confined space. The worker was standing over a sizer at the time of the shock. The worker was wearing gloves and was holding a fibre sling. The sling was attached to the hook of a small trolley-crane mounted on an overhead I-beam. A witness observed a blue spark from the crane moments after the shock occurred.

Cables that form part of a spring-loaded cable reeler arrangement must have adequate support to prevent any tension being applied to the glands / termination connections. Mines should ensure that their maintenance strategies cover all cables and components for any signs of tension or wear.
