WEEKLY INCIDENT SUMMARY

Week ending Friday 7 October 2022

CM9 reference	DOC22/285366
Mine safety reference	ISR22-40
Date published	14 October 2022
Approved by	Deputy Chief Inspector Office of the Chief Inspector

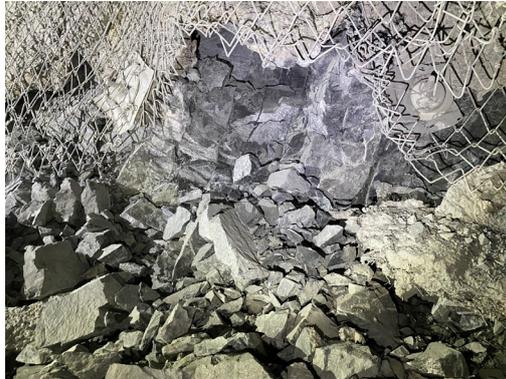
INCIDENT TYPE	SUMMARY	COMMENTS TO INDUSTRY
Dangerous incident IncNot0043138 Underground metals mine Ground or strata

A rock burst occurred in an underground metals mine. A drill rig was working in the area but the operator was not affected. A seismic event with a magnitude of 1.4 was measured at the mine. The mine operator stopped work, barricaded the area and commenced monitoring.	Mine operators are reminded of the update to the Work Health and Safety (Mines and Petroleum Sites) Regulation 2022 Schedule 1 Section 1(1)(x) where mine operators must consider the risk of rock, coal or related pressure burst as part of the PHMP for ground and strata failure.

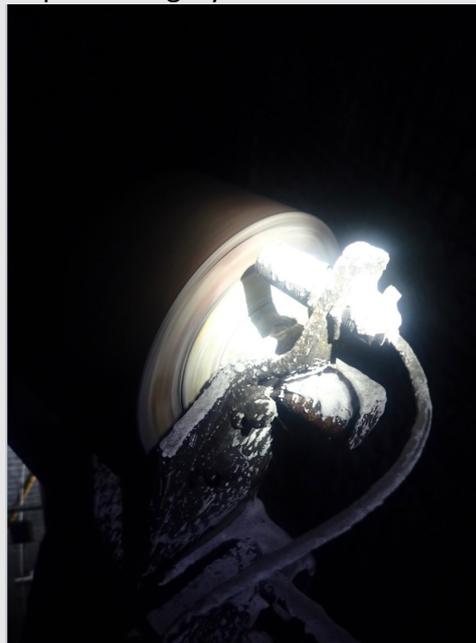
Dangerous incident
IncNot0043177
Underground coal
mine
Ground or strata

An electrician was cleaning a proxy sensor on a conveyor roller when their finger was caught between the sensor and the roller. The worker suffered a fractured finger, lost the fingernail and suffered soft tissue damage. The injury required surgery.

Workers should never place their hands or fingers near rotating components.
When a task involves working near rotating components, the equipment must be isolated first.

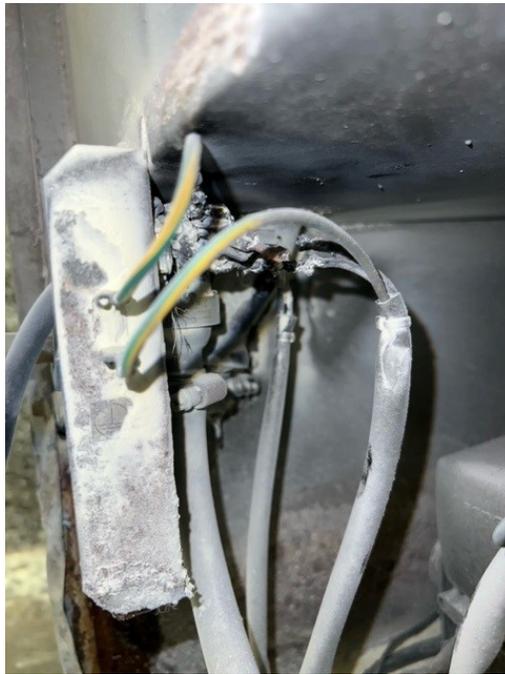
Dangerous incident
IncNot0043142
Underground
metals mine
Fire or explosion

An ice machine located near an underground crib room caught fire due to a faulty electrical connection. The fire was extinguished with a hand-held fire extinguisher.

Mine operators must have documented life-cycle maintenance strategies for plant and ensure that maintenance is undertaken in accordance with the manufacturer's recommendations.
Regular inspections and testing must be carried out on all equipment.

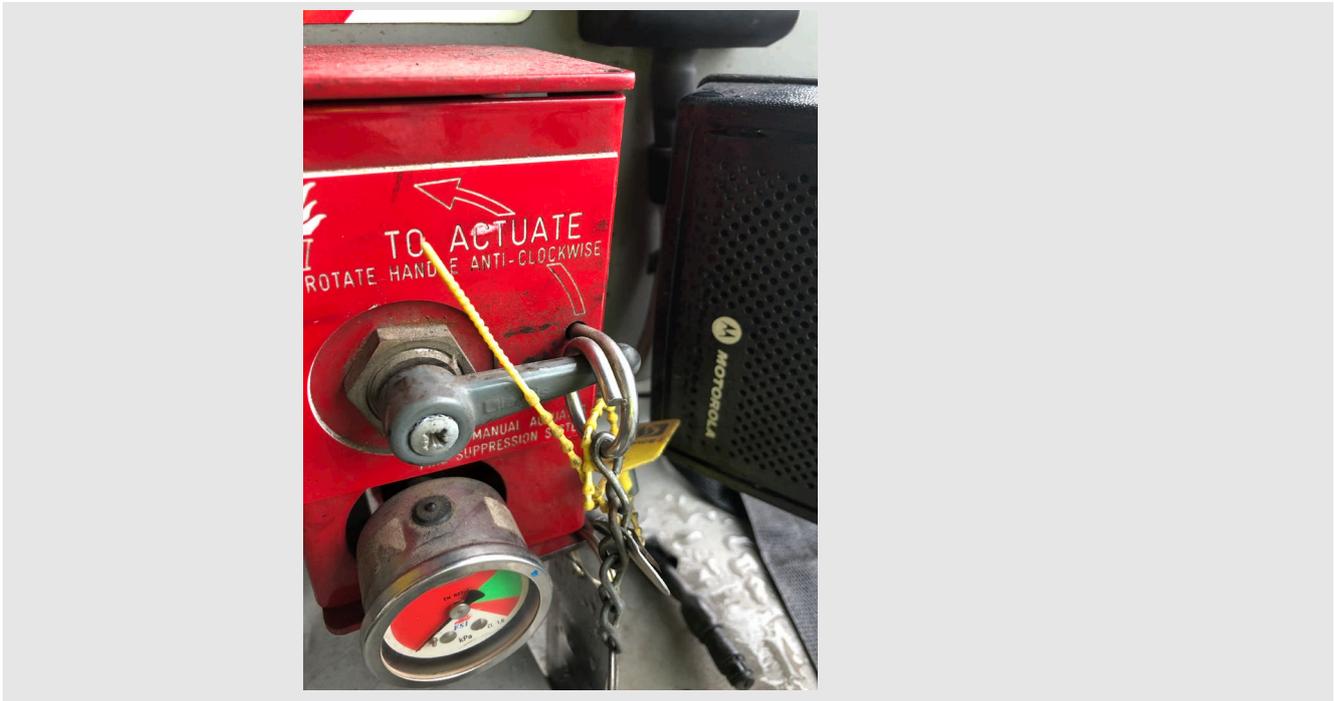
Dangerous incident
IncNot0043153
Open cut coal mine
Fire or explosion

A dozer operator jumped from the deck to the ground to escape flames when the dozer caught fire. The worker saw smoke and flames emanating from the left and right engine bay doors. As the worker tried to activate the fire suppression system from within the cab, the switch unit came away from the panel and couldn't be activated. The worker reversed the dozer to level ground so they could egress safely. When the worker tried to egress, the ladder was impeded by smoke and flames so the worker jumped from the deck to the ground. The worker was uninjured. The investigation identified that the safety clip was looped behind the activation handle. This prevented the safety clip from being able to be removed. The dozer was a hire plant that had a different activation method for the fire suppression system to those fitted other dozers on the site.

Operability of fire suppression systems in the event of a fire emergency is critical to the health and safety of operators on mobile plant. Inspections should confirm that fire suppression systems can be quickly activated. Mine operators should review second egress methods and regularly train workers in their location and use. Mine operators should ensure that change management processes identify the differences between new plant introduced to site and existing plant in use at the site.

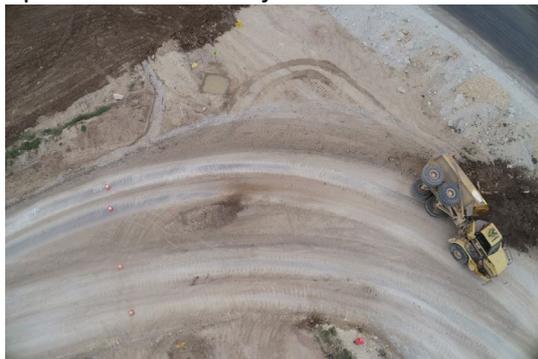
Dangerous incident
IncNot0043166
Open cut coal mine
Roads or other
vehicle operating
areas

An articulated dump truck was travelling around a right-hand corner when the rear tyre contacted the middle delineation island and tipped the tub onto its side. The cab remained upright and the operator was not injured.

The stability of articulated trucks is a known risk that should be managed at mines. Factors that truck operators must consider include (but are not limited to):

- speed of operation
- operating grades
- uneven surfaces (holes, rocks, foreign material)
- tipping of loads
- hang-up of loads
- movement of loads.

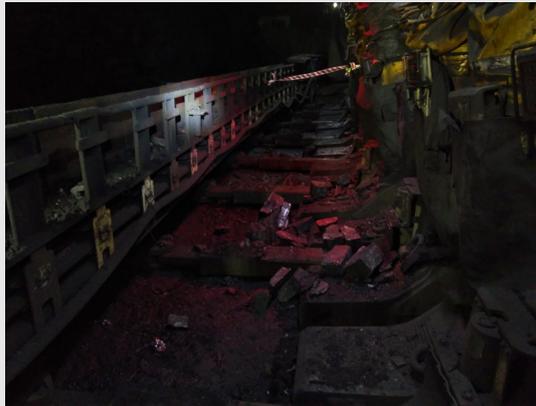
Dangerous incident
IncNot0043177
Underground coal
mine
Ground or strata

A slab of coal on the longwall fell forward onto the ranging arm, slid down the arm, spilling over the pan line and struck a worker on the ankle knocking them over. The worker was standing on the front walkway of the roof supports. The shearer was entering the snake in the tailgate. Cutting was done in compliance with the restricted zone limits.

Mine operators should consider flyrock and slabbing strata risks when determining restricted access zones for operators on longwalls. When reviewing controls related to a principal hazard, the impacts from all principal hazards must be considered.
