Investigation information release

Worker seriously injured using a crowbar to push a securing pin on a dozer counterweight during a lifting operation

Location: Werris Creek Coal Mine

Investigation information release IIR22-05

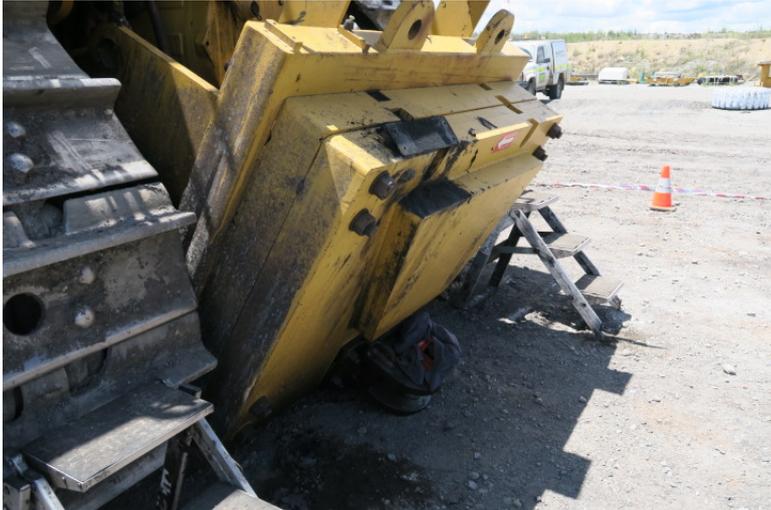
The counterweight was attached to the dozer by 2 top and 2 bottom securing pins.

A vertically slung two leg chain assembly (13 mm diameter grade 80T chain assembly with a WLL of 11.2 tonne at 60°) was attached to 2 lugs on the counterweight and lifted by the Franna crane while the 2 top securing pins were removed.

Figure 1 The dozer counterweight secured by the 2 lower pins and lowered to the ground after the incident.

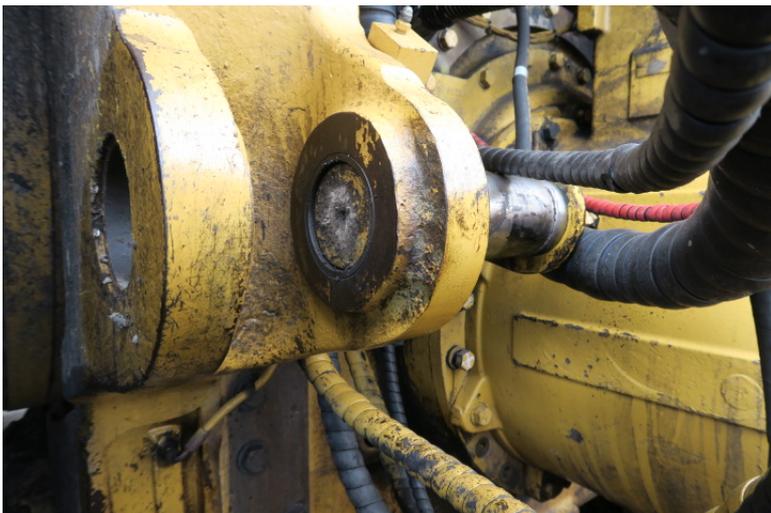
During removal of the second top securing pin the load on the Franna increased to about 5.5 tonne.

Figure 2 Post-incident location of the second top securing pin in the right hand side flange on the dozer

The injured worker continued to strike the pin several times. As the pin moved sideways it released the counterweight. The counterweight pivoted on the 2 lower pins and rotated back about 50 mm towards the Franna until the chain assembly held the weight and prevented it from moving further.

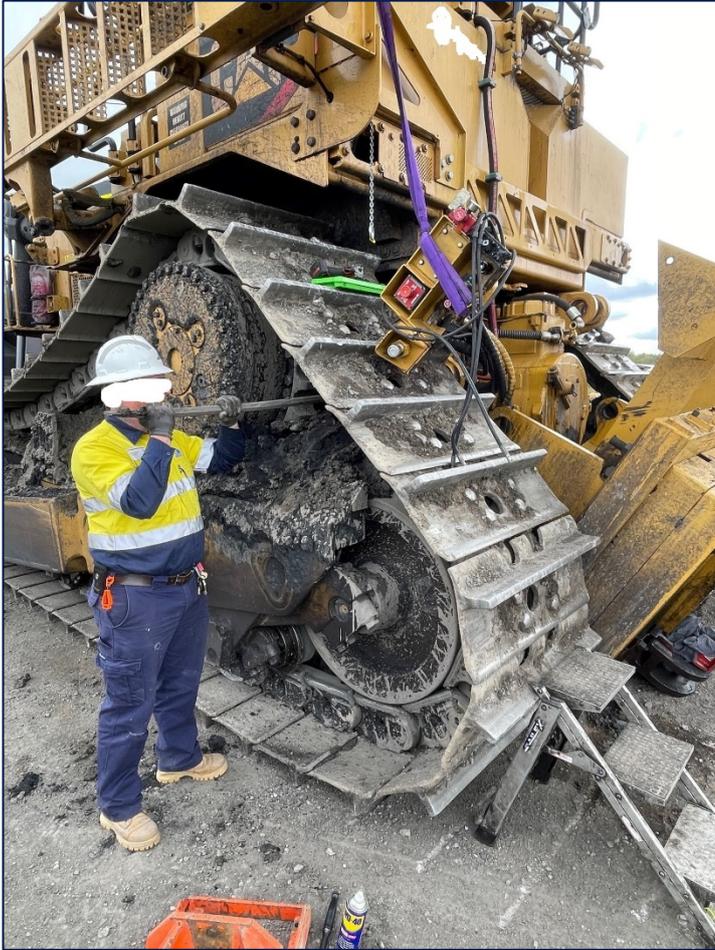
One of the workers used the crowbar to strike the second top securing pin. The injured worker took over the task and warned the other 2 workers about the potential for the counterweight to move.

The crowbar flicked sideways during the movement of the counterweight and struck the worker's head.

Figure 3 Post-incident simulation of the injured worker and position of the crowbar under the dozer track to push the second top securing pin horizontally so as to release the counterweight
