Investigation information release

Worker seriously injured during lifting activity

Event: Worker seriously injured while using a workshop overhead crane to remove a lifting plate

Location: Tarrawonga Coal Mine

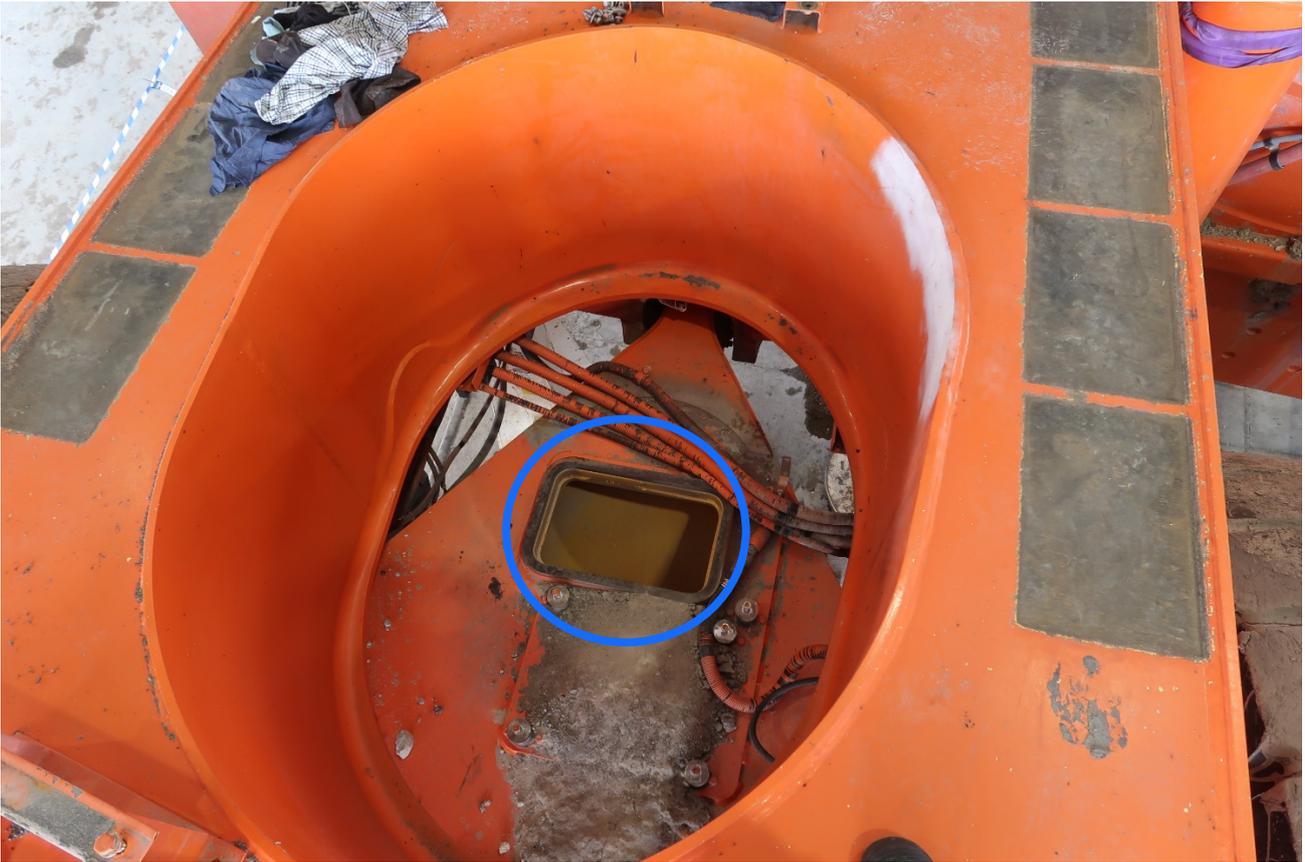
Initial information suggests that as the plate was lifted using the crane through the opening, it became wedged in the opening. The crane continued to apply load onto the plate to remove it from the hole. While under load, the plate became free and hit the worker on the leg, resulting in a serious injury.

Figure 1 The work area and air vent opening (circled) of the axle box through which the lifting plate was being manually manipulated

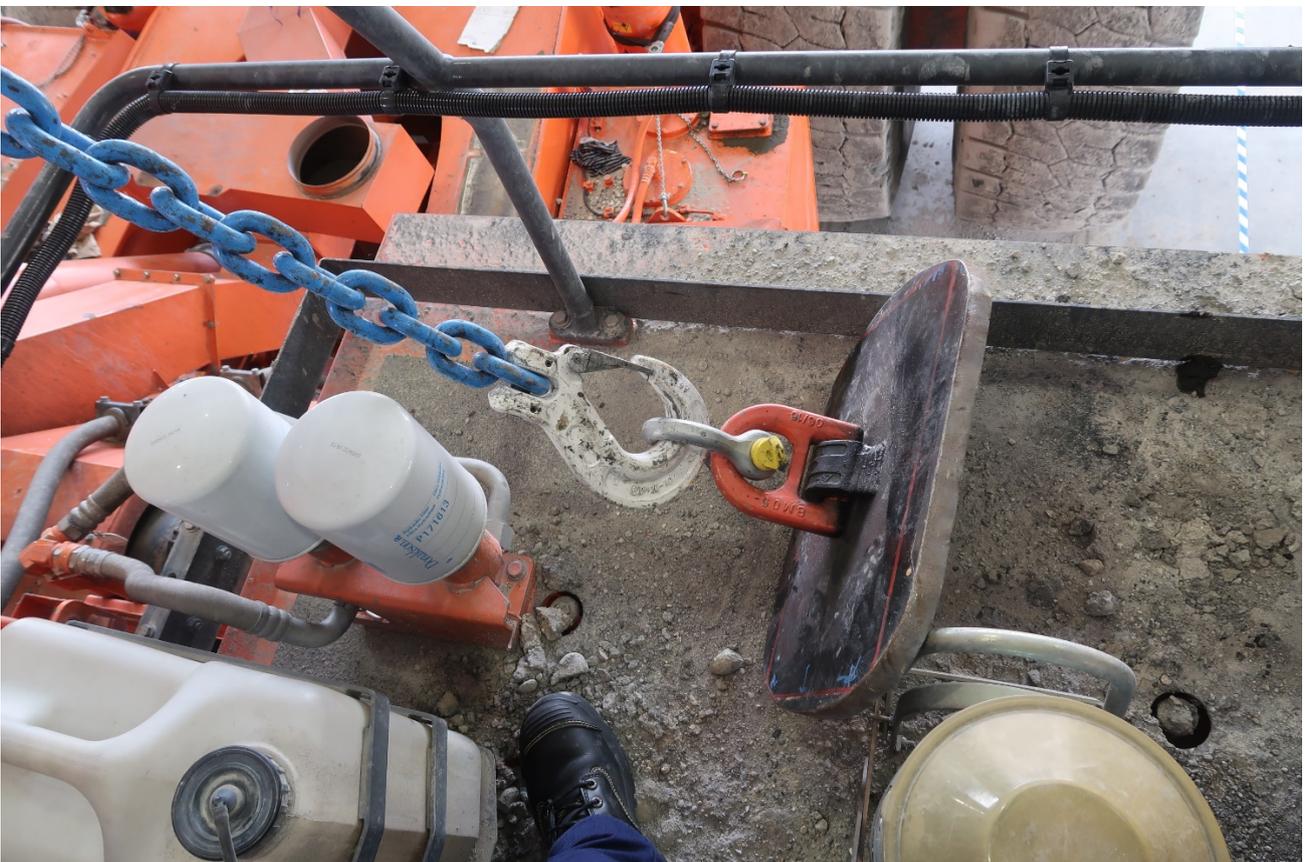
Figure 2 The lifting plate found after the incident on the cabin walkway
