Weekly incident summary

Week ending 11 November 2022

Document control	
CM9 reference	DOC22/324427
Mine safety reference	ISR22-45
Date published	18 November 2022
Authorised by	Deputy Chief Inspector Office of the Chief Inspector

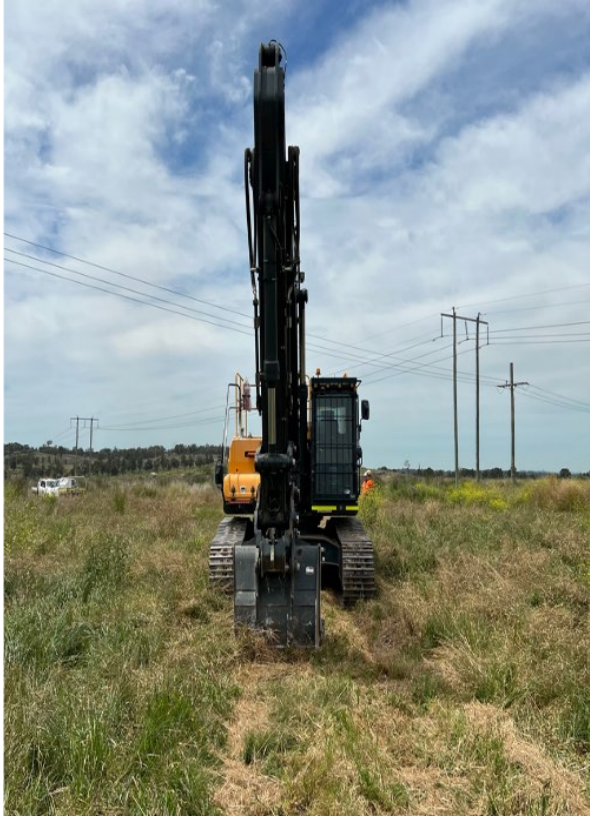
<p>Dangerous incident IncNot0043429 Open cut coal mine</p>	<p>An excavator operator was tramping a 30 tonne excavator from a road construction area to a borehole drill pad when the top of the excavator boom made contact with 11kV overhead power lines. The operator remained in the machine until the area was deemed safe.</p>

<p>Overhead powerlines are a known risk on mine sites.</p> <p>Refer to: SA20-08 Drill rig contacts 22kV power line SB15-05 Plant contacting overhead powerlines and structures</p>
<p>Dangerous incident IncNot0043419 Open cut coal mine</p>	<p>A haul truck collided with the support leg of a reject bin. The truck was approaching the bin at slow speed and was not correctly aligned to the bin.</p>	<p>When mobile plant is required to work in tight operating areas, barriers and guides should be used to assist workers to align their plant correctly to avoid colliding with structures and fixed plant.</p>

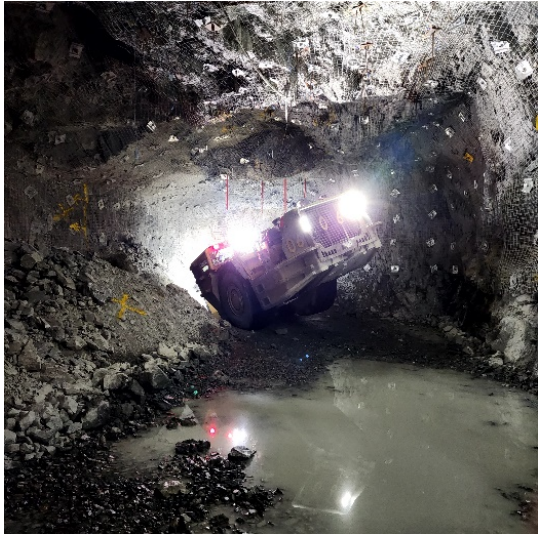
<p>Dangerous incident IncNot0043413</p> <p>Underground metal mine</p> <p>Ground or strata</p>  	<p>A loader was backfilling a stope when fill slumped, causing the loader to slump down on rill at stope edge.</p> <p>The operator escaped without injury.</p>

<p>When tipping into stopes, the stope edge should be clearly demarcated and easily visible to the loader operator.</p> <p>Inspections of the stope should be conducted regularly for water ingress and fines accumulation.</p>
<p>Dangerous incident IncNot0043412</p> <p>Open cut coal mine</p>	<p>A work crew was installing the final drive to a haul truck. The workers were using a powered hoist and trolley to position the final drive. On the sixth attempt at aligning the drive to the axle, the trolley was stopped and the jerking motion caused the final drive to rock forward, snapping the single retention chain. The final drive then fell from the trolley.</p> <p>An investigation identified the unit was intended to have 2 retention chains fitted and the workers</p>	<p>When equipment is introduced to site, it should be inspected to confirm that any required risk control measures are fitted and available to workers.</p> <p><u>Work Health and Safety (Mines and Petroleum Sites) Regulation 2022 Section 107 Duty to provide information, training and instruction</u> requires mines to provide workers with appropriate</p>

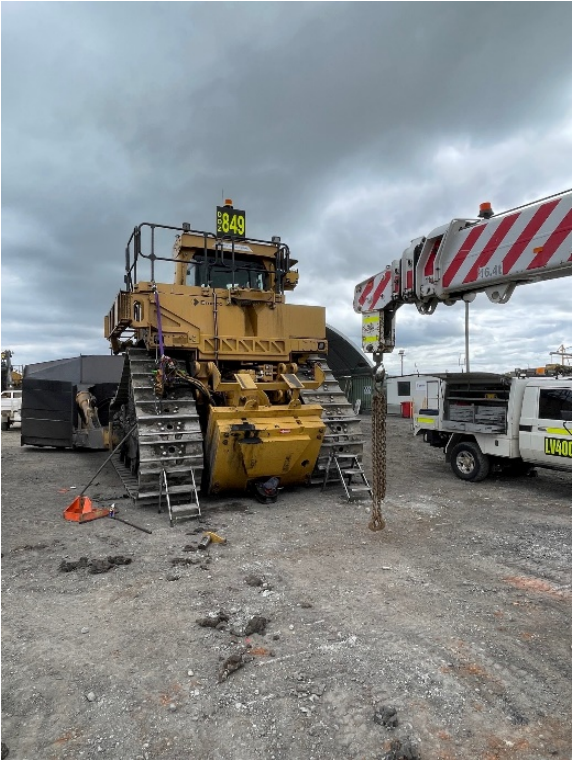
<p>information and training relevant to the task being conducted.</p>
<p>Dangerous incident IncNot0043399 Open cut coal mine</p>	<p>While removing a counterweight from a dozer, a worker suffered a laceration to the ear. The worker was using a crowbar to assist in removing a pin when the counterweight moved unexpectedly and the crowbar flung up, hitting his ear.</p> <p>The work crew was not supplied with the mass of the counterweight and had not adequately supported the counterweight.</p>

<p>An investigation is underway and further information may be released in the future.</p> <p>When planning tasks, workers must be supplied with relevant information, such as component weights and task procedures, to safely conduct the task.</p>
<p>Dangerous incident IncNot0043390 Construction materials Fire or explosion</p>	<p>A worker in a quarry was driving an articulated dump truck when the operator noticed smoke coming from the engine bay. The worker stopped and opened the engine bay and it burst into flames. He activated the onboard fire suppression, but this failed to extinguish the fire.</p>	<p>This incident should remind all mine operators of the consequence of fires on mobile plant.</p> <p>Mobile plant should be routinely inspected for flammable fluid</p>
