Weekly incident summary

Week ending 4 November 2022

Document control	
CM9 reference	DOC22/315895
Mine safety reference	ISR22-44
Date published	11 November 2022
Authorised by	Deputy Chief Inspector Office of the Chief Inspector

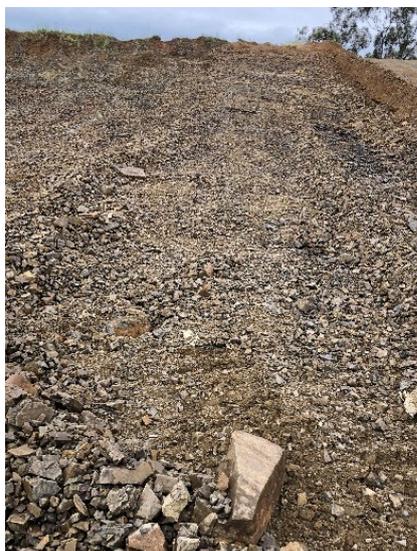
Incident type	Summary	Comments to industry
Dangerous incident IncNot0043352 Construction materials Roads or other vehicle operating areas	Three teenagers were injured when an all-terrain vehicle rolled in a quarry. The quarry was on private land and there were numerous potential access points. Two of the teenagers were treated for minor injuries and a third suffered severe abdominal injuries after being pinned under the vehicle.	All mines and quarries must have adequate site security. Where gates are required, they must be used and secured to prevent unauthorised access. Additional information may be published as required. This incident is the subject of an ongoing investigation.
