Compliance audit program

Mount Thorley Warkworth

Mount Thorley Operations Pty Ltd and Warkworth Mining Ltd

December 2022

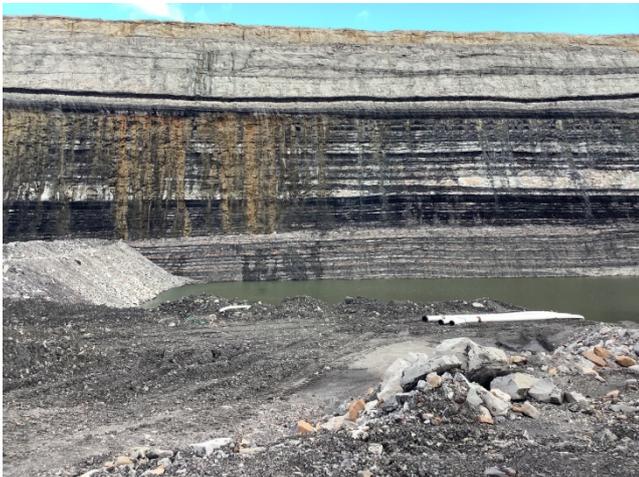
During the audit, the audit team noted the presence of potential AMD leachate (iron precipitants and efflorescence) within a layer in the western wall of the Loders Pit TSF (see figure 1). MTW advised that iron rich minerals were identified in this layer, likely reacting with salts. This raised observation of concern no. 1: MTW should develop and implement standard business practices to identify and manage potentially hostile/carbonaceous materials within the mine plan.

Figure 1 Potential AMD leachate within western wall of Loders TSF

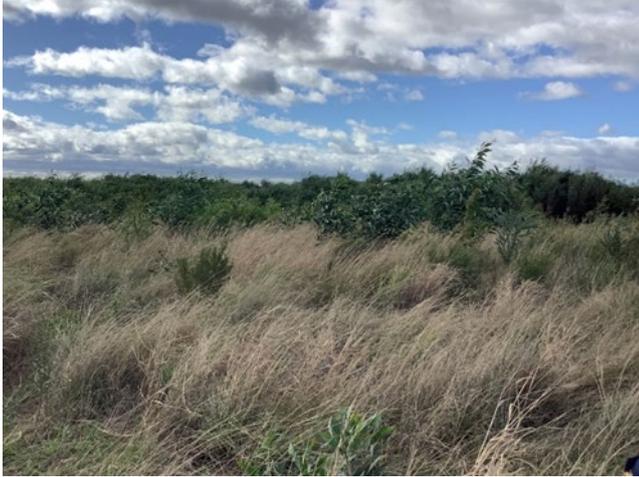
- The audit team noted from the annual reports that in 2020, 281.6ha of existing rehabilitation areas received weed treatment (including boom spray, wick wiper treatment or selective weed control methods) and 255.9 ha were treated during 2021. During the site audit, the audit team noted amongst other weed and invasive / more prevalent species, significant presence of rhodes grass, galena, stinking roger and acacia saligna across rehabilitation areas (See Figure 2). MTW advised the audit team that the weed control program was targeting Rhodes grass which is being managed with selective treatments and relying on establishment of a native vegetation canopy to ‘shade out’ the grass.

- Regarding acacia saligna weed control, MTW noted they were mulching the acacia and wiping regrowth with little to no natives sown into that area. The mulch was used in the rehabilitation soil stockpile which would not be used in rehabilitation areas due to the potential seed load contained within the mulch. This raised observation of concern no. 2: the use of exotic cover crops across inactive rehabilitation areas (such as the “Green Mile” emplacement area) provides further impacts for future rehabilitation and establishing native vegetation as required by the MOP and development consent. MTW have committed to investigate why rehabilitation was not successful in these areas, and what strategies can be employed to reduce prevalence of weeds and improve native vegetation establishment.

Figure 2 Rhodes grass and acacia saligna dominant across rehabilitation areas

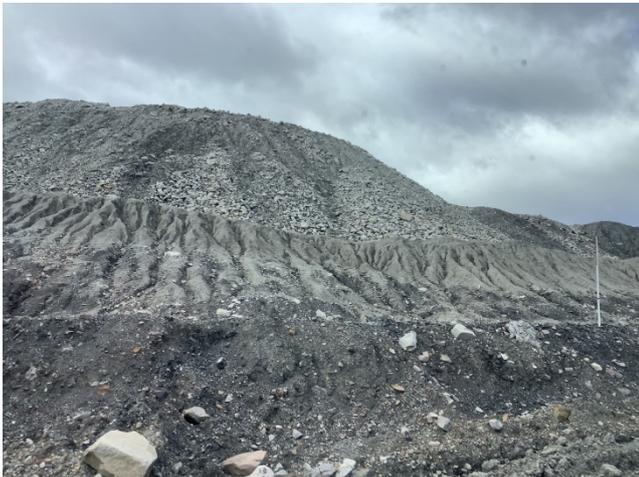
- Rilling and erosion was identified by the audit team along the high wall, south of the Mini Strip TSF (Figure 3). MTW advised that the area had been inspected with geotechnical and geochemical testing undertaken.

Figure 3 Rilling and erosion along high wall, south of Mini Strip TSF

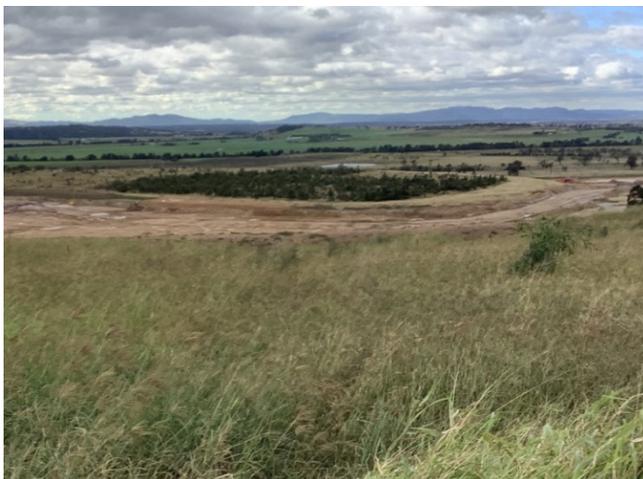
Figure 4 Tailings dam 1

- capping and rehabilitation of tailings dam 1 and 2 (TD1 and TD2) had progressed (Figures 4 & 5). The audit team were advised for TD1, new materials had been used from the new dam to cover the site. TD1 had been rehabilitated, however, MTW were increasing the height of the dam and leveling the site, using clay materials. TD2 was last used for tailings in 2014. The dam was partially capped with Red Bank fly ash, at 46m depth. Capping had ceased due to instability associated with the fly ash (fines) towards the centre and requirement for further desiccation of the material due to recent rainfall resulting in up to 1.5m water pooling within the facility. MTW noted 8 million cubic metres of capping material is required to finish with a dome shape final landform.

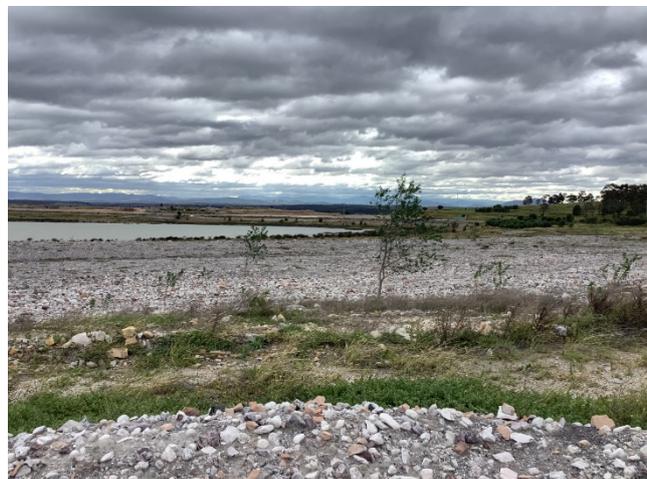
Figure 5 Tailings dam 2

- Settling dams or other dams (condition 56 of CCL753) – during the site visit, the audit team observed the partial capping of tailings dam 2 and found no issues.

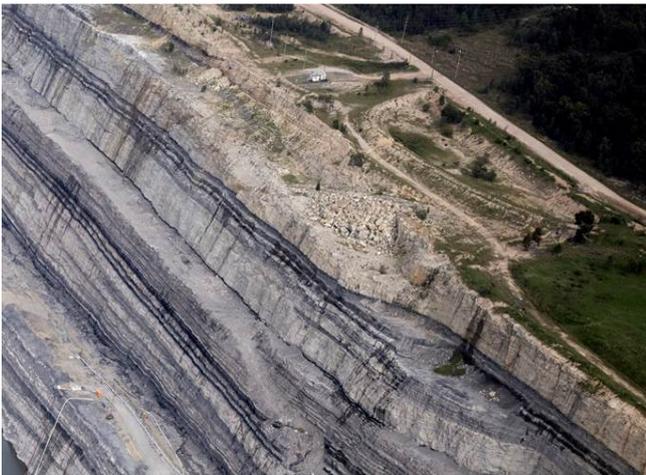
- The audit team inspected the Loders Pit TSF - with no tailings deposited on the day (Figures 6 to 9). The audit team noted loose material along the high wall, initially believed to be a potential failure. However, further clarification from MTW confirmed this was a section of wall blasted to create access onto the catch bench from above and that the material is back from the crest, posing no risk of rockfall to operations below – as evident from Figure 6. MTW noted a high wall stability investigation had been completed – suggesting the high wall would have long term stability. MTW noted water had been diverted away from the tailings with decanting using pumps occurring within the TSF. MTW advised Loders Pit is regularly inspected for geotechnical hazards and a geotechnical hazard report for MTW is produced monthly, along with monthly surveys to determine volumes deposited. As illustrated in Figure 1, the audit team also noted the presence of potential AMD leachate (iron precipitants and efflorescence) in the western wall of the Loders Pit TSF (observation of concern no. 1).

Figure 1 Loose material observed on the high wall - Loders Pit TSF (Image provided by MTW representative)

- Prevention of soil erosion and pollution (condition 30 CCL753 and CL219, condition 31 of ML1412 and condition 16 of ML1590) – a stability issue was noted along the high wall of the Loders Pit tailings storage facility during the site audit. This was raised earlier as observation of concern no. 3.

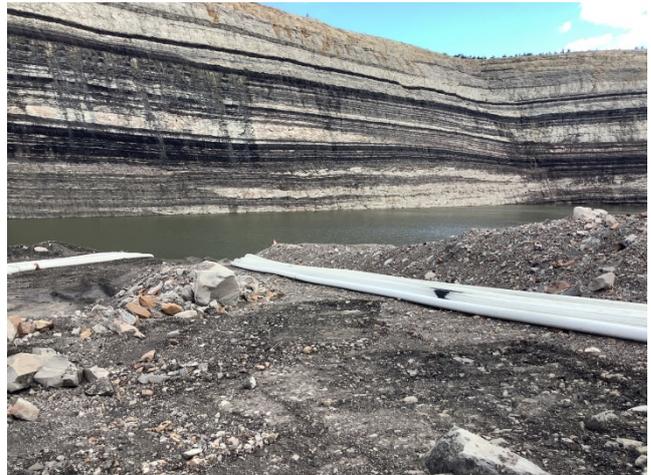
Figure 2 High Wall - Loders Pit TSF

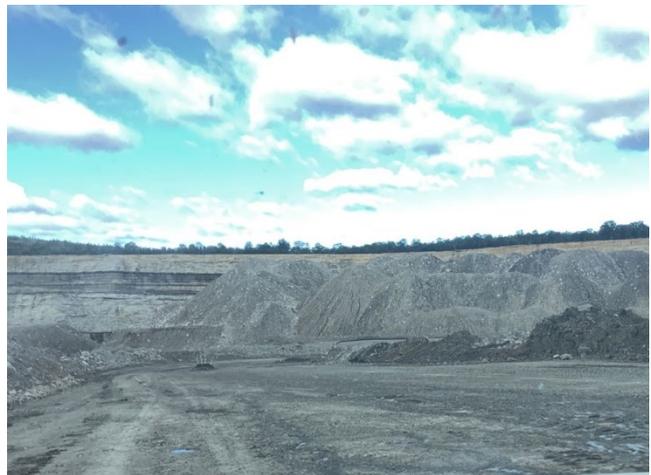
Figure 4 Overburden emplacement within Loders Pit TSF

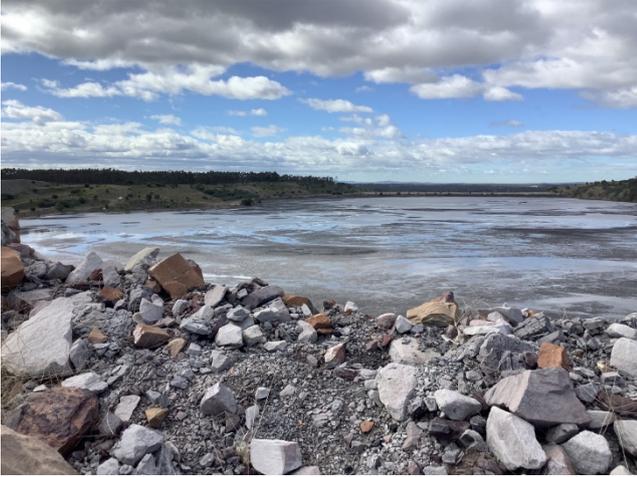
- The western face of the South Pit Centre Ramp area was inspected during the audit (Figure 10 & 11). Flocculants had been added to the surface and vegetation was establishing along the northern and southern face of the Centre Ramp tailings dam.

Figure 5 South Pit Centre Ramp tailings – Northern face

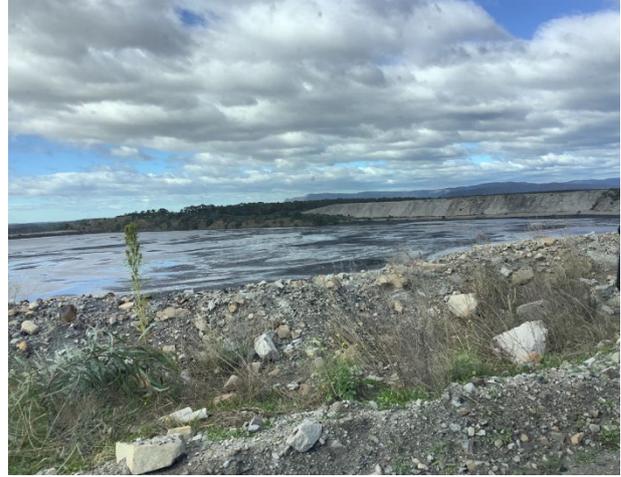
Figure 6 South Pit Centre Ramp Tailings – Southern face

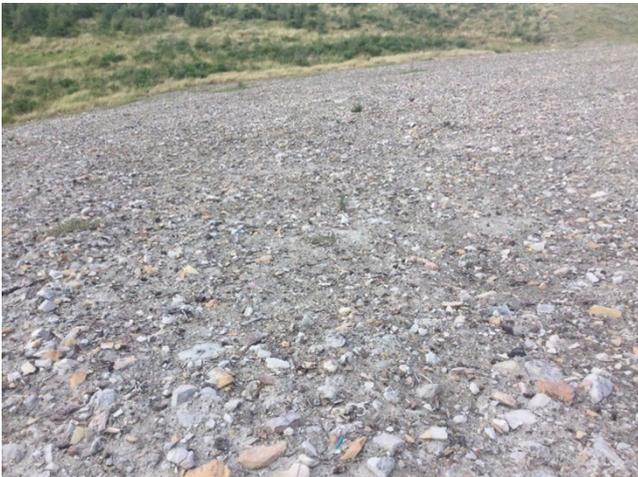
- MTW noted “Remondis” (Awaba Compost) and “Better Grow” (Mine Rehab Compost) composts were used across rehabilitation areas. The Better Grow compost has higher nutrient levels due to biosolids used during the composting process. The Remondis compost is made solely from source segregated food and garden waste with the minus 15mm component screened off for use in the nursery market. The removal of this fine material would likely reduce the nutrient levels in the resulting compost product as well. The audit team noted putrescible waste items in the Remondis compost (see Figure 14). This raised observation of concern No. 3: MTW should confirm the use of Remondis and Better Grow composts comply with Environmental Protection Authority (EPA) standards.

Figure 9 Remondis compost with putrescible wastes

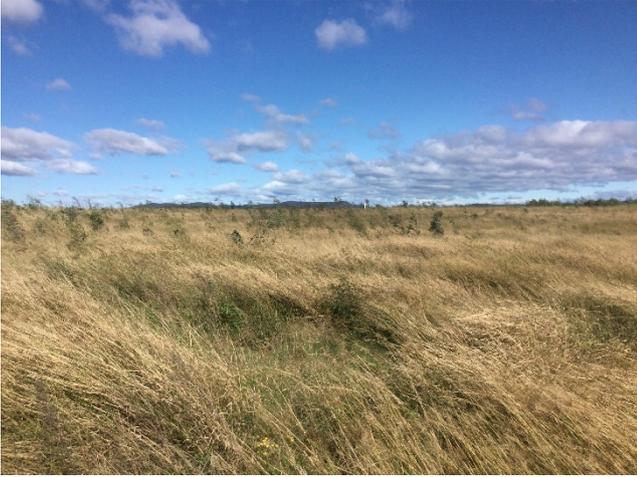
- During the audit, rehabilitation and trial areas between and north of the Centre Ramp TSF and Loders Pit were observed (Figures 16 to 21). The compost trials included areas with and without compost and found that the Better Grow compost (with high nutrient levels), stimulated exotic grass growth in topsoiled rehabilitation areas resulting in poor native vegetation establishment. However, MTW has had good results for establishment of native vegetation with the Better Grow compost where it is mixed with mine spoil and gypsum to form a growth medium. In the spoil/compost application, the weed seed load in topsoil is not present so weed competition is not a problem. In 2021, MTW attempted to solve the exotic grass issue seen in topsoiled rehabilitation by sourcing the Remondis compost with lower nutrient levels. It was found, however, the Remondis compost resulted in poor native vegetation establishment when used in the spoil/compost application (as seen in the foreground of Figures 12, 13 and 14). MTW suspects that higher nutrient level composts are better suited for use in spoil/compost applications. This theory will be tested with side-by-side trials of the Remondis and Better Grow compost products spread on spoil/compost rehabilitation areas in 2022. The audit team noted some diverse native species coming through including kangaroo grass, eucalypts and acacias, although sparse.

Figure 11 Rehabilitation trial area - rhodes grass dominant

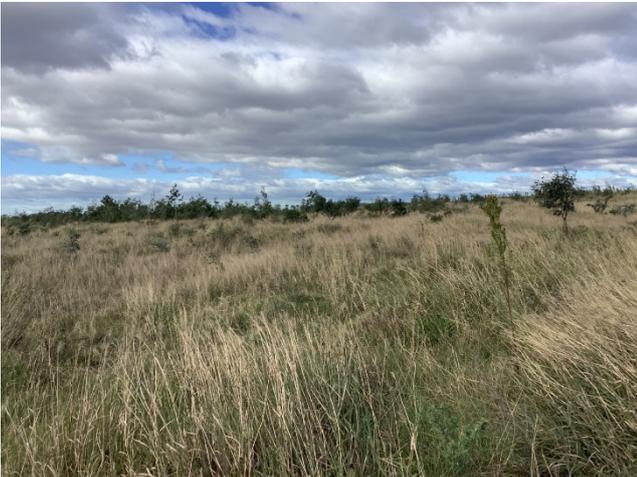
Figure 13 Weed species present within rehabilitation trial areas

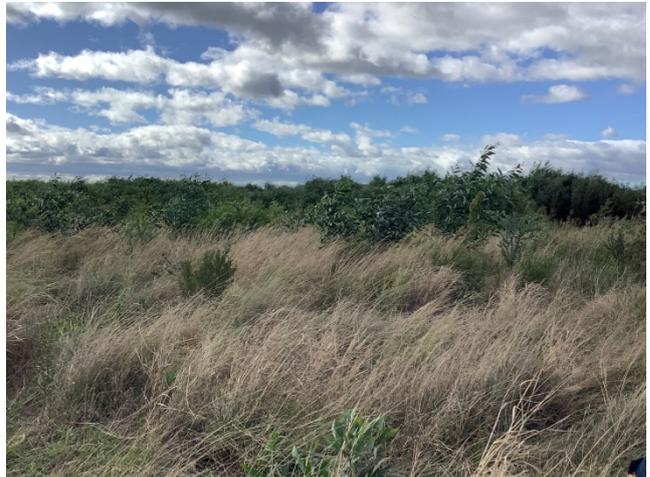
Figure 14 Area dominated by rhodes grass and acacia saligna

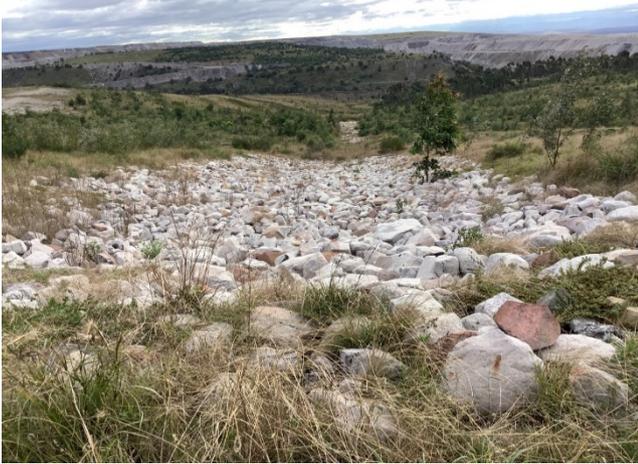
Figure 15 Green Mile drop structure

- The drop structure within the 'Green Mile' emplacement area was designed using geo-fluv modelling and although not consistent with modern modelling, no erosion issues were observed. The area was seeded in 2019 and a mixture of rock and basalt had been used in its construction. Weedy vegetation, was observed across the area, raised earlier as observation of concern no 2 – and the audit team noted limited planned response action by MTW.
