**Compliance Audit Program**  
New Berrima Quarry  
**The Austral Brick Company Pty Ltd**

*December 2022*

Title: New Berrima Quarry

Subtitle: The Austral Brick Company Pty Ltd

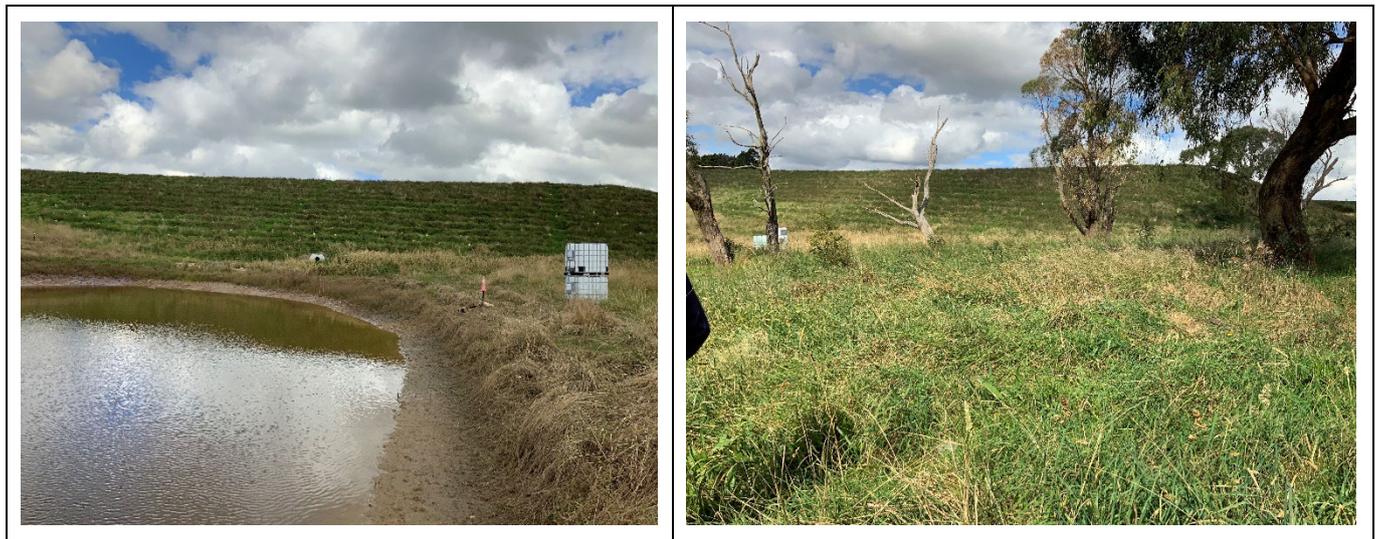
Information provided by Austral Bricks indicated that additional trees were planted within the northern tree screen of the site. However, it was unclear if the species planted were representative of the Southern Highland Shale Woodland EEC. During the inspection, recent plantings were observed within the northern tree screen area.

Following the audit, the revegetation contractor advised Austral Bricks that representative species from the Southern Highland Shale Woodland EEC were used within the northern tree screen. However, due to site constraints such as soil moisture conditions, additional non-listed species were used to ensure rapid growth and survival. These additional species were all Australian natives.

Figures 1 and 2 Northern Visibility Bund in background with evidence of recent planting activity

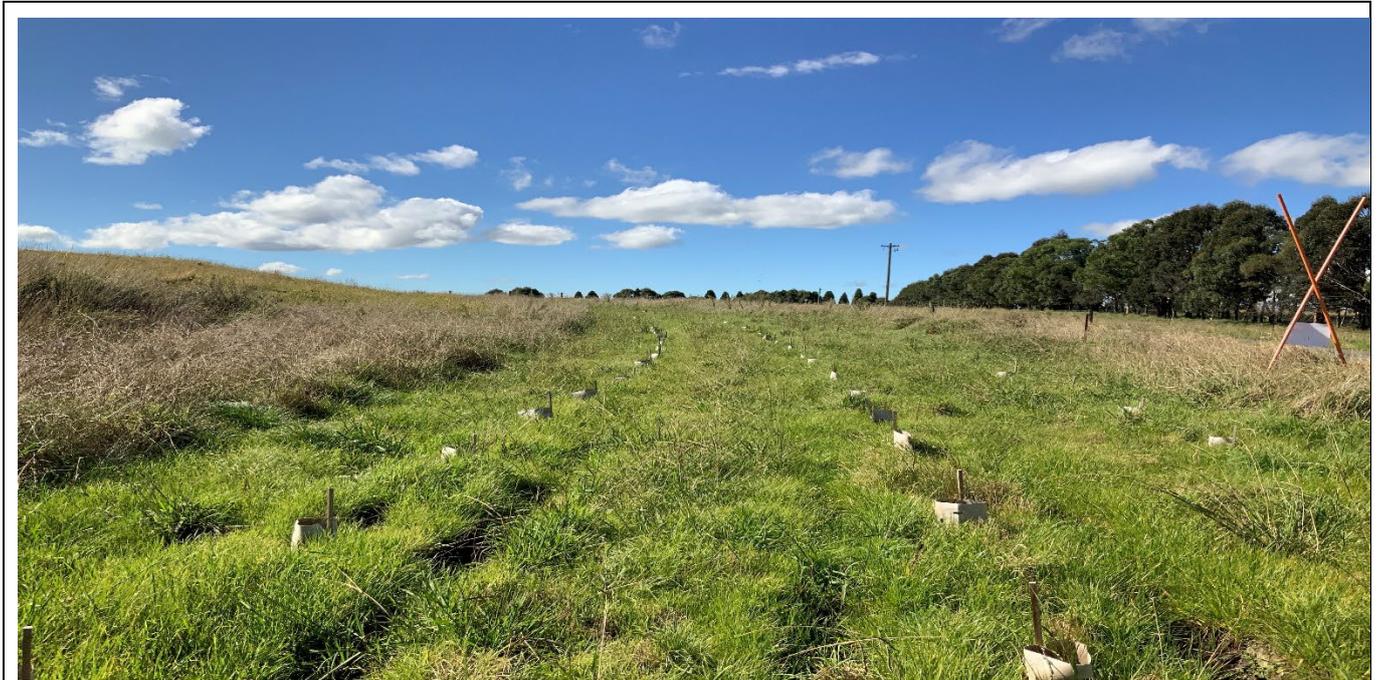
Information provided during interviews indicated that a tree screen was planted along the south-eastern periphery of the Surplus Overburden Stockpile. However, it was unclear if the species planted were those listed in the MOP commitment. During the inspection, it was observed that recent plantings had occurred on the south-eastern periphery of the Surplus Overburden Stockpile.

Following the audit, the revegetation contractor advised Austral Bricks that only one of the listed Eucalyptus species (*E. mannifera*) was used in the south-eastern tree screen. *Acacia melanoxylon* was also used. The contractor indicated that the other listed Eucalypt species would not have been suitable for this area since the area was ‘holding water’ at the time of planting so the substitute species, *Casuarina cunninghamiana* and *Eucalyptus elata* were planted.

The substitution of species for better performance in specific site conditions is acknowledged. However, it is important to ensure compliance with commitments made in the approval documents, in particular section 2.3.8 of the MOP, and where this is not possible, to apply for a satisfactory amendment or modification to the relevant approvals (raised as Observation of Concern No.1).

Figure 3 Evidence of tree planting at the south-eastern side of the Surplus Overburden Stockpile

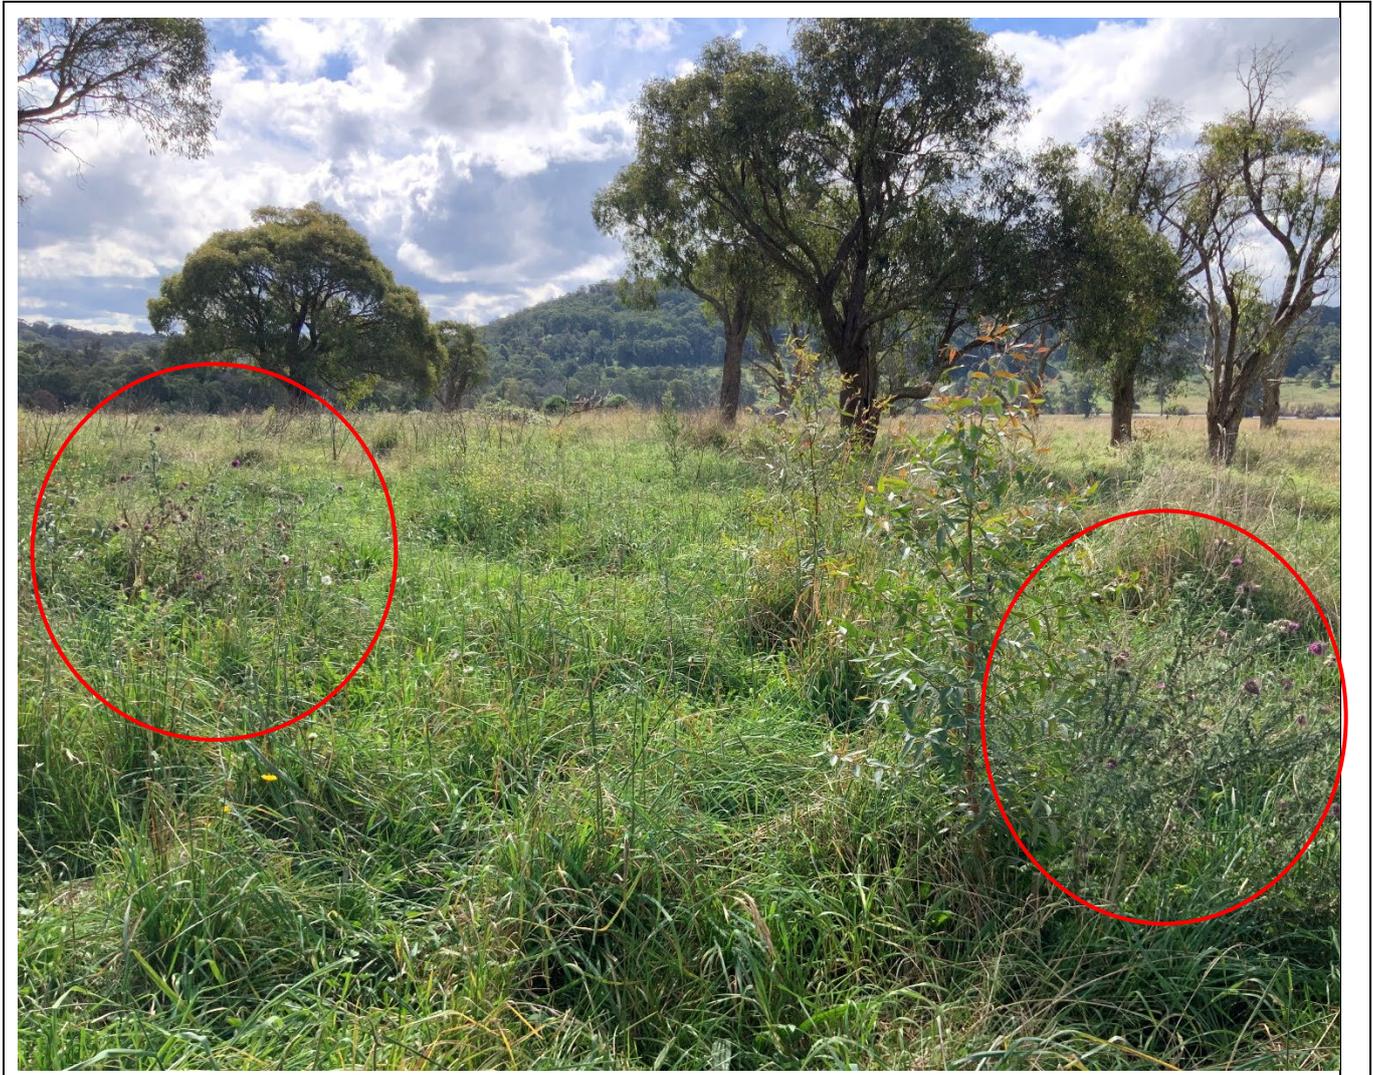
During the inspection, a moderate infestation of the noxious weed, Nodding Thistle, was observed around the northern tree screen area. This weed had significant dispersal capability and extended seed longevity in the soil. If left untreated this weed could completely prevent the use of the land for future grazing.

Figure 4 Northern tree screen area showing evidence of Nodding Thistle infestation (shown in red circles)

Monthly inspections for weed and pest infestations should be undertaken to ensure outbreaks are identified and controlled early. Suitable control of the Nodding Thistle infestation should be undertaken as soon as possible (raised as Observation of Concern No.2).
