# Investigation information release

## Loader falls into stope

**Location:** Perilya Potosi operation, Broken Hill, NSW

## Investigation information release IIR22-06

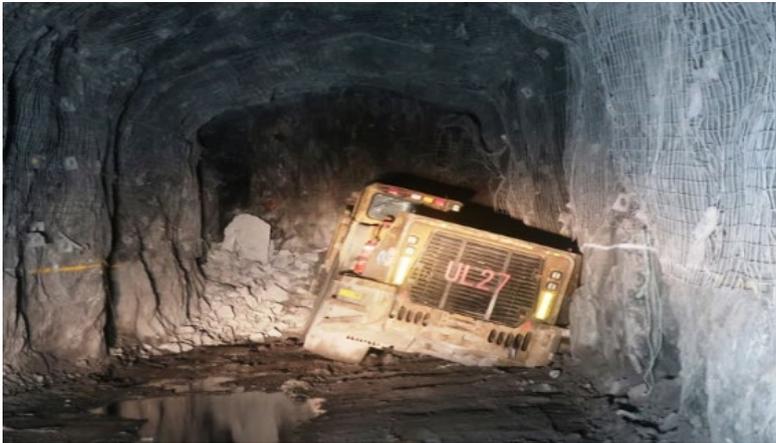
A loader operator was extracting material from a previously fired development heading at the 16 NPE 3400 north on the 16 level at the Potosi underground mine. While bogging, the loader operator felt the loader sag to the right and thought there was a flat tyre on the CAT 2900 loader. The operator exited the machine and saw the right-hand side wheels of the loader had dropped into a void that had formed in the floor of the drive. The operator immediately notified the shift supervisor.

Figure 1 Loader in the 16 level 3400 NPE development drive in the void in the floor

Mine operators should ensure that all known voids are documented and the process for any designs including changes to designs are thoroughly reviewed before the plans are approved.

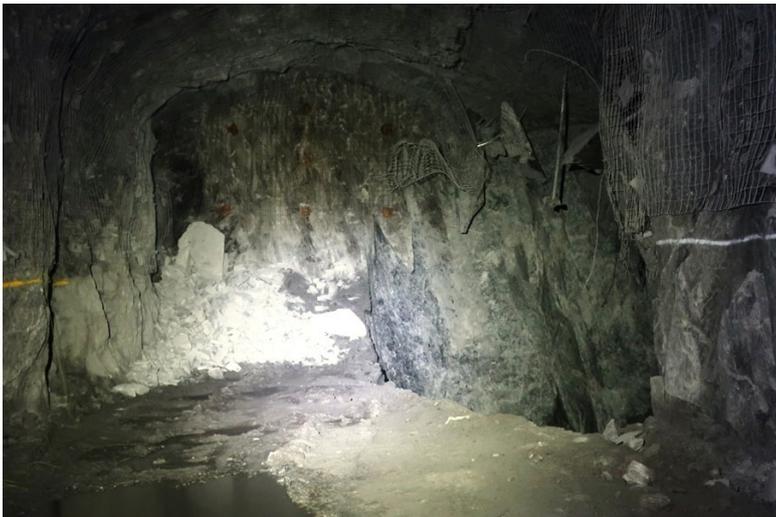
The incident was escalated to the mine's senior management who decided to barricade the area and further investigate the situation on the following shift. During the night, the void which had developed at the development heading, enlarged letting the loader fall about 15 metres into the previously mined stope. The loader came to rest on the level below.

Figure 2. Void opened up on the 16 level 3400 NPE development drive

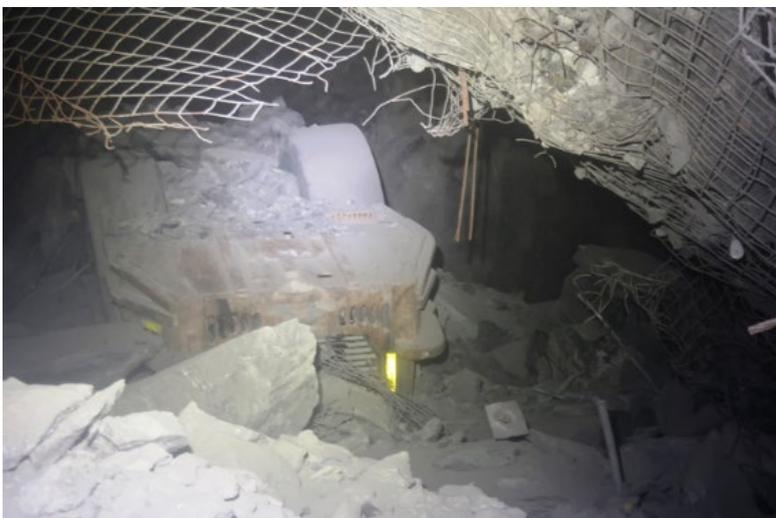
Figure 3. Loader in the 17 level 3400 NPE stope.
