Safety Bulletin

December 2022

Dangerous lifting equipment incidents increase

Safety Bulletin SB22-14

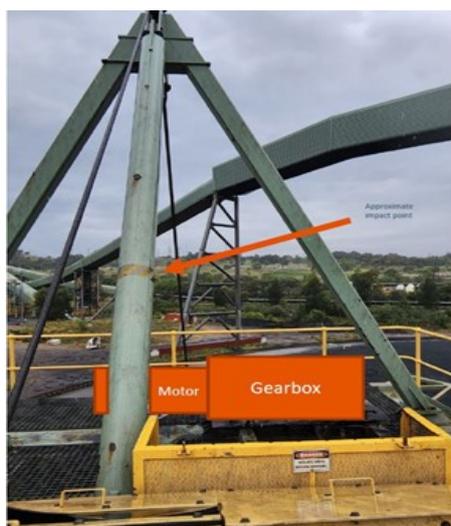
Figure 1: Reclaimer motor and gearbox

1. Dangerous incident – 13 November (Figure 1)

A work group at an open cut coal mine was installing a 2.7 tonne motor and gearbox assembly at the top of a reclaimer. The assembly was being lifted in with a slew crane when the job coordinator, not part of the work group, approached the task. The coordinator observed the load swinging around and instinctively reached out and grabbed the load. The coordinator's left hand index finger was caught between the load and the structure of the reclaimer, partially amputating the finger.

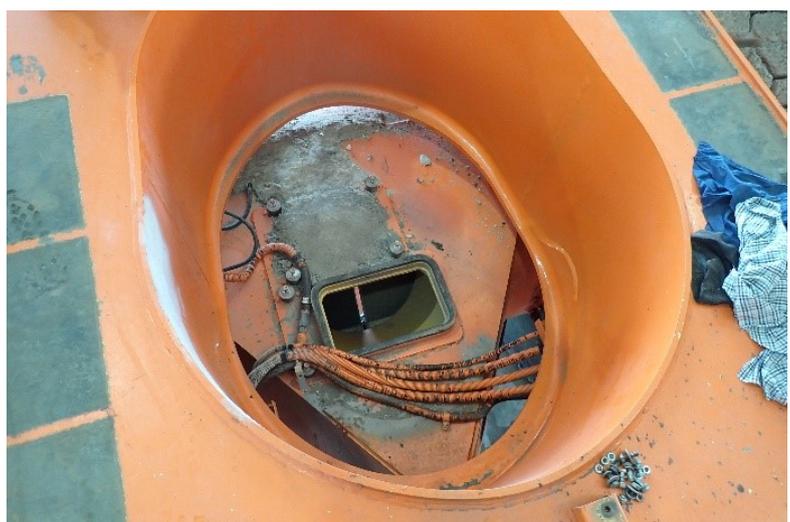
Figure 2: Haul truck rear axle box hole

2. Dangerous incident – 13 November (Figure 2)

At an open cut coal mine, a plate was being removed from the rear axle box hole of a haul truck using an overhead crane. The plate sprang out and hit a nearby worker, causing a compound fracture to the lower leg. The worker was transported to hospital by ambulance. The plate, chain and crane hook landed on the deck of the truck.

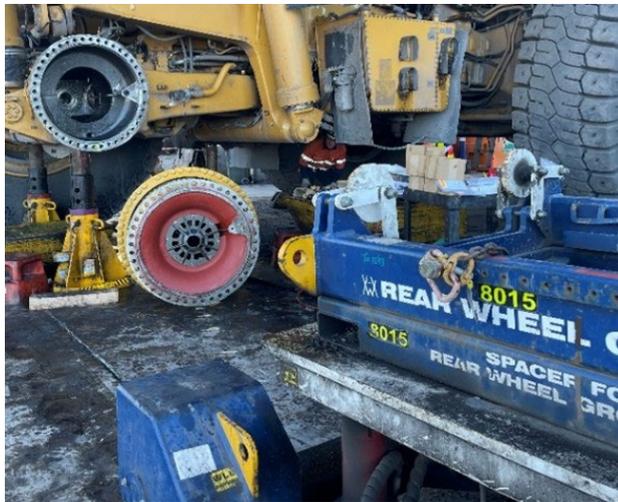
Figure 3: Truck final drive and jig trolley

3. Dangerous incident – 9 November (Figure 3)

A work crew at an open cut coal mine was installing the final drive to a haul truck. The workers were using a powered hoist and trolley to position the final drive. On the sixth attempt at aligning the drive to the axle, the trolley was stopped and the jerking motion caused the final drive to rock forward, snapping the single retention chain. The final drive then fell from the trolley requiring a worker to take evasive action to avoid being hit. An investigation identified the unit was intended to have 2 retention chains fitted and the workers had not been supplied with the manual for the trolley hoist.

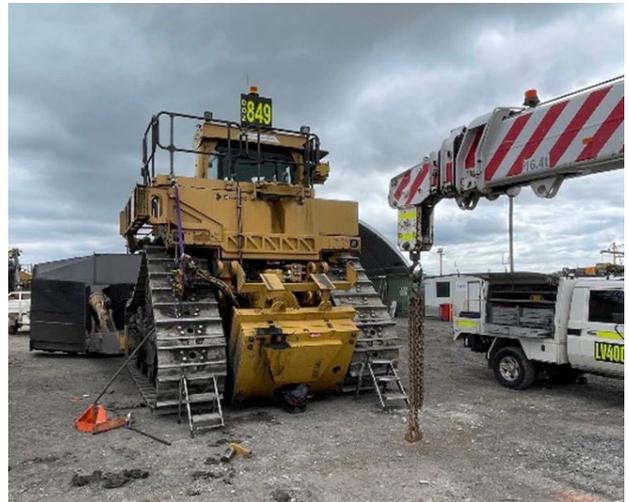
Figure 4: Dozer counterweight

4. Dangerous incident – 8 November (Figure 4)

While removing a counterweight from a dozer at an open cut coal mine, a worker suffered a laceration to the ear. The worker was using a crowbar to assist in removing a pin when the counterweight moved unexpectedly and the crowbar flung up, hitting his ear. The work crew was not supplied with the mass of the counterweight and had not adequately supported the counterweight.

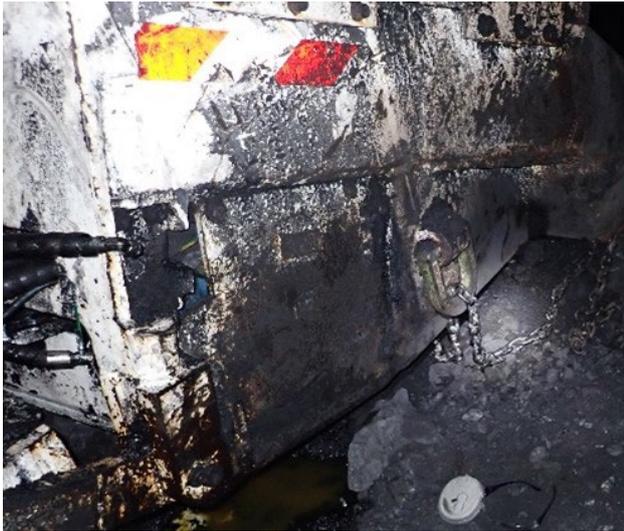
Figure 6: Continuous miner apron

5. Dangerous incident – 19 October (Figure 5)

A continuous miner at an underground coal mine was being prepared to be trammed out of the panel for repairs to the shovel lift cylinder and clevis. Due to the damage, the shovel had to be supported from the cutter boom. The cutter boom was lowered and a 10 mm chain connected to RUD lugs on either side of the shovel. The miner driver powered up the miner, started the hydraulic pumps, and moved to what he thought was a safe place clear of the chain on that side of the miner. As the cutter boom was raised, the chain failed on the opposite side of the cutter boom and flung in an arc. The chain hit the worker on the face and shoulder. The worker required stitches to their cheek and neck.

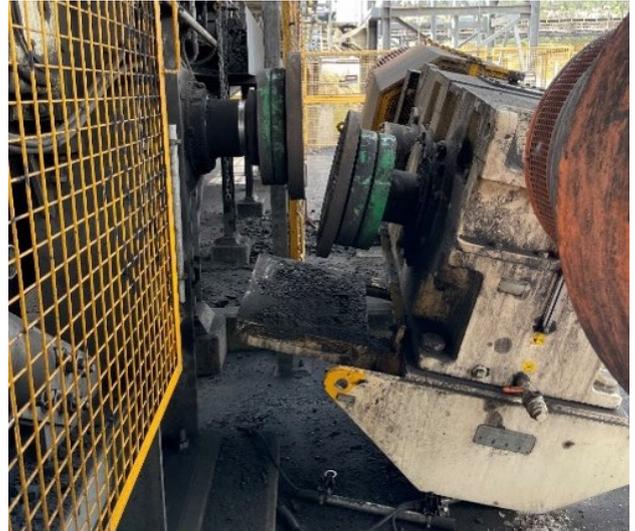
Figure 7: Conveyor drive

6. Dangerous Incident – 18 October (Figure 6)

Several workers at an open cut coal mine were preparing to remove a conveyor drive assembly (motor, gearbox and torque arm). An electrician was disconnecting the motor and another worker was removing the coupling covers. The worker proceeded to unbolt the coupling before the assembly was slung or supported. The unit rotated forward narrowly missing the workers.

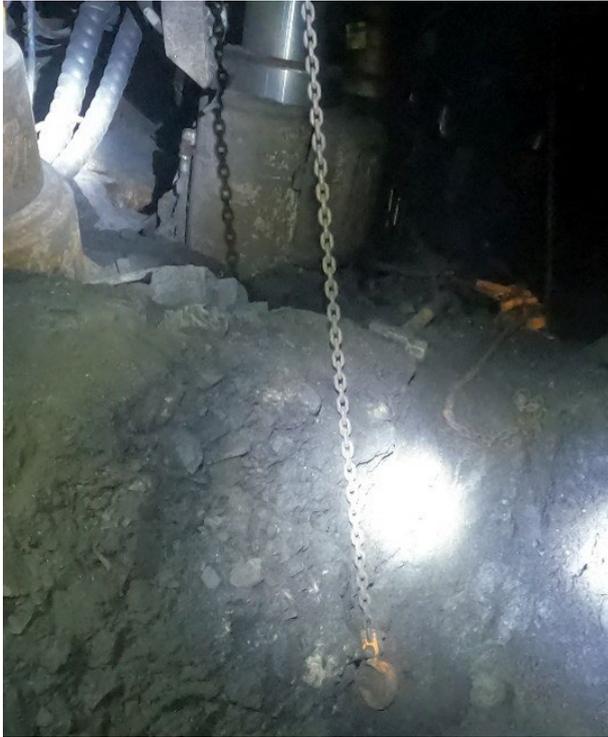
Figure 7: Chain hoist to remove relay bar pin on longwall tailgate roof support

7. Dangerous Incident – 17 October (Figure 7)

A mechanical tradesman at an underground coal mine was directed to separate the tailgate drive from four powered roof supports. A lever hoist chain was wrapped around the relay bar shear pin to remove it. Load was applied to the lever hoist and then the tailgate drive moved with a heavy lift machine. The worker then applied additional load to the lever hoist. The chain released from the pin and hit the worker in the face.
