Marrangaroo Quarry Final Audit Report

Metromix Pty Limited

December 2022

Department reference number: RDOC22/258380

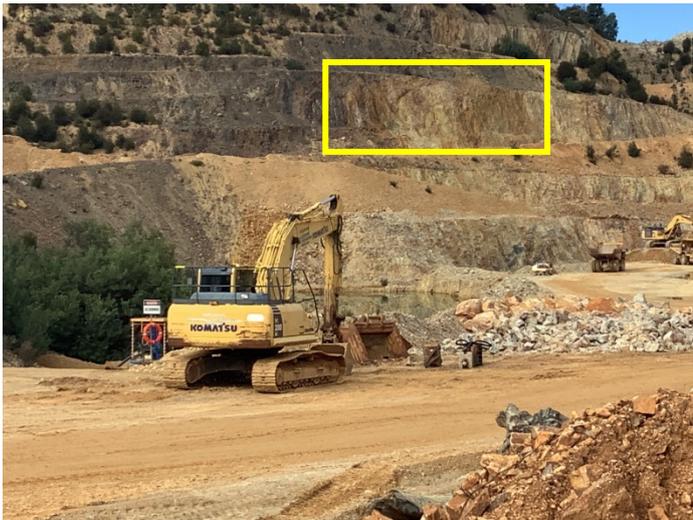
Section 3.2.3 of the MOP recognized that material prone to generating acid mine drainage sulphides were identified within a 'discrete' zone of the southern face of the North-South Quarry. This zone was a 'contact zone' formed during the emplacement of the carboniferous granites and contained 'low grade' quartzite, shale and sandstone material. The sulphides, whilst significant in their concentration, were limited to a small area for which no further extraction activities were planned, shown in Figure 1 below. The audit team noted the geological investigations undertaken in 2015, which determined no significant/immediate risks posed by the presence of these sulphides. It was noted that the quarry managed the risk by ensuring no acidic water (pH of <6.5) was discharged from the quarry by monitoring on-site water storages and ensuring that where discharge events was likely (ie. due to significant wet weather), water was treated with alkaline amendment to increase pH to within the required criteria.

Figure 1 'Discrete' zone of material prone to generating acid mine drainage – southern face of the North-South Quarry

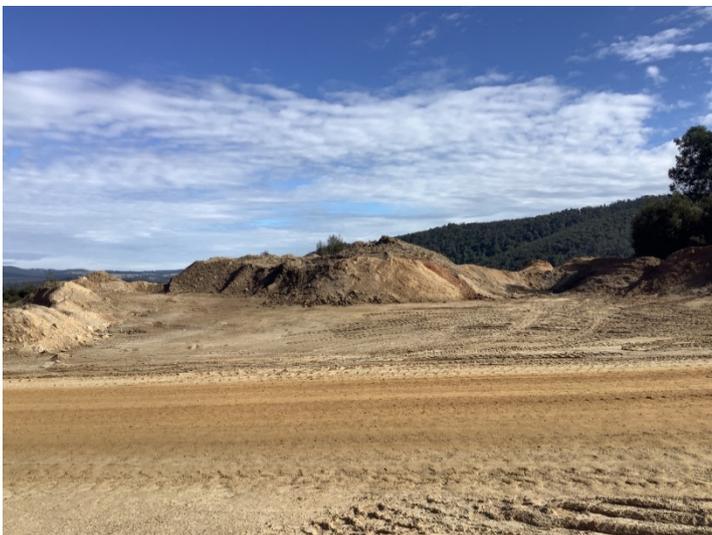
- overburden management – MOP section 2.3.4 notes that all waste rock/overburden material and unsaleable fines and split rock, not sold as fill material, would be placed as backfill within the South-West Quarry void. It was intended that the South-West Quarry would be backfilled to approximately 960m AHD and ultimately be used for product stockpiling. The South-West Quarry stockpile areas were observed by the audit team while on site (see Figure 2 below)

Figure 2 Soil stockpile observed at South-West quarry area

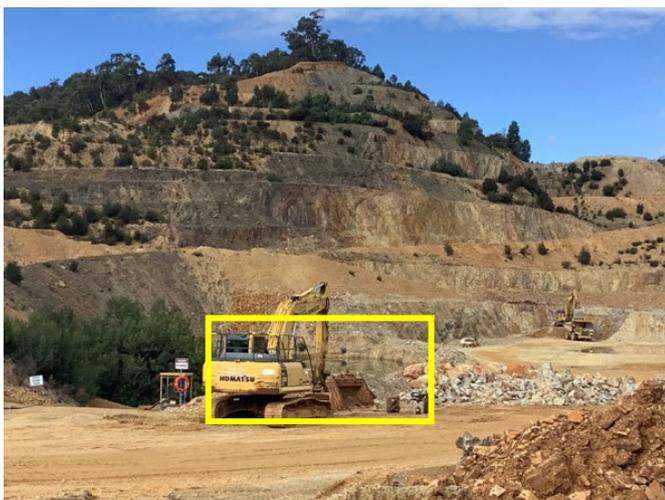
- the North-South Quarry sump was progressively pumped out following high rainfall in early 2022
- electric pump with float was installed at the BHP Dam to ensure the stored water did not exceed set levels. It was noted that the pump is checked as part of the weekly inspection schedule

Figure 3 North-South Quarry Sump

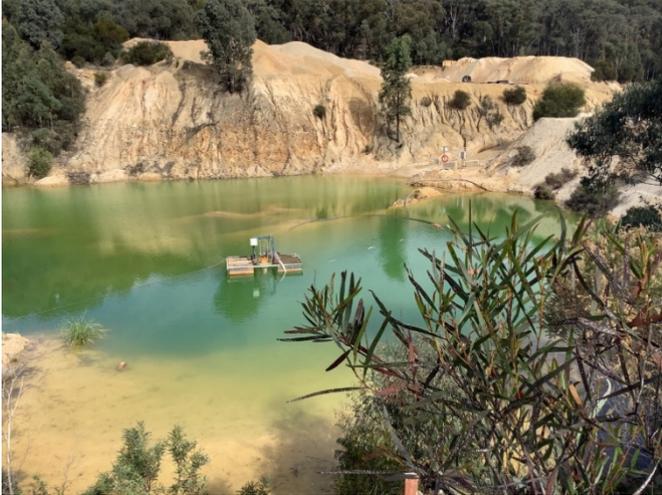
- while the BHP dam capacity wasn’t physically increased as proposed, Metromix advised that relocating the water pump within the dam provided a better response for pumping water once trigger levels were reached to ensure desired capacity.

Figure 4 BHP dam

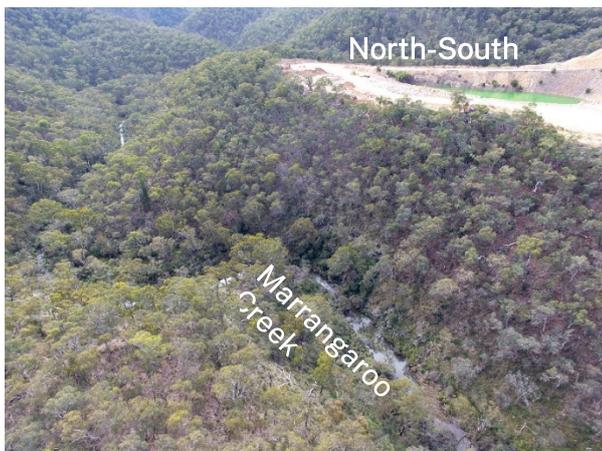
Section 3.2.15 of the MOP noted that an Aboriginal artefact scatter was identified near Marrangaroo Creek in the southwest area of the quarry site. A 60 m conservation zone was established surrounding the scatter and Metromix advised that the site was located downslope of the North-South Quarry extension limit bund wall, and as such, the conservation zone was complied with as the area was relatively inaccessible.

Figure 5 Aerial photo of Aboriginal artifact scatter, downslope of the North-South Quarry extension limit bund wall

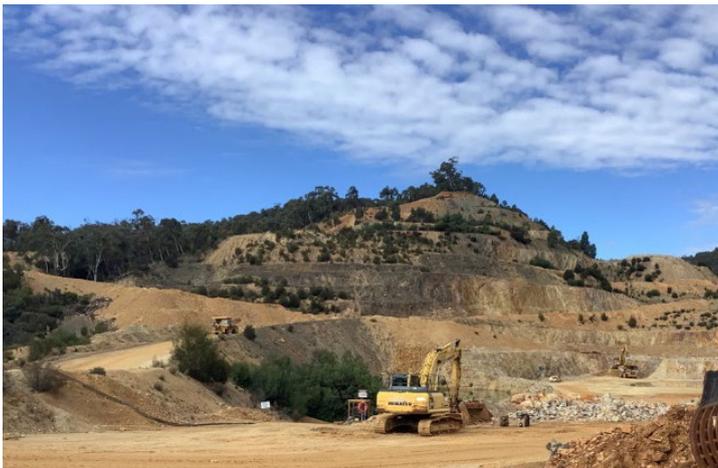
- vegetation was observed to be establishing on the final extraction benches on the limit of the North-South Quarry (Figure 6). Metromix advised the benches were backfilled and seeded progressively

Figure 6 Revegetation of the benches- North-South Quarry

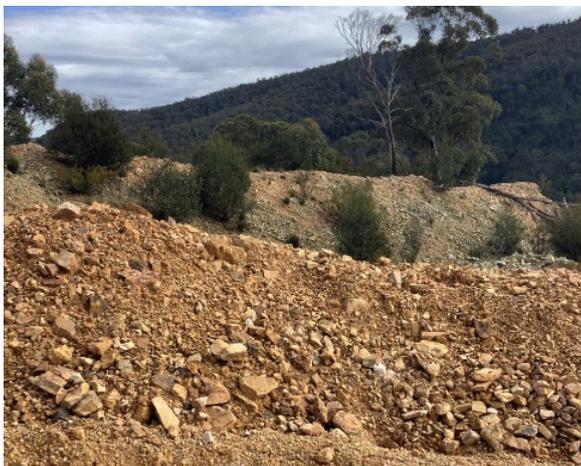
- establishing native vegetation was also observed along the extraction limit western boundary (Figure 7)
- Metromix advised that a soil manure hydromulch mix was used in erosion areas along the site boundaries and water management structures across the site. Native vegetation seeds endemic to the region were used for revegetation, as confirmed in the three yearly monitoring report prepared by Aquila Ecological Surveys, dated January 2022. It was also noted that felled timber was used to lay down on benches for use in erosion control

Figure 7 Extraction limit western boundary

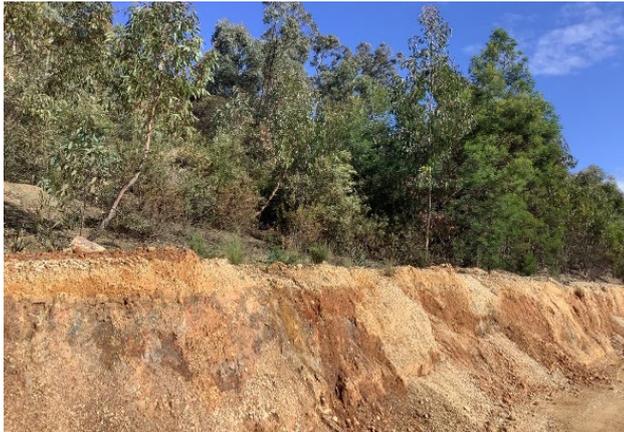
Figure 8 Natural vegetation area – Monitoring Point 2

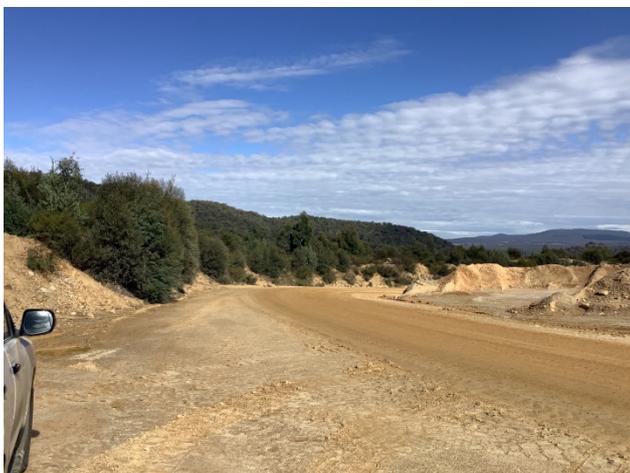
- the surrounding revegetation areas along the South-West quarry area were observed to be establishing well and Metromix noted that spray seeding along the southern bank was successful. Metromix advised that there was no formal schedule for monitoring and maintaining the rehabilitation sites, other than the six existing monitoring sites. Metromix engaged a contractor (New Era) who undertook spray seeding and weed management on an annual basis, which was targeted based on the site. Some bare patches along the benches (Figures 9 to 11) were observed during the audit.

Figure 9 Native revegetation along South-West quarry boundary

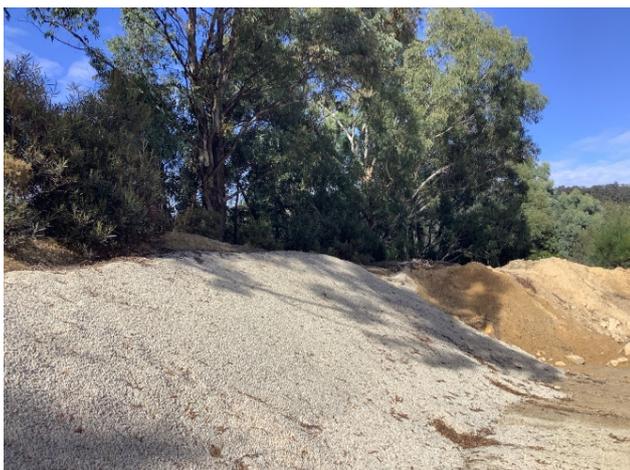
Figure 10 Native revegetation along South-West quarry boundary

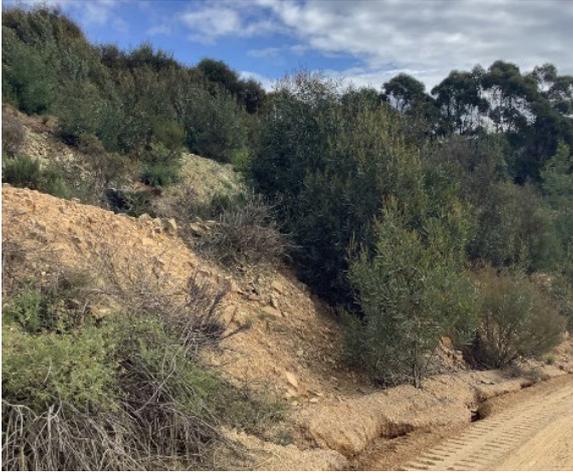
Figure 11 Bare areas along the benches

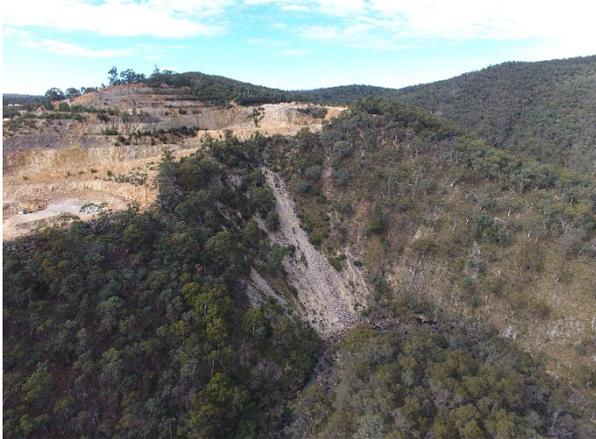
- Prevention of soil erosion and pollution (condition 14 of PLL584, ML1522, ML4635, ML4636 and ML6388, and condition 16 of PLL602 and MPL221) – drone footage taken during the audit along the western side of the North-South Quarry extension limit bund wall identified what was thought to have been a significant landslip, directing sediment and debris into Marrangaroo Creek (see Figures 12 to 14). Metromix has since advised that this is a historic issue, which occurred during extraction of the resource where material had been pushed over the high wall. This was raised as observation of concern no. 1 and will be subject to further investigation by the Regulator.

Figure 12 Landslip North-South Quarry bund wall

OBSERVATION OF CONCERN NO.	DESCRIPTION OF ISSUE	RECOMMENDATION
1	<p>Drone footage taken during the audit along the western side of the North-South Quarry extension limit bund wall identified what was thought to have been a significant landslip, directing sediment and debris into Marrangaroo Creek.</p> <p>Metromix has since advised that this is a historic issue, which occurred during extraction of the resource where material had been pushed over the high wall.</p>	Subject to further investigation by the Regulator

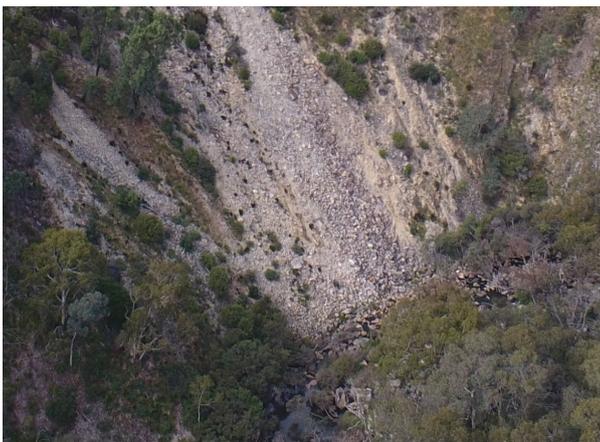
Figure 13 Sediment and debris upslope of Marrangaroo Creek

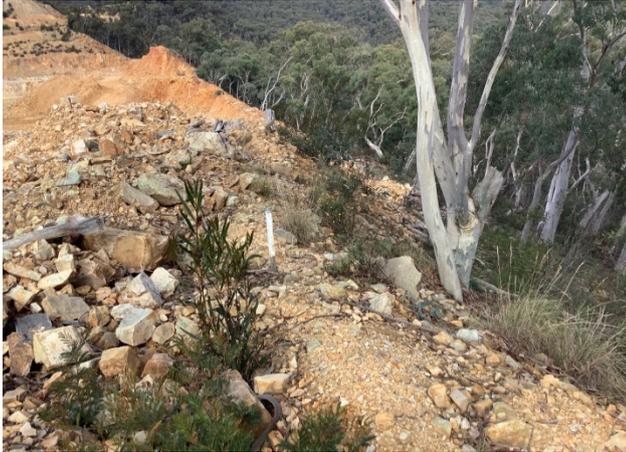
Figure 14 Top of the bund wall at the northern end of the North-South Quarry extension limit bund wall
