# Investigation information release

## Outburst at NSW underground coal mine.

**Location:** Appin Colliery

# Investigation information release IIR22-07

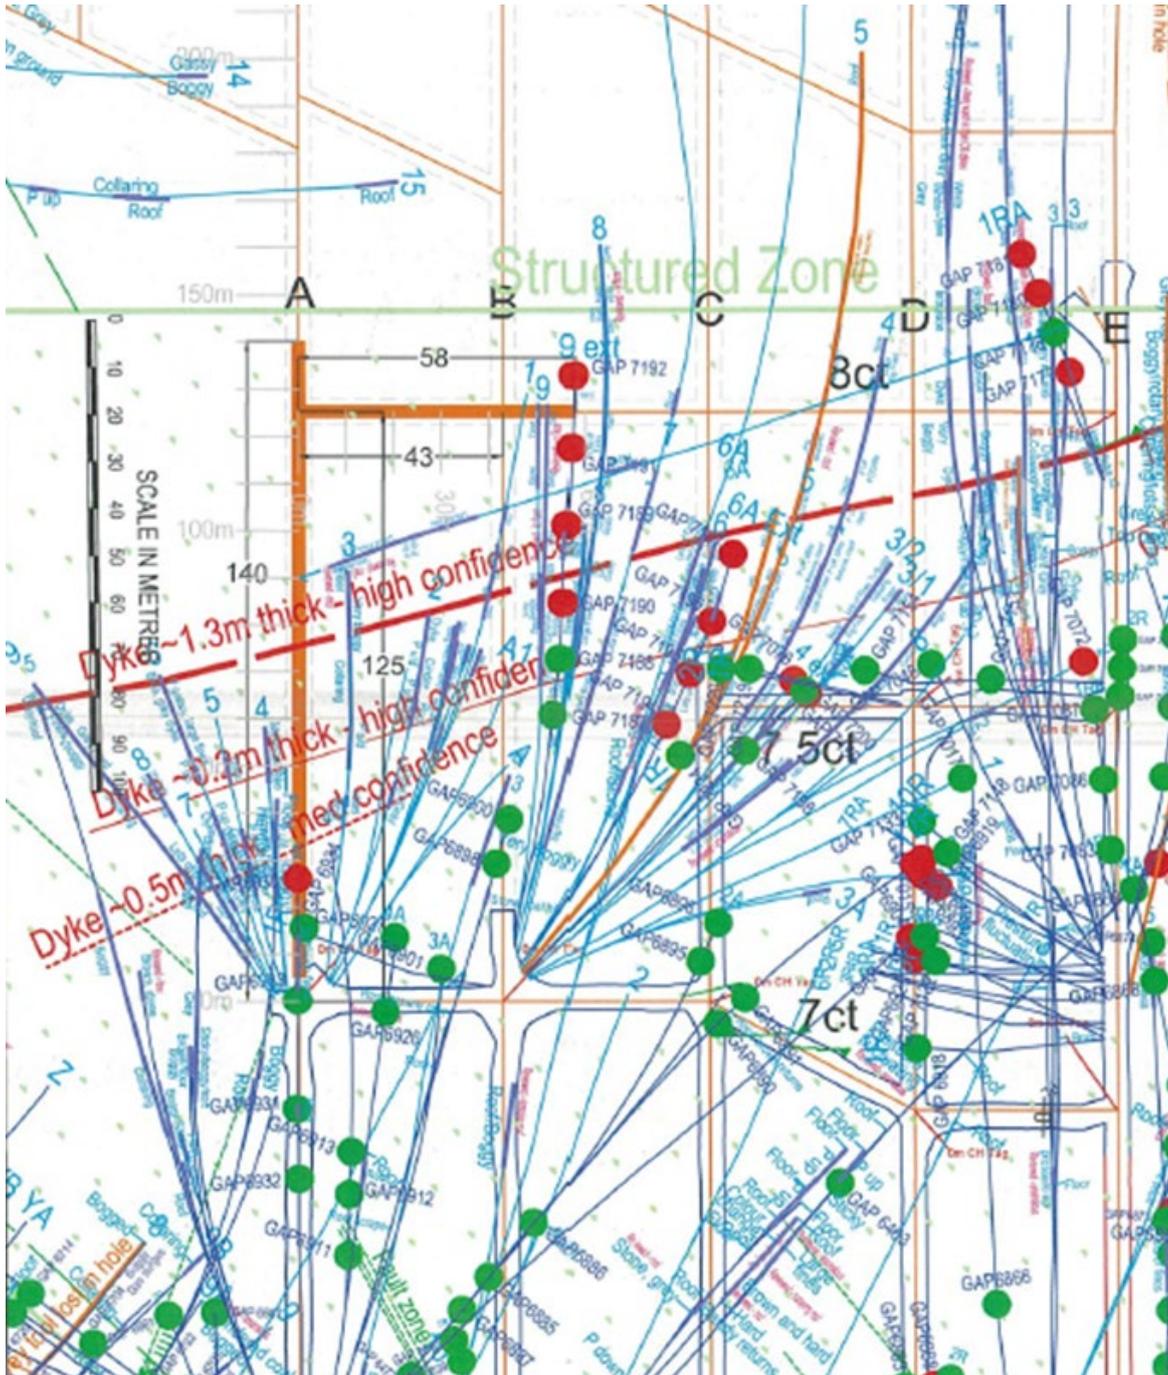
The area crossed a 1.3 metres to 1.7 metres thick dyke zone about 80 degrees to the heading as well as a strike slip fault sub parallel to the heading about 25 degrees.

Figure 1: Original geology prior to A heading outbursts

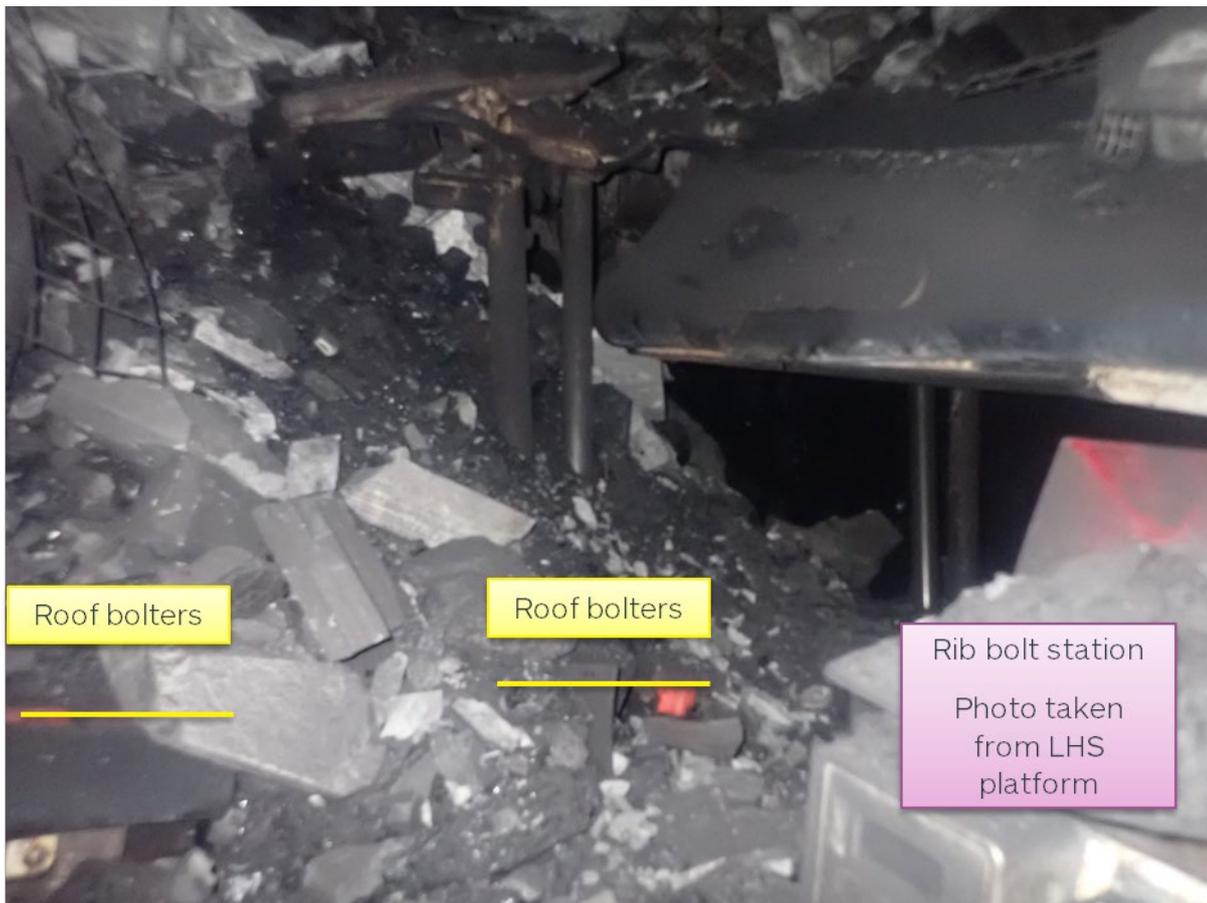
- A remote outburst occurred while mining more than 14 m<sup>3</sup>/t.
- About 5-8 tonne (estimate) material was ejected.
- Material was thrown up to 2 metres on the left-hand side of continuous miner.
- A gas release caused the auxiliary fan to trip.
- The maximum methane level in the return was 1.37% (note the return was part of no-go zone).
- Total gas released was 915 m<sup>3</sup> (530 m<sup>3</sup> methane and 385 m<sup>3</sup> carbon dioxide).
- The area was highly structured and essentially undrained.
- A small dyke at the outburst site (estimated from drilling) was not present – a small slip/strike fault was present.

Figure 3: Event 1. Left-hand side of miner showing roof bolter positions and burst material

- The inspector who assessed the incident considered that the remote mining controls which were in place at the time were effective.
- A geological and geotechnical inspection and appraisal identified jointing, strike/slip fault. There was no evidence of a small dyke or cinder and no evidence of outburst cone.
- A revised authority to mine (ATM) was issued with a predicted small dyke removed from the reissued ATM.

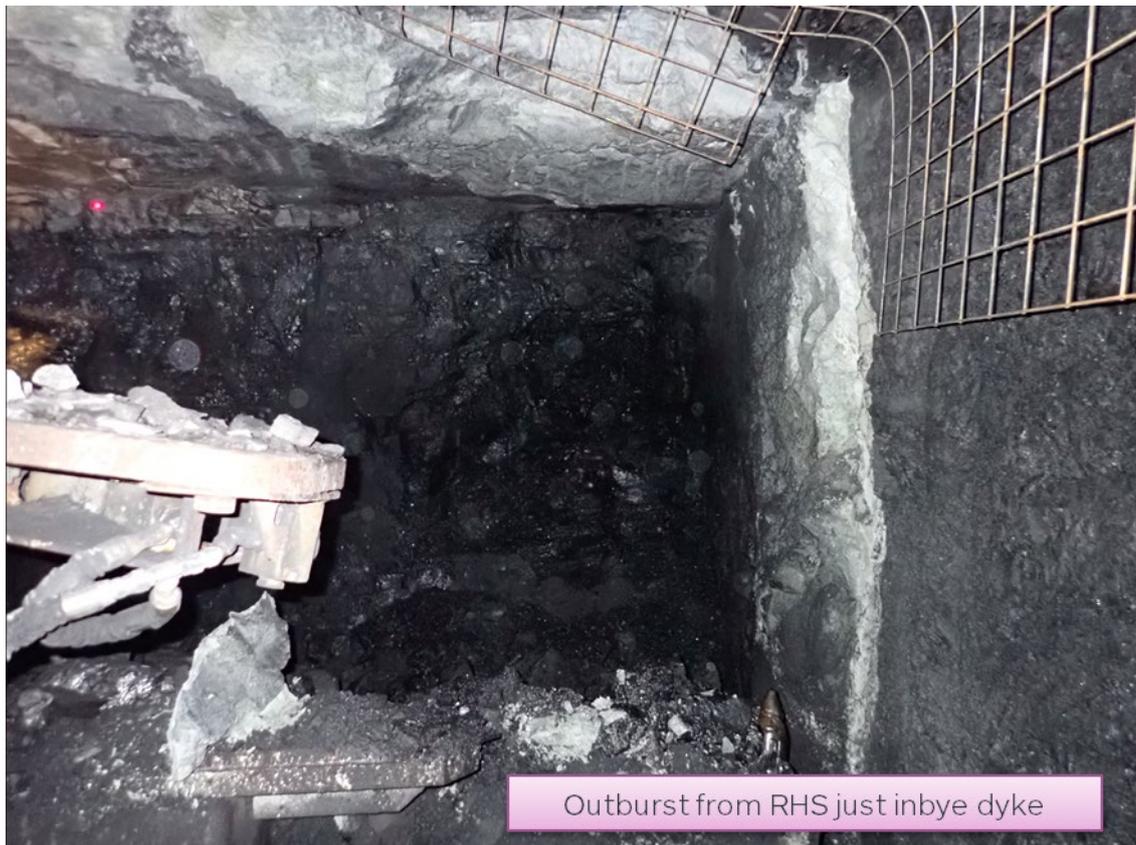
- About one tonne of coal was ejected.
- Material thrown up to 4.5 metres from right-hand side corner to the left, with no coal being thrown over the continuous miner.
- A methane gas release caused the auxiliary fan to trip.
- The maximum methane level in the return was 0.63% (note the return roadway was part of no-go zone).
- Total gas released was 298 m<sup>3</sup> (163 m<sup>3</sup> methane and 135 m<sup>3</sup> carbon dioxide).
- The area was highly structured, and essentially undrained.

Figure 4: Event 2 view of small outburst on right-hand side of heading

- The inspector who assessed the incident again considered that the remote mining controls which were in place at the time were effective. A geological and geotechnical inspection and appraisal identified jointing, strike/slip fault, confirmation of main dyke zone and a small outburst cone.
- A decision was made to drill 2 in-seam gas drainage flank holes in A heading.
- The left-hand side flank hole was drilled to 20 metres and drill rods were bogged.
- The right-hand side flank hole was drilled to 28 metres and drill rods were bogged.
- A revised ATM was issued to mine B heading, while the 2 in-seam gas drainage flank holes in A heading were being drilled.

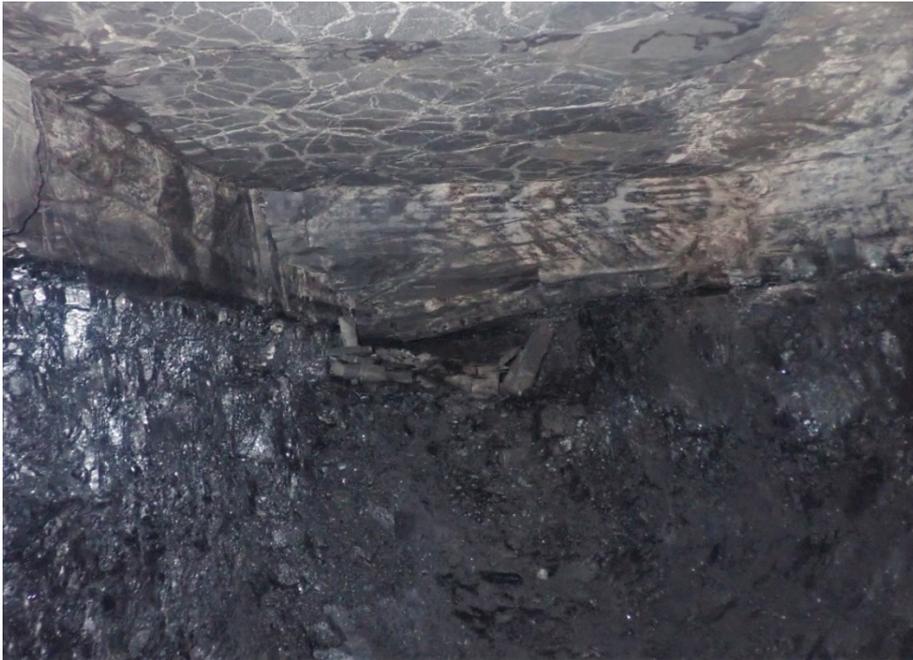
The deputy reported a small coal slump on the right side and an outburst cone was evident in the left side of the face about one metre diameter and 2.5 metres deep. Roof material had fallen out to about 400–800 mm across heading, higher cavity bias towards the centreline.

- An outburst occurred whilst remote mining coal with a gas content of more than 14 m<sup>3</sup>/t.
- About 8 tonne of coal was ejected from the void.

- Material slumped off RHS rib area. Three shuttle cars' worth of material was removed from in front of the loader blade (combination of roof, face, void, and coal cut during sequence. No large blocks or fine coal were present on platforms. The boom of the miner had small amounts of material build-up and the head of the miner was buried under coal and roof stone.
- A methane gas release caused the auxiliary fan to trip.
- The maximum methane level in the return was 2.2% methane general body. (note return part of no-go zone).
- Total gas released was 1568 m<sup>3</sup> (878 m<sup>3</sup> methane and 690 m<sup>3</sup> carbon dioxide).
- The area was highly structured, and essentially undrained.

Figure 5: Event 3. View of left-hand side face cone after material cleaned out

- As per the previous two events, the remote mining controls were considered to be effective in managing the risk to workers.
- A geological and geotechnical inspection and appraisal identified jointing, strike/slip fault and outburst cone. Further inspection due following advancing A heading face beyond the current outburst cone.
- A revised ATM was issued to mine the inbye section of A heading only.
- The mine revised the return airway contamination plans/dilution models and exclusion zones related to remote mining operations.
- Assess the capability for the remote operating station cameras to record footage and the auxiliary fan trends to be recorded for replay.

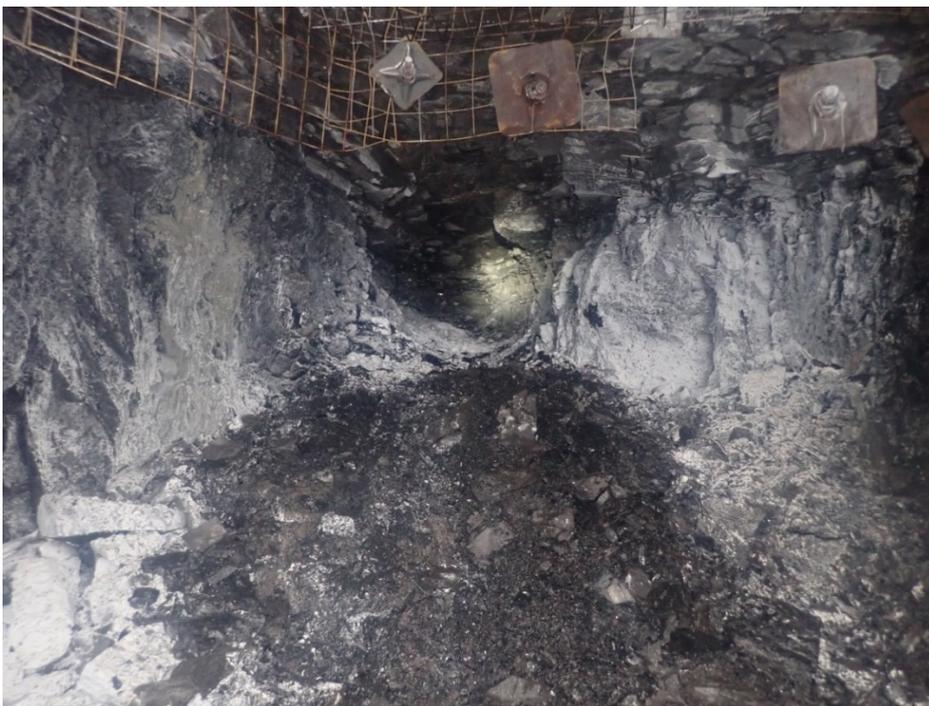
Figure 6: Event 3. View of left-hand side cone after strata support installed
