Weekly incident summary

Week ending 13 January 2023

Weekly incident summary week ending 13 January 2023

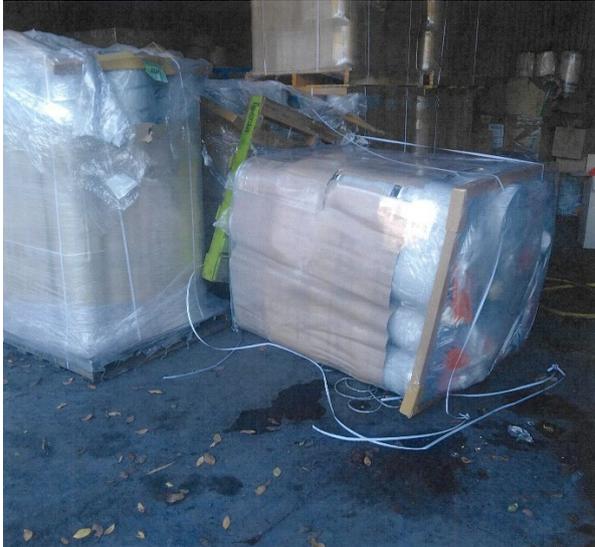
While positioning a large air conditioner unit on top of a transformer, a worker suffered a serious finger laceration that required surgery.	When large components are being moved or positioned by workers, suitable mechanical aids and task-sequencing should be used to reduce the workers' exposure to pinch points and manual handling injuries.
Dangerous incident IncNot0043846 Underground coal	A worker was struck on the head and shoulder by a falling pallet that was stacked with diesel particulate filters. One pallet had been stacked on another and other workers had been removing filters from the lower pallet.	Mines should review their practices for stacking filters and other consumables. Workers must consider the stability of stacked pallets when removing items so as not to pose a hazard to other workers.

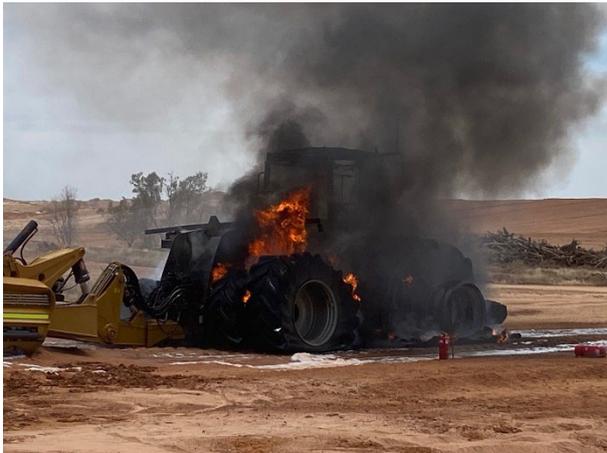
<p>High potential incident IncNot0043845 Mineral sands Fire or explosion</p>

<p>A large tractor was working on rehab carting topsoil. Fluid sprayed from the engine bay over the windscreen and shortly after flames appeared around the engine. The operator received minor burns to their wrist and was taken to hospital for assessment. Several nearby workers immediately rendered assistance and attempted to extinguish the fire.</p> <p>The workers were unable to directly raise the emergency and relied on another worker to relay the emergency message.</p> <p>The mine's emergency response team responded with a fire tender, and water carts were used to extinguish the fire.</p> <p>The tractor was destroyed.</p>

<p>An investigation into this incident has commenced and further information may be released in the future.</p> <p>Mines must ensure all work groups have suitable means to raise emergencies, including when working in isolated or locations remote from mine infrastructure.</p>
