Weekly incident summary

Week ending 20 January 2023

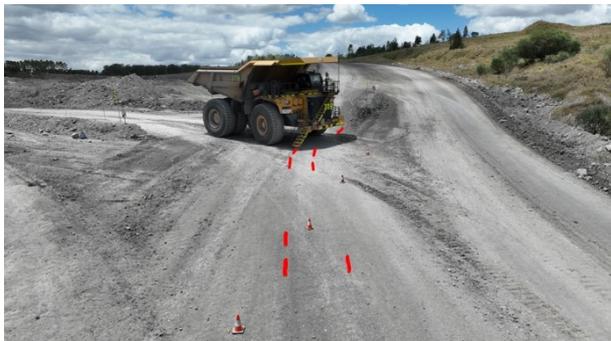
<p>A haul truck was stopped at a give way sign at an intersection. Another haul truck was approaching with a light vehicle in convoy.</p> <p>After the haul truck passed the intersection, the stationary truck began to move forward, turning right into the path of the light vehicle. The light vehicle operator was distracted while looking for the two-way approaching the intersection and when looking up had to take evasive action to avoid a collision.</p> <p>The proximity detection system alarmed.</p>

<p>maintenance, and use of battery-operated tools.</p> <p>Workers must ensure that intersections are clear before proceeding.</p> <p>Mine operators should take a risk-managed approach considering the hierarchy of controls when reviewing their principal hazard management plans to ensure that all workers show appropriate situational awareness of their surroundings and other vehicles on the road.</p> <p>Mine operators should have regard for human and organisational factors when reviewing the number of systems devices that may alarm in haul trucks. Mine operators should assess the risk of white noise and desensitising workers to alarms.</p>

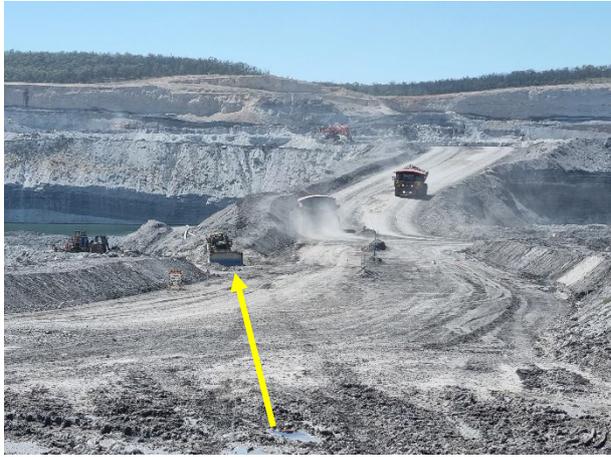
<p>was taken up by the D11 dozer. While the D11 dozer was repositioning, the sling slipped off the ripper.</p> <p>The D10 dozer then rolled approximate 230 metres down a ramp. The dozer stopped when it struck a windrow.</p>

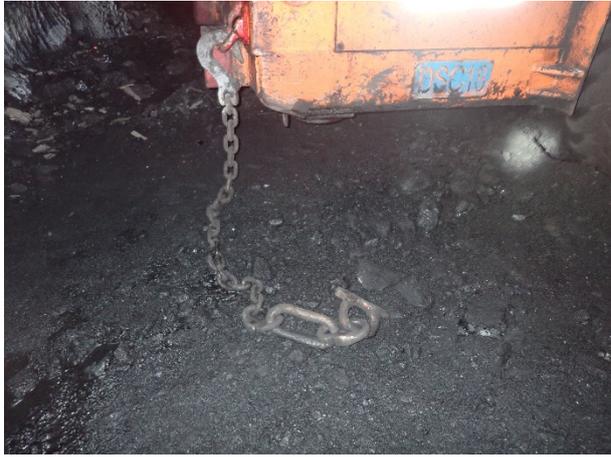
<p>A shuttle car became bogged in an intersection. A load haul dump (LHD) was brought into the intersection to assist recovery. A safety chain fitted to the LHD was attached to the shuttle car.</p> <p>While attempting to free the shuttle car, a RUD lug broke the weld and flung towards the shuttle car. Two operators were hit in the legs.</p> <p>One worker suffered a laceration that required stitches. The other worker had no injuries.</p>

<p>Safe standing zones must be identified and communicated before towing and snigging activities commence.</p> <p>Attachment points on mobile equipment must only be used for the purpose intended by the equipment designer. Attachment points must be maintained and should undergo regular non-destructive testing.</p>
