Investigation information release

Uncontrolled dozer travels 230 metres down a ramp

Incident date: 15 January 2023

Location: Maules Creek Coal Mine

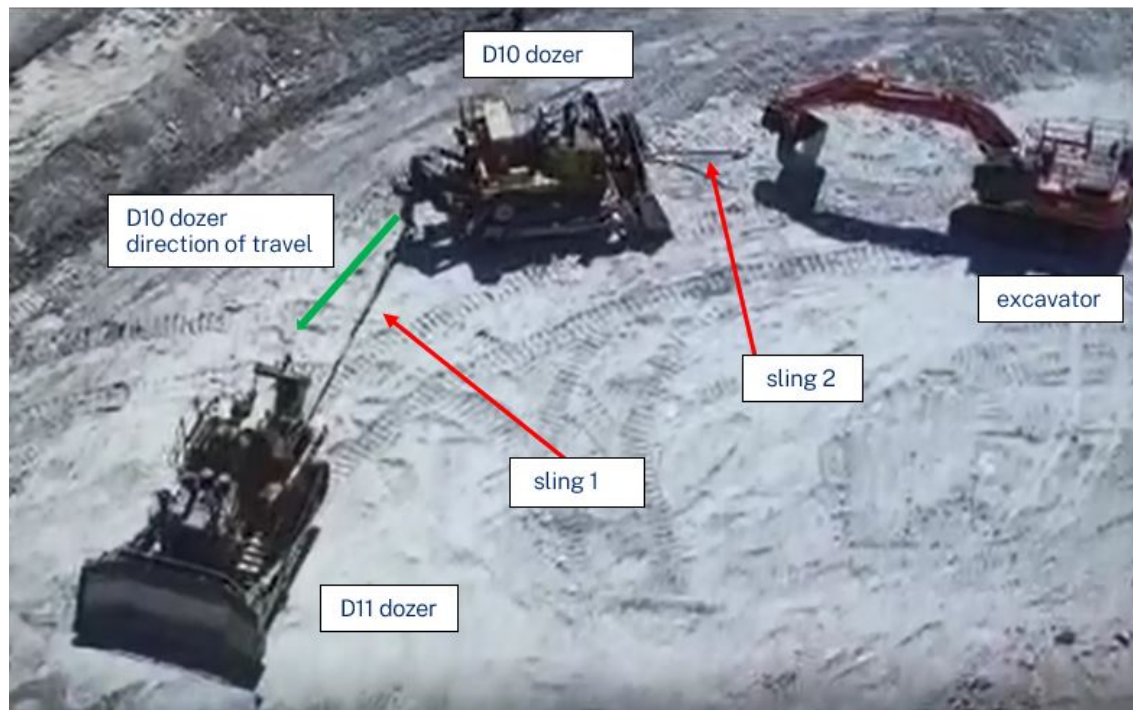
When the task was ready to start, the wheel loader was not available and a decision was made to deviate from the JHA and use the D11 dozer as the tow machine with a 36-tonne excavator used as a brake stop (see Figure 1). Preliminary inquiries indicate the JHA was not reconsidered and the risks arising from the work task were not reassessed once the wheel loader was no longer to be used as part of the recovery, and the function of the D11 dozer changed.

Figure 1: Drone imagery showing the positions of machinery before incident

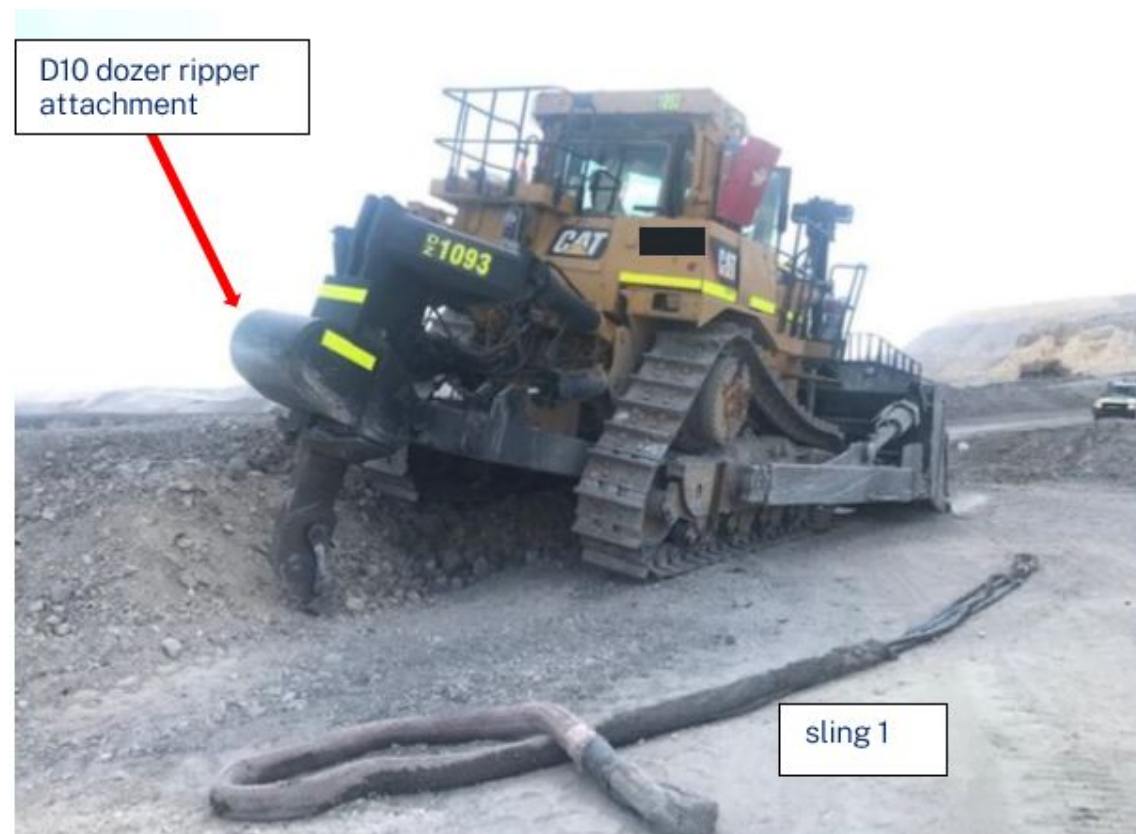
- the rear of the D10 and D11 dozers being connected by a fibre recovery sling looped around their respective ripper attachments (sling 1) (see Figure 2)
- a second fibre recovery sling connecting the front of the D10 dozer to the 36-tonne excavator being positioned behind it to provide braking (sling 2)

Figure 2: Sling 1 used to connect the ripper attachments of D10 and D11 dozers

The D11 dozer operator then tried to reposition the dozer, resulting in slack in the remaining intact sling (sling 1). This caused the sling to slip off the D11 dozer's ripper attachment resulting in the unrestrained D10 dozer rolling down the ramp in an uncontrolled manner for about 230 metres before coming to a stop on a windrow (see Figure 5). Access to the ramp area was restricted before the task began, and no workers were injured as a result of the incident.

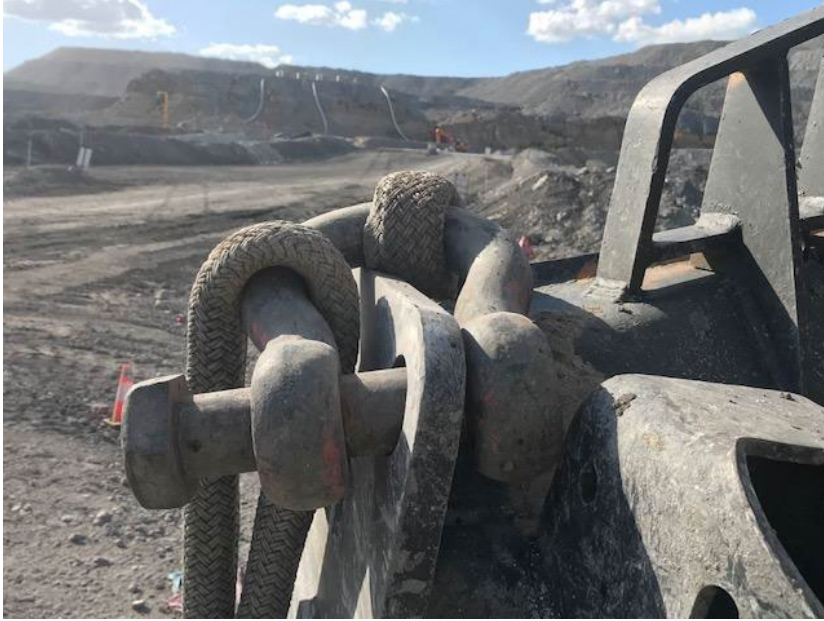
- sling 2 being connected with a D-shackle to a tow/lifting point on the D10 dozer blade (see Figure 3) and then looped around the arm of the excavator bucket attachment across a right-angled steel edge.

Figure 3: D-shackle connecting sling 2 to D10 dozer blade tow/lifting point

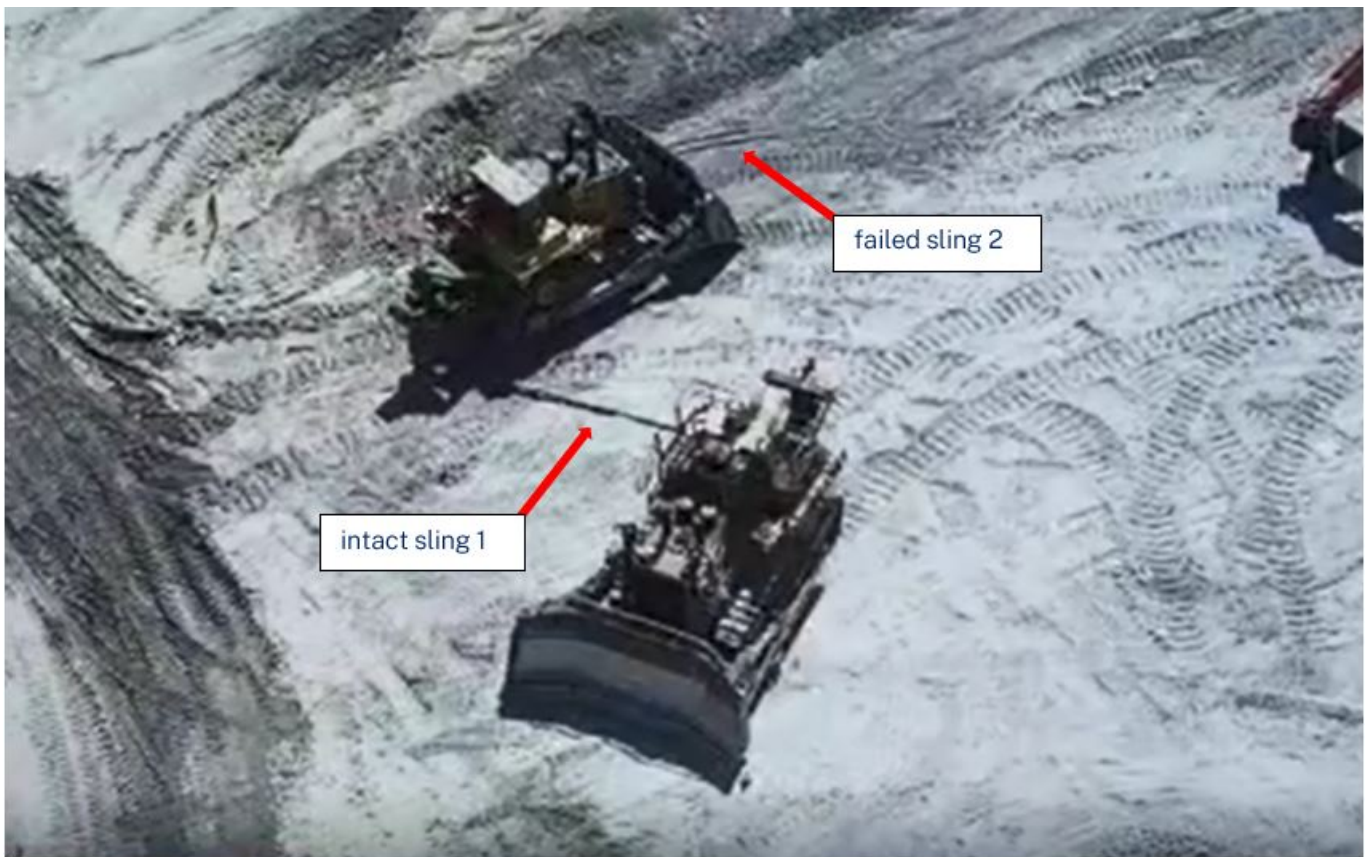
Shortly after the towing began, sling 2 rapidly tensioned and then broke away from the arm of the excavator. The D10 dozer then rolled a short distance until tension developed on sling 1 and it came to a stop as shown in Figure 4.

Figure 4: Drone imagery showing the position of the D10 dozer after the rear sling failed

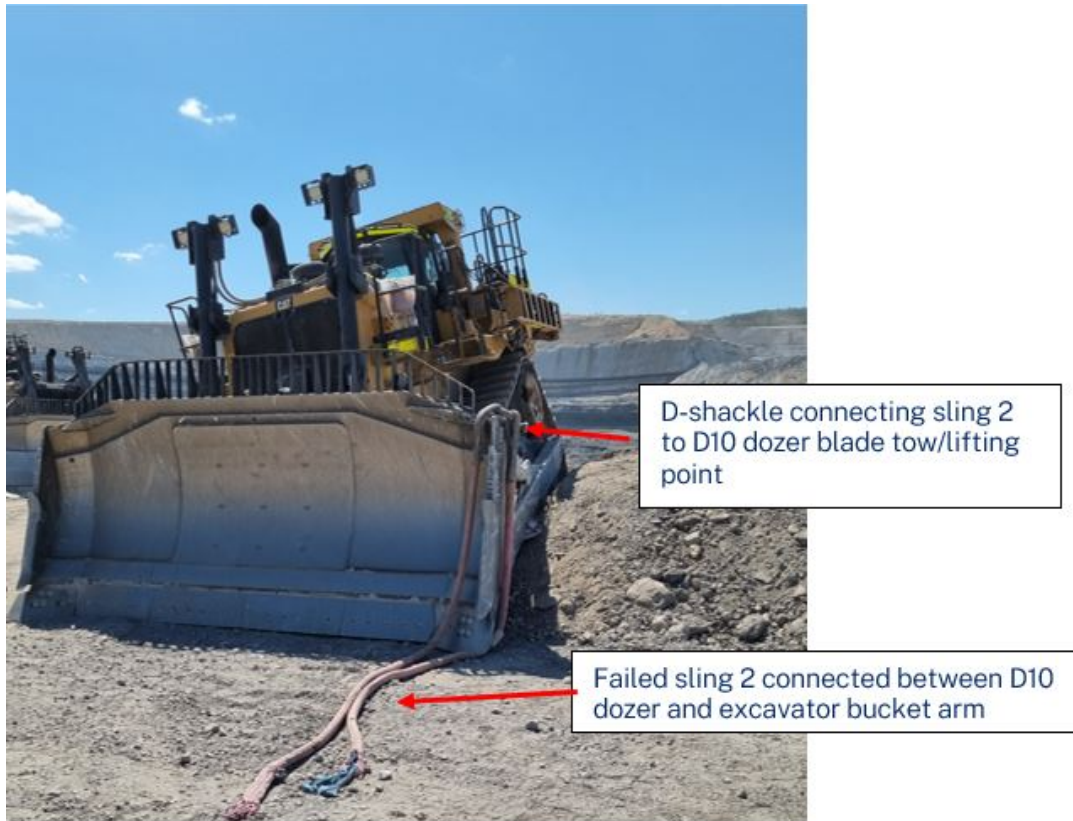
Figure 5: Final location of the D10 dozer after uncontrolled travel down the ramp
