Quarterly safety report

October to December 2022

Title: Quarterly safety report – October to December 2022

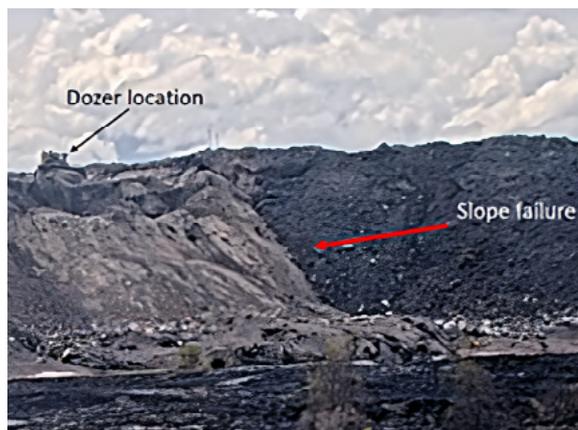
Picture 1.
Slump location.

Dangerous incident | IncNot0043318 – tailings dam slump

Summary: A slump occurred at a tailings dam while a dozer was preparing the area for a remote dozer push. The preparation works included establishing a tip head at the dozer sighter peg line and filling in the void area prior to the sighter pegs.

Comments to industry: Mine operators must have safe systems of work in place to inspect highwalls, low walls and dumps. These inspections must consider weathering effects, ground water and conditions that affect the stability. The adequacy of control measures, including survey controls, should be verified. Operators working in the vicinity of geotechnical hazards should be trained and deemed competent to do so. Refer to Safety Bulletin [SB20-01 Failure of highwalls, low walls and dumps](#)

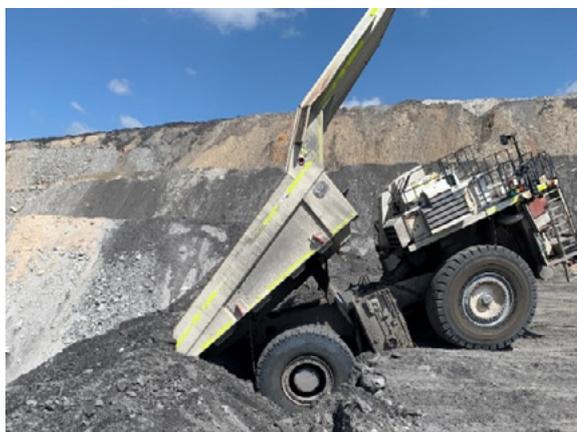
Picture 2.
Rear wheels of dump truck.

Dangerous incident | IncNot0043667 – dump failure

Summary: A haul truck was dumping material when the dump failed and the rear wheels of the truck sank. The body was half raised. Cracking was identified on the dump 14 hours earlier. The dump was cut down as per the mine's trigger action response plan (TARP). The mine was in the process of rebuilding the dump when the failure occurred.

Comments to industry: When conditions warrant a change in TARPs and operating conditions, thorough assessments need to be made before returning to normal operations. Consider the suitability of material when building dumps and when determining if edge dumping or dumping short. All workers should be trained in the use and requirements of relevant TARPs.

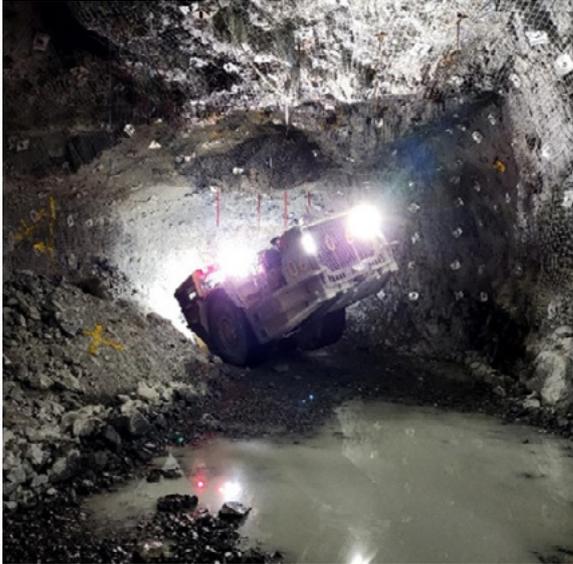
Picture 3.
Loader slumped down.

Summary: A loader was backfilling a stope when fill slumped, causing the loader to slump down on rill at stope edge. The operator escaped without injury.

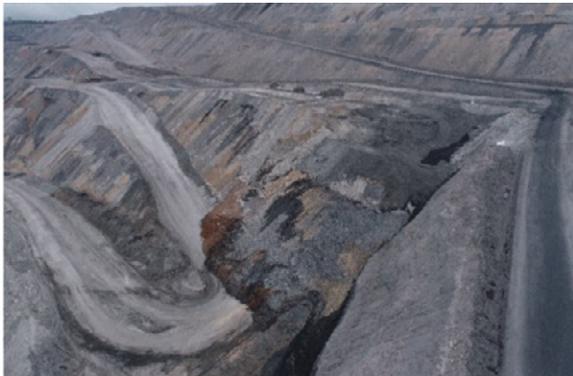
Picture 4.
Slump location.

Summary: A dozer operator noticed minor cracking on a dump and notified their supervisor. The supervisor inspected the area and believed the cracks were associated with reject management at the front of the dump and only affected the current lift (7 m high). A hard barrier was established behind the area and the dozer operator was tasked with cutting down the dump. Later in the shift, the dozer operator noticed movement on the dump and began to reverse. The section of the dump the dozer was on slumped about 10 m. The dozer was unable to exit the dump. The operator raised the emergency. A second dozer cut an access path for the first dozer to safely exit the area.

Comments to industry: When a hazard is identified, workers must not be placed at risk to remediate the hazard. The integrity of waste material and impacts on the mine design must be considered when dumping reject material in the mine.

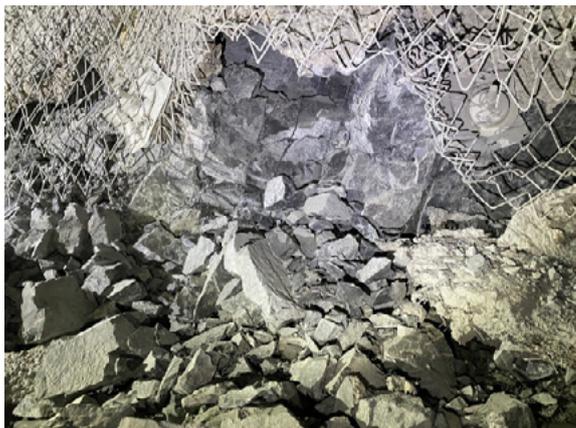
Picture 5.
Rock burst.

Summary: A rock burst occurred in an underground metals mine. A drill rig was working in the area but the operator was not affected. A seismic event with a magnitude of 1.4 was measured at the mine. The mine operator stopped work, barricaded the area and commenced monitoring.

Comments to industry: Mine operators are reminded of the update to the Work Health and Safety (Mines and Petroleum Sites) Regulation 2022 Schedule 1 Section 1(1)(x) where mine operators must consider the risk of rock, coal or related pressure burst as part of the PHMP for Ground and Strata failure.

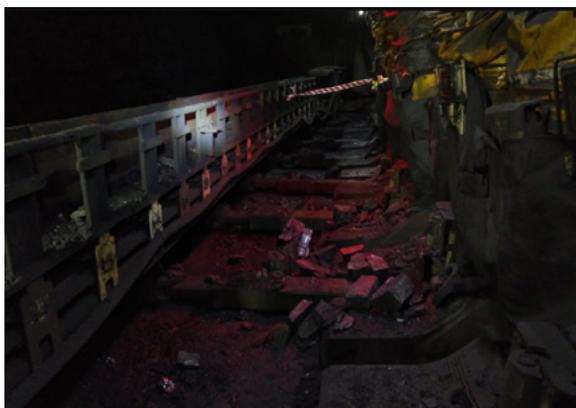
Picture 6.
Fall of coal.

Summary: A slab of coal on the longwall fell forward onto the ranging arm, slid down the arm, spilling over the pan line and struck a worker on the ankle knocking them over. The worker was standing on the front walkway of the roof supports. The shearer was entering the snake in the tailgate. Cutting was done in compliance with the restricted zone limits

Comments to industry: Mine operators should consider flyrock and slabbing strata risks when determining restricted access zones for operators on longwalls. When reviewing controls related to a principal hazard, the impacts from all principal hazards must be considered.

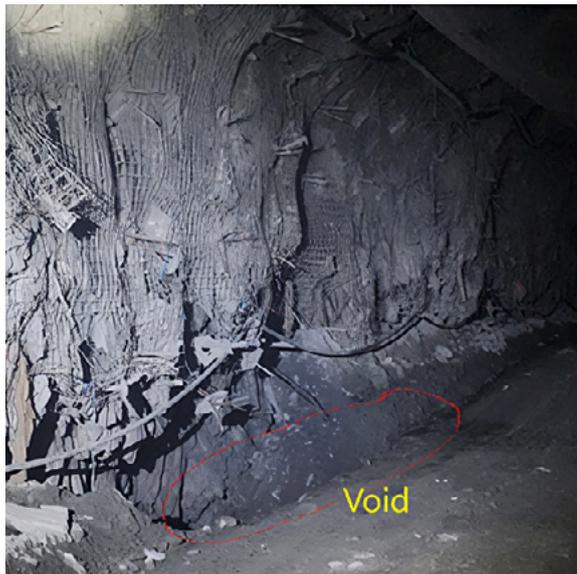
Picture 7.
Void area.

Summary: A loader operator went into the wrong draw point and proceeded to start bogging out in an underground metalliferous mine. While attending a production drill on the level above, a fitter has observed a void in the floor of the drive. The fitter and the production driller retreated from the drive and informed the shift supervisor. The area was then barricaded, and geotechnical assessment planned.

Comments to industry: Mine operators should use higher order controls to prevent inadvertent bogging of rills such as physical barriers.

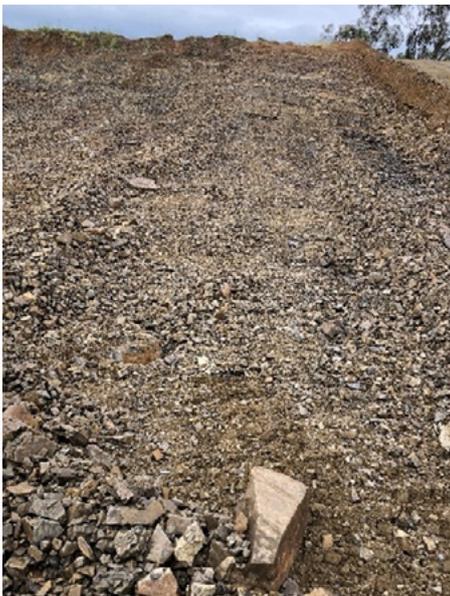
Picture 8.
Terrain at quarry.

Dangerous incident | IncNot0043352 – ATV rollover

Summary: Three teenagers were injured when an all-terrain vehicle rolled in a quarry. The quarry was on private land and there were numerous potential access points. Two of the teenagers were treated for minor injuries and a third suffered severe abdominal injuries after being pinned under the vehicle.

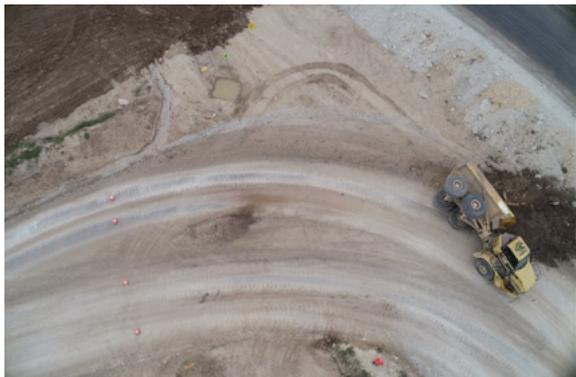
Picture 9.
Scene of incident.

Summary: An articulated dump truck was travelling around a right-hand corner when the rear tyre contacted the middle delineation island and tipped the tub onto its side. The cab remained upright and the operator was not injured.

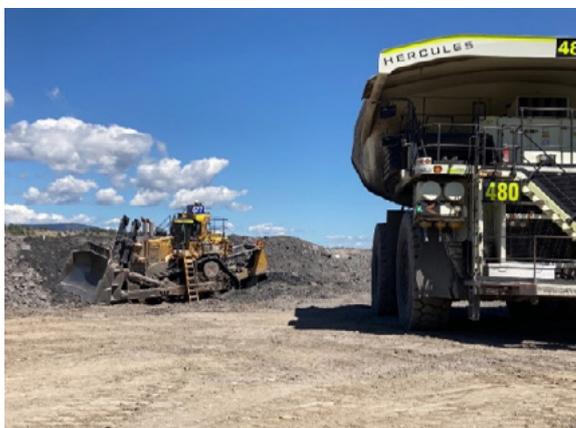
Picture 10.
Damaged dozer.

Summary: A collision occurred between a dozer and a dump truck. The dump truck operator was a trainee with 6 months' experience. On the operator's fourth load, the dozer operator requested the load be dumped at the start of the dump at 45 degrees. The dozer operator was referring to the opposite end of the dump to where the previous loads were dumped. The truck operator proceeded to the previous point and started to reverse at an angle. The dozer operator started to reverse and noticed the rear of the truck as they were about to collide and tried to call the operator to stop. The truck hit the dozer, damaging the dozer's GPS/aerial.

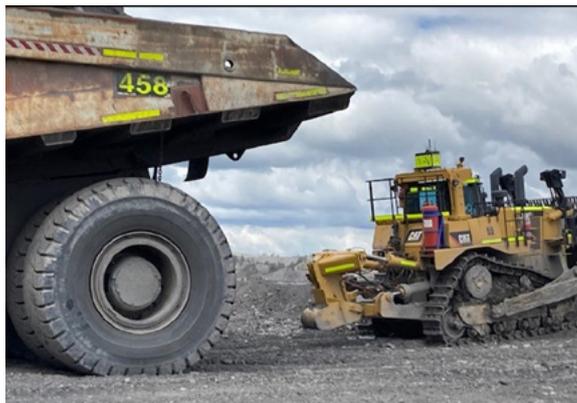
Picture 11.
Truck and dozer.

Summary: A truck operator reversed a dump truck into a dozer on a dump. The dozer was parked in the correct position next to the windrow waiting for the truck to dump. As the dump truck was reversed, the operator lost sight of the dozer and continued to reverse. The position 6 wheel contacted the dozer’s ripper box.

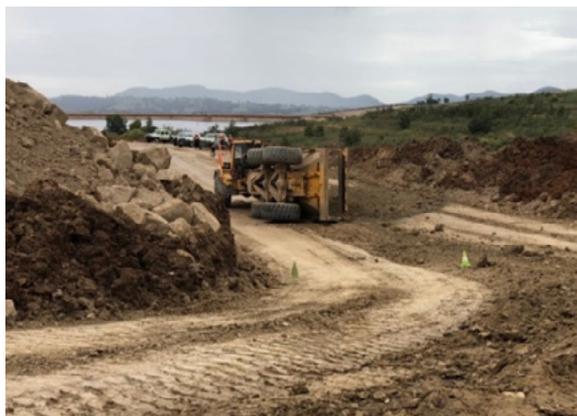
Picture 12.
Trailer rollover with cab remaining upright.

Summary: An articulate dump truck was hauling material to a waste dump. While travelling around a corner, the trailer rolled over. The cabin remained upright and the driver was uninjured.

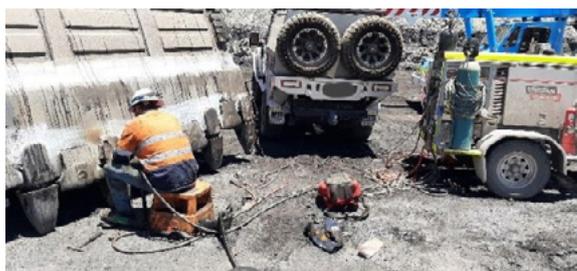
Picture 13.
Light vehicle on site.

Summary: While a boilermaker was repairing the bucket of a large excavator, a light vehicle slowly rolled from its parked location. The vehicle narrowly missed the boilermaker as it rolled. The vehicle was parked for some time before the incident occurred.

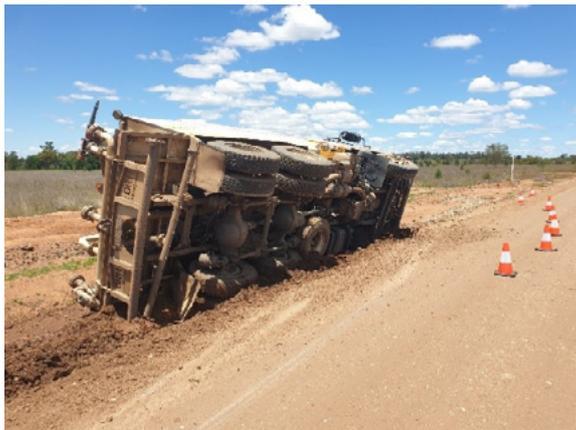
Picture 14.
Water cart rollover.

Summary: A road-registered water cart moved to the edge of the road and hit a soft section, slowly rolling onto the side. The driver was not injured.

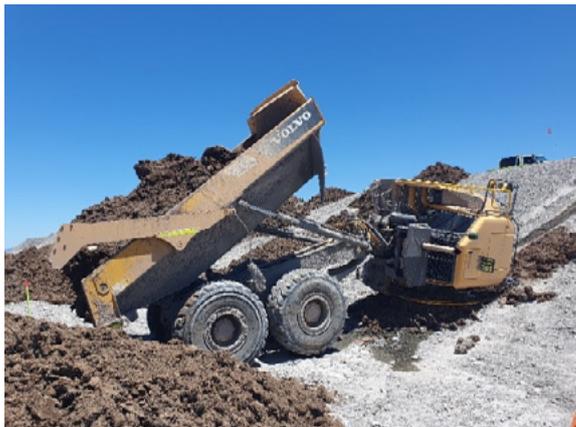
Picture 15.
Cab rollover on articulated truck.

Summary: An articulated truck was being used as part of rehabilitation works hauling topsoil. While unloading on a grade, the cab rolled and the tub stayed upright. The operator was uninjured but required assistance to exit the cab.

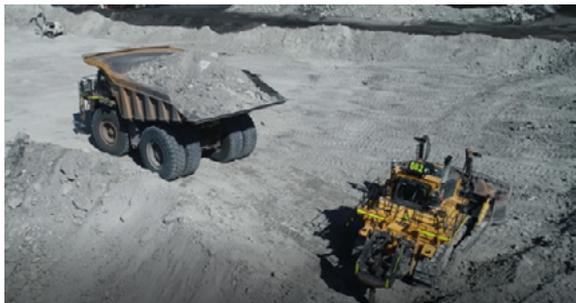
Picture 16.
Haul truck and dozer.

Summary: A haul truck was reversing at a tip head where it reversed into a dozer, making contact with the rollover protective structure (ROPS).

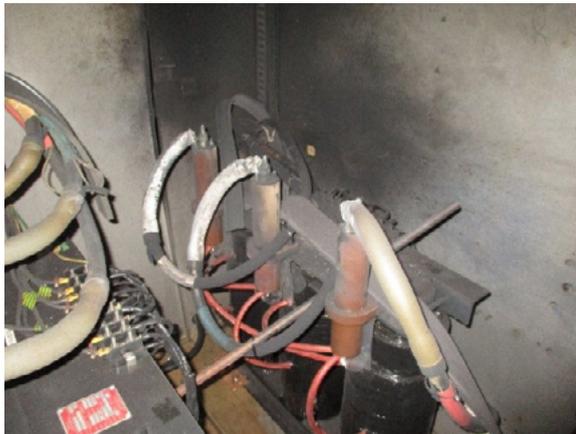
Picture 17.
Result of arc fault.

Summary: An underground coal mine was restoring power following a disturbance on the incoming supply. The supply was restored to an underground distribution board and all 4 outlets had been powered for several minutes. A hissing sound lasted for 5-10 seconds. An arc fault then occurred. The arc front propagated from the enclosure to the PLC cabinet and then external to the enclosure. The surface substation tripped. Four nearby workers suffered discomfort and ringing in the ears, several reported a blocked ear sensation.

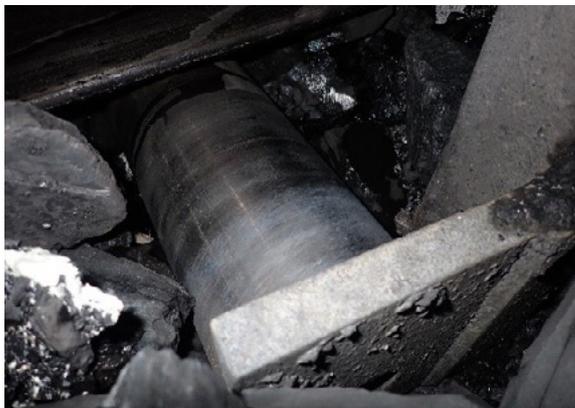
Picture 18.
Result of boot end fire.

Summary: A small fire occurred at the outbye end of a longwall boot end. Workers on the face smelled smoke and found a flame about 100 mm in height. The fire was on a fist-size lump of coal. The longwall had been stationary for 24 hours due to strata issues. Five metres of structure had been removed and the boot end raised to full height to maintain clearance. Material spalled from the off-walk side rib under the belt. Over time, the boot end lowered due to creeping hydraulic cylinders. This gradually lowered the belt to the point where it was making contact with spalled material.

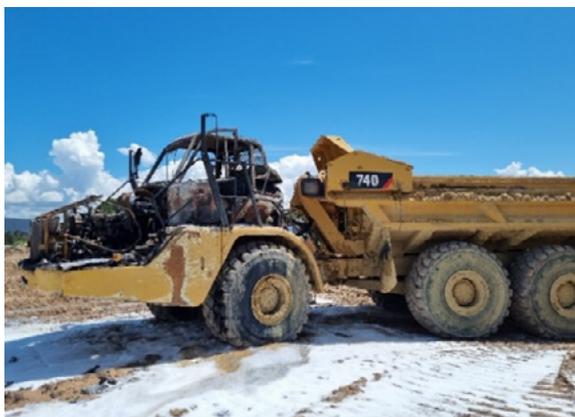
Picture 19.
Engine bay and cabin damage.

Summary: A worker in a quarry was driving an articulated dump truck when the operator noticed smoke coming from the engine bay. The worker stopped and opened the engine bay and it burst into flames. He activated the onboard fire suppression, but this failed to extinguish the fire. The local fire brigade sent several units to respond to the fire. The engine bay and cabin were destroyed. There were no injuries. Due to the extent of the damage, a cause has not been identified.

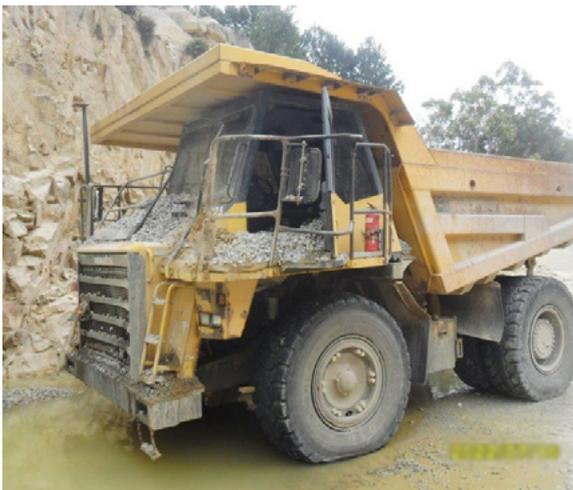
Picture 20.
Damaged dump truck.

Dangerous incident | IncNot0043131 – failure of silo

Summary: While loading a dump truck from a silo, the driver noticed there was material coming out of the silo near the top of the cone. The driver closed the clam shells and drove out from under the bin. In order to open the clam shells to empty the bin, the truck driver positioned the truck to the bin to have access to the clam shell controls from the truck's platform. The driver then opened the clam shell slightly. As the truck driver returned to the cabin and started to reverse, the silo failed and material rilled over the front of the truck smashing its windscreen. The operator was uninjured.
