# Weekly incident summary

## Week ending 10 February 2023

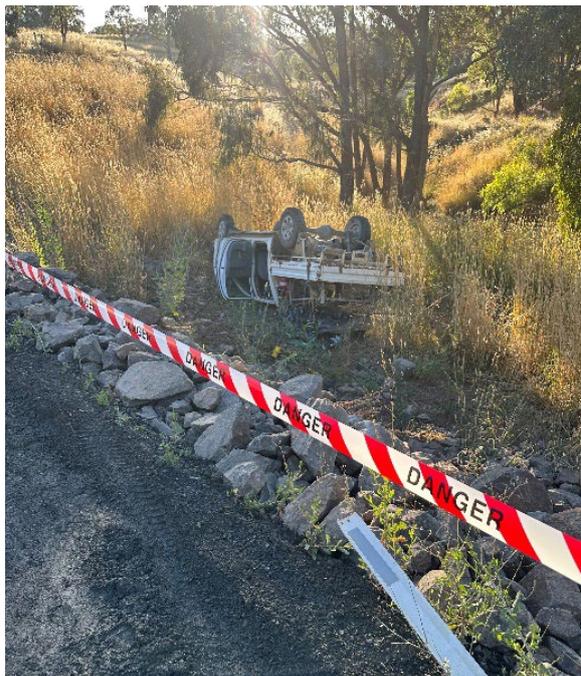
| Incident type | Summary | Comments to industry |
|---|--|---|
| Dangerous incident<br>IncNot0044036<br>Open cut coal mine<br>Roads or other vehicle operating areas | A light vehicle was travelling along an access road at 3.40am when the vehicle left the road and rolled. It is believed that the operator had a fatigue event. The worker exited the vehicle without injury. | Workers must present as fit-for-work. Fatigue and fitness for work must be managed in accordance with the mine’s health control plan. This includes ensuring workers show up to work with adequate sleep and are free of alcohol and drugs. Adequate fatigue breaks should be built into shift patterns and work plans.<br><br>Mine operators should review that adequate windrows are in place where vehicles are at risk of driving over embankments. This should be consistent with the mine’s roads and other vehicle operating areas – principal hazard management plan. |
