Weekly incident summary

Week ending 10 February 2023

Weekly incident summary week ending 17 February 2023

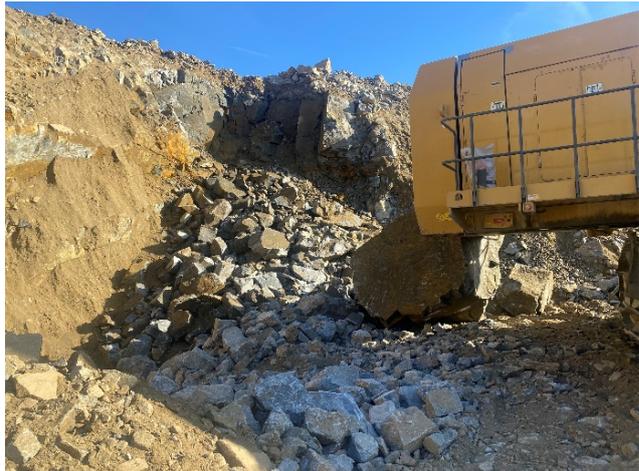
Incident type	Summary	Comments to industry
Dangerous incident IncNot0044101 Construction materials Ground or strata failure

A large excavator was loading a mobile crusher on the pit floor when an 2-3 tonne stone fell from the face and hit the counterweight of the excavator. The operator was not injured.

Wall design (mine planning) must consider slip planes, hydrology and other environmental factors that may reduce high wall integrity. Blast designs must be reviewed and changed when the correct fragmentation is not being achieved. Dig faces must not be undercut when large material is present in the face. This practice exposes workers and equipment to unnecessary risk.

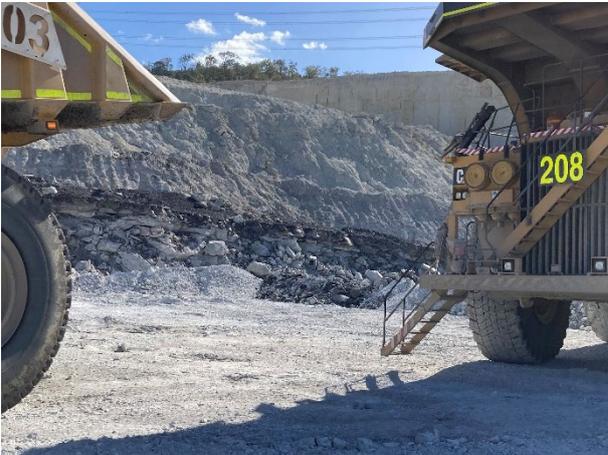
Incident type	Summary	Comments to industry
<p>Dangerous incident IncNot0044100 Open cut coal mine Roads or other vehicle operating areas</p>

<p>The operator of a haul truck was trying to park next to a parked haul truck. The operator misjudged and the rear left of the tray hit the front right tray of the truck.</p>

<p>Equipment operators must check their surroundings before parking. Workers must ensure the correct separation distance between equipment is applied when parking and not rush to park up for breaks or shift end.</p> <p>Park-up areas should be designed and constructed to drive through to prevent reverse parking and have adequate lighting and demarcation.</p>
<p>Dangerous incident IncNot0044093 Construction materials</p>	<p>A contract boilermaker felt a tingle while using a portable 240 volt welder. He was using the welder during muggy conditions and attributed the shock to sweat.</p> <p>He was taken to hospital for an ECG and cleared of injury.</p>
