# Weekly incident summary

## Week ending 17 March 2023

Document control	
CM9 reference	RDOC23/72972
Mine safety reference	ISR23-12
Date published	24 March 2023
Authorised by	Deputy Chief Inspector Office of the Chief Inspector

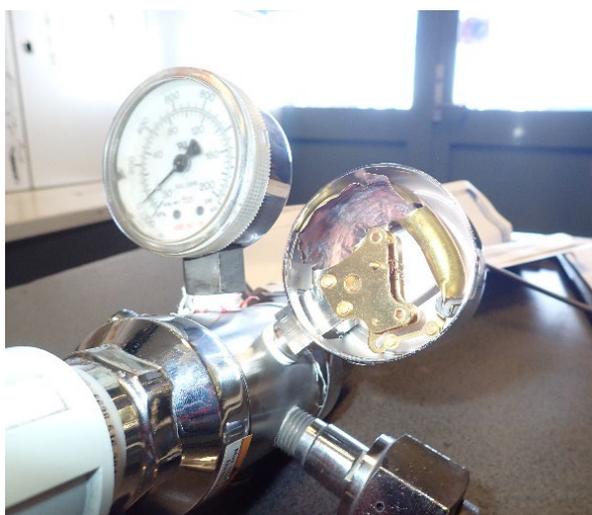
Incident type	Summary	Comments to industry
Dangerous incident IncNot0044301 Underground coal mine	A control room operator changed a pressure gauge on a regulator fitted to a nitrogen bottle. When pressure was applied, the gauge failed and burst. A piece that was ejected grazed the worker's jaw. The bottle contained nitrogen at 200 bar. The installed gauge was rated to 200psi (14 bar).	Workers must ensure any component being changed out is like-for-like. Where like-for-like components are not available, alternatives must undergo a thorough assessment to ensure the replacement is suitable and without risk.  Work involving pressurised systems and components must only be carried out by workers who are competent, trained and appointed.

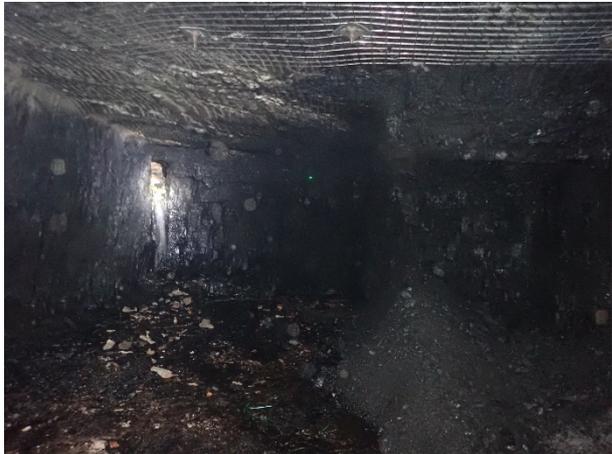
<p>While mining in a development panel, a continuous miner exposed a fault-related void that contained water. The water entered the working face. The inflow of water slowed significant by the end of the shift.</p>

<p>Mine operators should review their procedures for advancing towards a known geological structure to ensure the presence of gas and/or water has been considered and controls are in place.</p> <p>Mine operators should then consider what equipment is required to have on standby.</p>

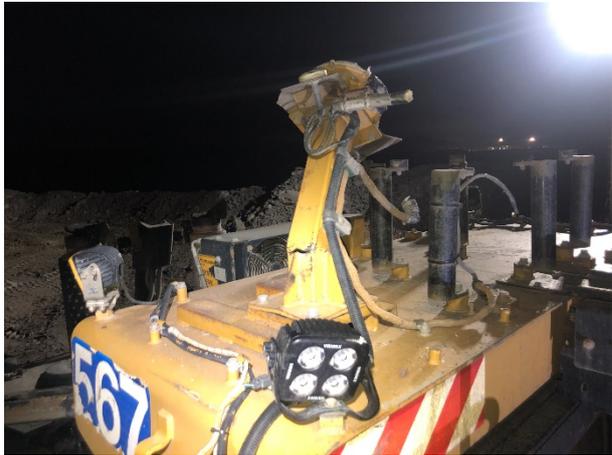
<p>On night shift, a haul truck entered a dump and lost sight of a dozer when it was reversing. The truck was positioned between a lighting tower and the dozer, casting a shadow over the dozer.</p> <p>The truck did not feel any contact so the operator drove out to re-set, reversed in and dumped. The dozer operator called to stop the truck. The worker was uninjured.</p>

<p>Mine operators should review dump procedures and consider segregation or bunded areas for dozers.</p> <p>Lighting plants must be positioned to avoid glare and shadowing work areas. When workers identify hazards for inadequacy with lighting in their work area, they should immediately report this to their supervisor.</p>
