# Weekly incident summary

## Week ending 7 April 2023

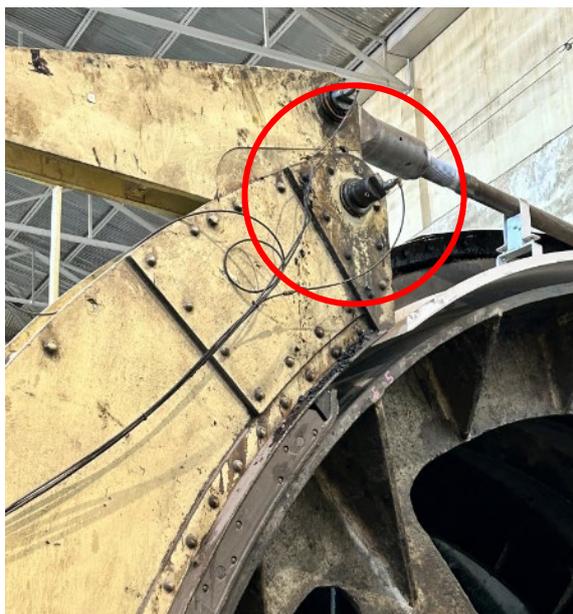
Incident type	Summary	Comments to industry
Dangerous incident IncNot0044421 Underground metal mine Mine shafts and winding systems	During a walk around inspection of a man-riding shaft winder, it was noticed that an upper brake calliper pin had worked its way out about half the length of the pin. The split pin and retaining washer were missing. The opposite side calliper was still intact.	Mines that operate winders should review maintenance inspection and testing schemes, including pre-use inspections, to ensure components related to safety-critical functions such as brakes are fit to operate.

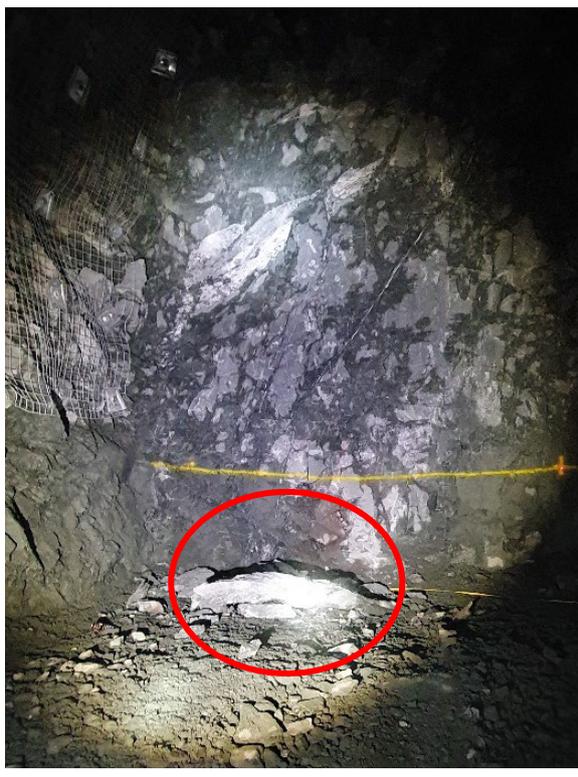
<p data-bbox="397 672 1011 824">A Jumbo operator and an offsider were marking up a development face. A piece of stone fell from the face and struck the Jumbo operator on the back of the head and shoulder.</p> <p data-bbox="397 828 1011 1003">The offsider helped get the Jumbo operator back from the face and rendered first aid. The injured worker was transported to hospital via ambulance where the laceration was stitched, and scans cleared the worker of any fractures.</p>

<p data-bbox="1035 672 1461 1048">Mine operators should review their risk assessments and principal hazard management plans for ground and strata to ensure that controls are identified and implemented to prevent rocks falling from development faces that could cause serious injury or kill mine workers. Controls should be focussed on the engineering level or higher.</p> <p data-bbox="1035 1052 1461 1227">The use of engineering controls to manage the risks at a development face are widely used across the underground hard rock industry.</p>
