Weekly incident summary

Week ending 21 April 2023

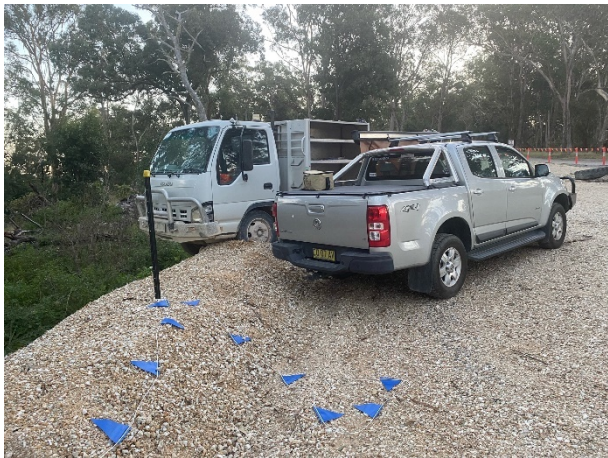
Incident type	Summary	Comments to industry
Dangerous incident IncNot0044531 Construction materials Roads or other vehicle operating areas	<p>A man was driving a light-rigid truck and parked in a car park in front of their private vehicle. The truck driver left the truck, which started to roll forward. The driver unsuccessfully tried to get back into the truck and as he tried to jump away, he slipped and the outside rear wheel ran over his ankle.</p> <p>The truck rolled forward hitting his own vehicle and stopped on a bund. He was cleared of any fractures and only suffered minor grazing.</p>

<p><u><i>The Work Health and Safety Act 2011 Section 28</i></u> requires workers to take reasonable care of their own health and safety and not affect the health and safety of others at work.</p> <p>Workers must also comply with reasonable instructions and procedures of the workplace. Parking fundamentally stable before exiting a vehicle is a reasonable instruction or procedure.</p>

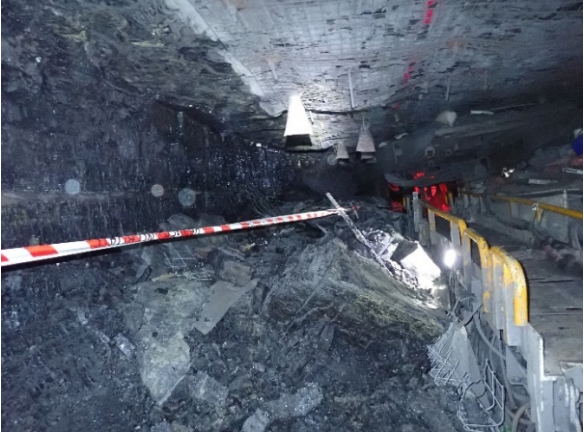
<p data-bbox="113 1368 371 1592"> Dangerous incident IncNot0044502 Underground coal mine Ground or strata failure </p>

<p data-bbox="411 1368 1018 1547"> A fall of rib occurred adjacent to a crusher. The fall was about 13 metres long, 2 metres high and a metre deep. The mine operator had recognised that changes were required to strata support requirements, but failed to upgrade the support in this area before the longwall retreated. </p>

<p data-bbox="1018 1368 1481 1559"> When strata support designs change, mine operators should re-assess areas already supported to ensure the adequacy of existing strata support. </p>

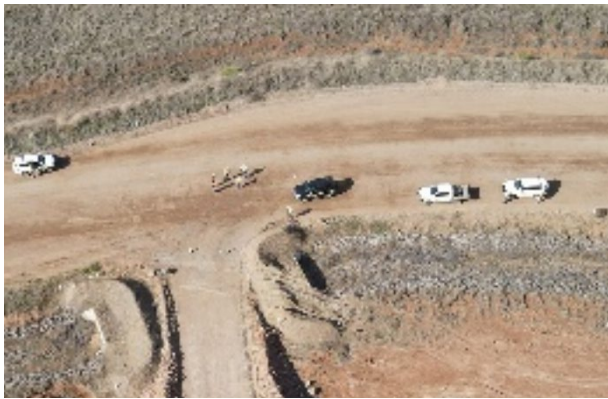
Incident type	Summary	Comments to industry
Dangerous incident IncNot0044501 Underground metal mine Roads or other vehicle operating areas	<p>A worker driving a haul truck had a micro-sleep. The truck went through a bund, crossed an intersection and then through another bund. The truck narrowly missed driving off the headwall of a culvert. There were no other vehicles in the intersection.</p> <p>The operator was not injured. The worker continued driving and later reported the incident.</p>

<p>Mine operators should conduct a review of haul road windrows design to confirm the size of the windrow is appropriate for the size of the vehicles operating on that road.</p> <p>Mine operators should also confirm that contractors have a fatigue management plan, and that fatigue is included in the health control plan.</p> <p>Refer to our website on the health control plan (here) and the Fatigue Management Guide</p>
