Weekly incident summary

Week ending 4 August 2023

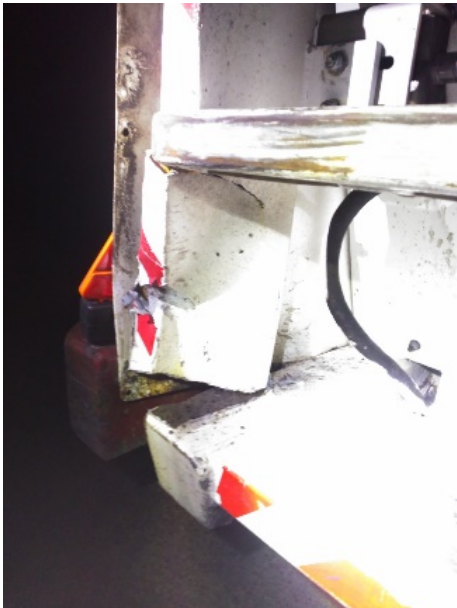
Incident type	Summary	Comments to industry
<p>Dangerous incident IncNot0045147 Underground coal mine Roads or other vehicle operating areas</p>

<p>A personnel transporter carrying a full load of passengers was stopped to allow a load haul dump (LHD) to pass in the drift. As the LHD passed the transport, the pod being carried by the LHD clipped the rear of the personnel transporter. The incident resulted in minor injuries to one of the passengers.</p>

<p>Mine operators should review their procedures for vehicles passing in an underground roadway.</p> <p>Workers must ensure safe clearances can be maintained when passing in underground roadways. Where clearances cannot be maintained, shunting procedures must be followed.</p>

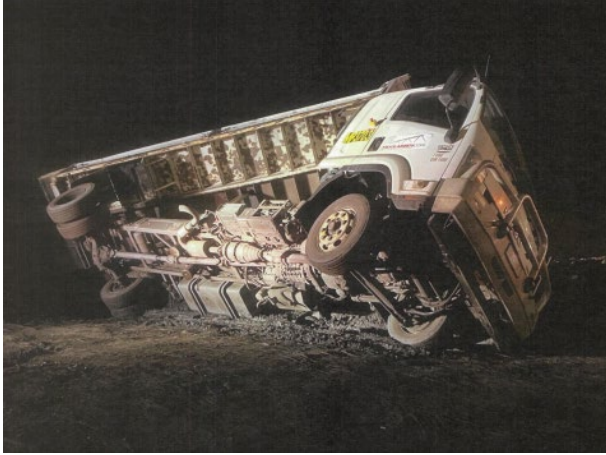
Incident type	Summary	Comments to industry
<p>Dangerous incident IncNot0045171 Underground coal mine Roads or other vehicle operating areas</p>

<p>A road-registered 10 tonne tipper truck had a partial, slow 45 degree rollover because of washery spillage material hanging up in the tray. Two people in the truck were able to escape from the cabin onto another vehicle.</p>

<p>Mine operators should consider the most appropriate truck type for the material being transported. Workers should monitor for material hang up and should report unsafe conditions to their supervisor.</p>
<p>Dangerous incident IncNot0045178 Open cut coal mine Roads or other vehicle operating areas</p>

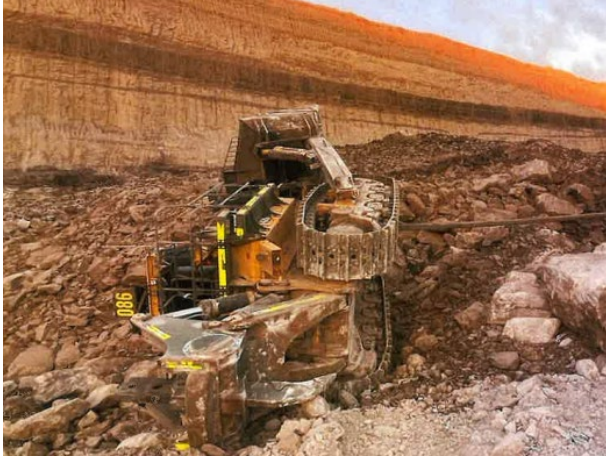
<p>A dozer rolled onto its side while working to push material to an excavator on a double bench. The dozer became destabilised when one of its tracks ran over a large boulder and the machine tipped onto its side. The operator was uninjured and was able to remove himself from the machine.</p>

<p>Pre-task inspections of work areas should be undertaken to identify and manage the hazards present. This should include confirming lighting is adequate for the tasks being conducted in the area.</p> <p>Dozer operators need to remain situationally aware while the dozer is in motion and continually assess the work area for hazards.</p> <p>Pre-task inspections of work areas must be monitored and confirmed by supervisors.</p> <p>Refer to safety bulletins: SB19-01 Rise in dozer incident putting operators at risk SB19-10 Dozer incidents increase despite warnings</p>
