Safety Alert

Date: October 2023

Conveyor tail pulley fire

Safety Alert SA23-03

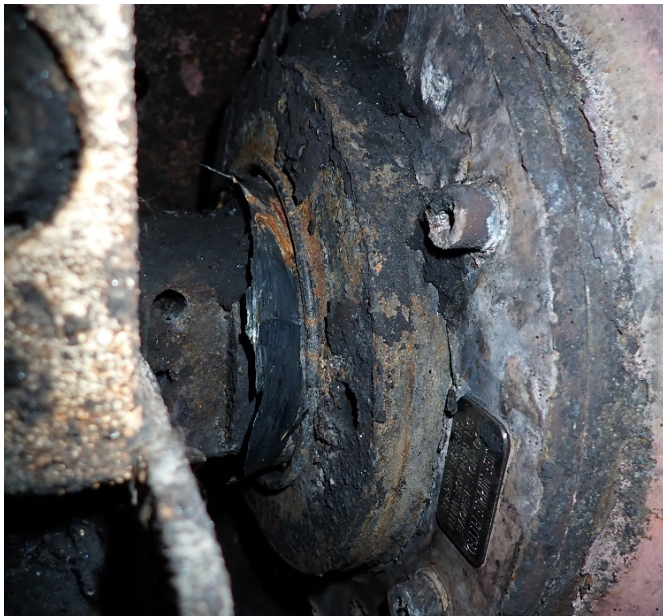
Figure 1: Failed tail pulley bearing

The mine determined the fire was caused by a failed tail pulley bearing. The 2 tail pulley bearings were monitored by resistance temperature detectors (RTDs). Tail pulley bearing temperature trending was available through the mine's monitoring system.

The grease used in the bearing had a melting point of 180°C and a flash point of 230°C.

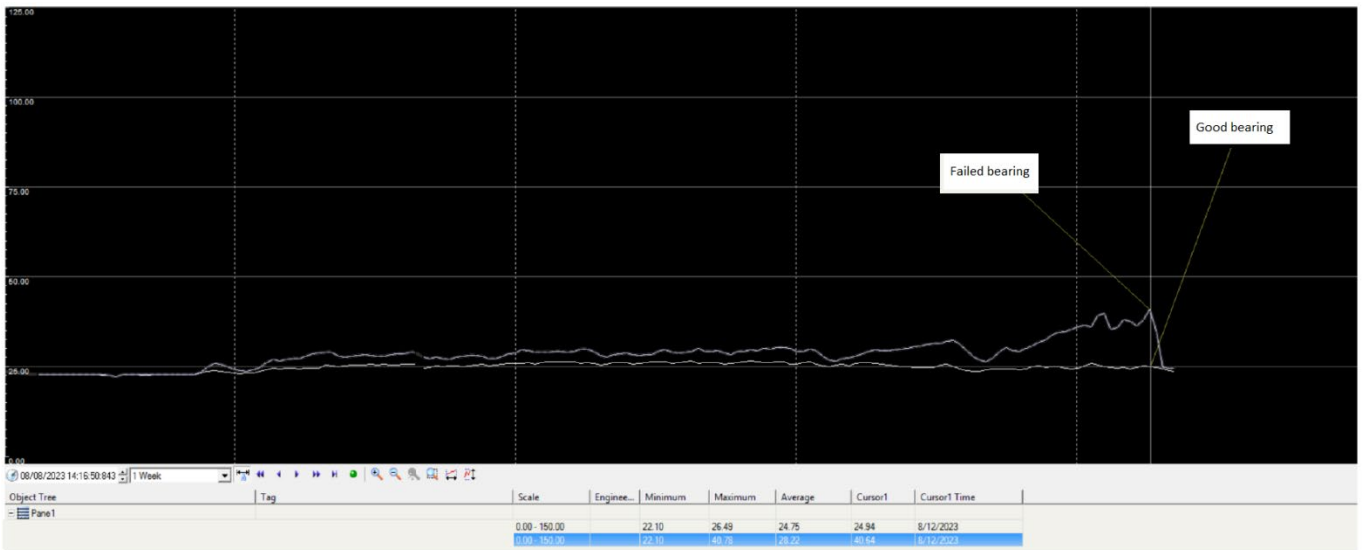
The recorded temperature of the bearing involved in the incident rose to about 41°C compared with the recorded temperature of the opposite pulley bearing that remained relatively steady about 25°C. The monitoring system was set to alarm when bearing temperature reached 65°C.

1. The design length of the RTDs monitoring the tail pulley bearing temperatures was 450 mm. The RTDs installed in the tail pulley assembly were only 290 mm, meaning that the measured temperature may not have reflected the actual bearing temperature.
2. The tail pulley bearing temperatures were monitored independently. Differential temperature monitoring of pulley bearings was the established standard at the mine but was not in place for the longwall tail pulley.

Monitoring records for the tail pulley involved in the incident revealed bearing temperature divergence began several days before the incident. An alarm setting of 10°C differential temperature (for example), would have provided several hours warning of the failure.

Figure 2: Bearing temperature monitoring for the week prior to the incident

- establish systems to verify that devices provided to manage fire risks detect, alarm and trip in accordance with equipment specifications.
- ensure that monitoring systems are installed and operated to manage fire risk as described in the mine’s safety management system.
- ensure monitoring data is readily available to enable the identification of emerging hazards.
