# Weekly incident summary

## Week ending 13 October 2023

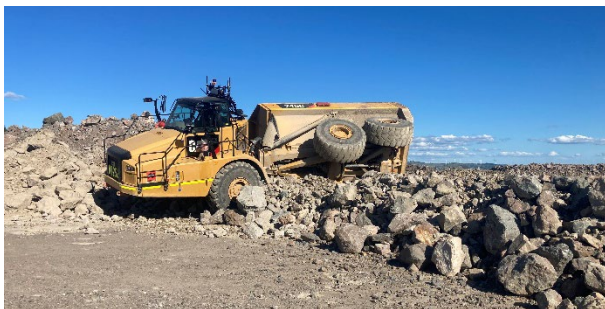
Incident type	Summary	Comments to industry
Dangerous incident IncNot0045563 Underground metals mine	<p>A worker was driving an articulated dump truck when they reached for a drink bottle. The truck hit a windrow, rode over the windrow and the tub rolled.</p>

<p>When operating mobile plant, workers must remain focused on controlling the item of plant and their surroundings. Mobile plant should be safely stopped before carrying out tasks that remove the focus from safely operating plant.</p>
