Safety Bulletin

Date: November 2023

Incidents show poor response to tyre fires on heavy earth moving machinery

Safety Bulletin SB23-09

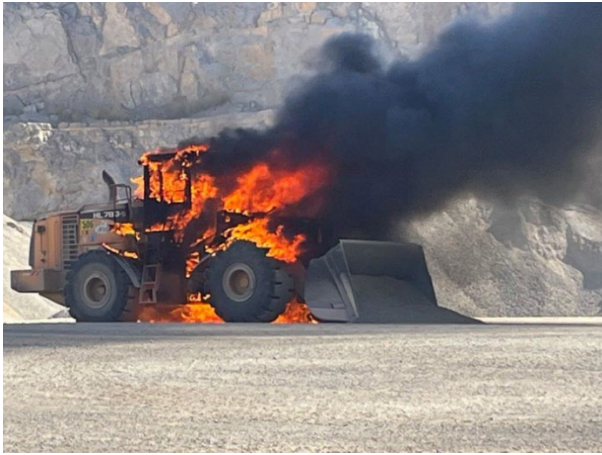
Figure 1: Hyundai 780-9HL loader fire

A front-end loader was operating at the tip face of an open cut mine when operators noticed a loss of power. Subsequently, a fire started on the machine.

Regulator inspectors found the mine did not have a good working knowledge of the risks associated with heavy machinery tyres when exposed to heat and fire conditions.

Because of this, the response to the incident involved staff entering an area that should have been declared an exclusion zone for worker safety. The mine did not implement its emergency procedures/plan adequately.

The mine operator's training and response plans did not identify or control the risks of a tyre explosion because of fire or heat. Although eventual exclusion zones were established, they were primarily for investigation and HAZMAT purposes.

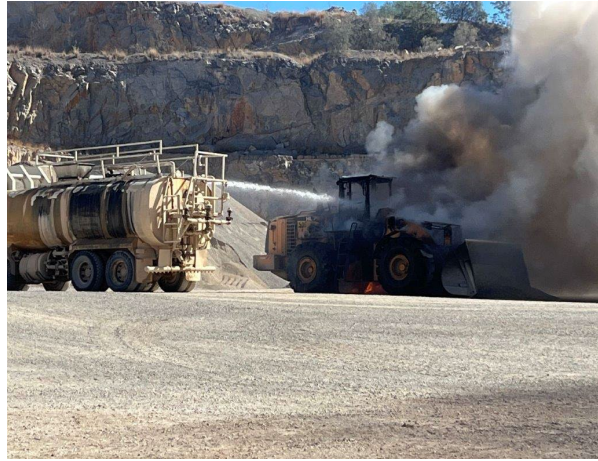
Figure 2: Hyundai 780-9HL loader fire

Multiple staff members including watercart operators entered the exclusion zone to take photos, monitor or conduct firefighting operations. Figure 2 shows the watercart parallel to the loader and within the hazardous zone.

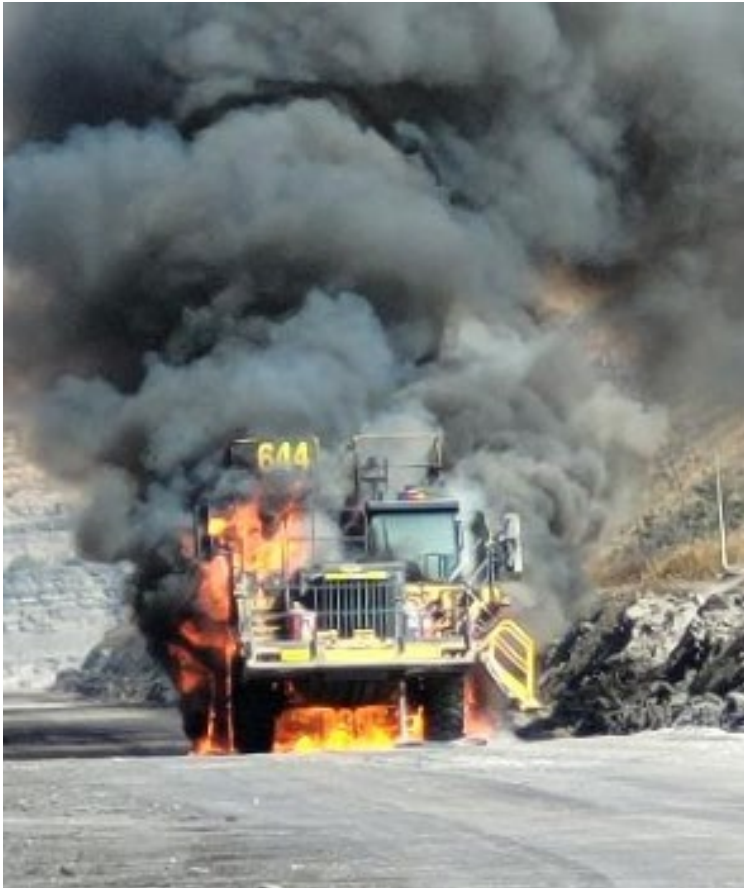
Figure 3: Caterpillar 773F service cart fire

A fire on a broken down service cart that was being towed occurred, as part of a recovery operation at an open cut coal mine. The mine operator called an emergency, attempted initial firefighting operations, removed exposures from the vicinity and then withdrew and placed an exclusion zone around the fuel cart of 300 metre for 24 hours.

No additional people were placed at risk and the potential danger was mitigated.

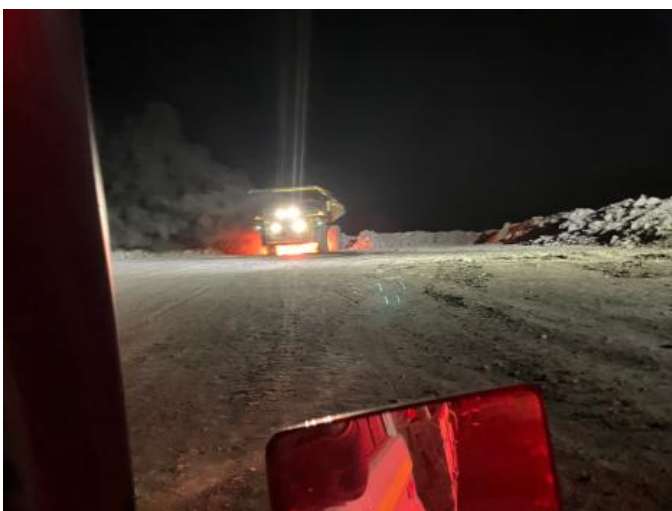
Figure 4: Komatsu 830E dump truck fire

A rear dump truck was being operated at a dump on an open cut coal mine. The truck caught on fire while on the dump and flames quickly engulfed the cabin. Fast notification from a nearby dozer operator and calm instructions enabled the trainee operator to exit the vehicle unharmed.

An emergency was called and response teams with watercarts attended the scene and extinguished the fire. The cabin-operated fire suppression system was not successfully initiated by the operator.

The dangers of hot tyre fires were not initially considered within the emergency response, and watercarts tried to extinguish the fire in close proximity to the tyres in a forward-facing orientation. Once the risk of tyre fires was communicated, watercarts approached the dump truck in reverse at 45-degree angles, still inside the exclusion zone.

The mine operator had thermal imaging temperature monitoring available, but it was not used for throughout the response phase of the incident. A supervisor activated the external fire suppression on the truck's bumper after approximately 42 minutes after the fire began, placing themselves in close proximity to the hot tyres.

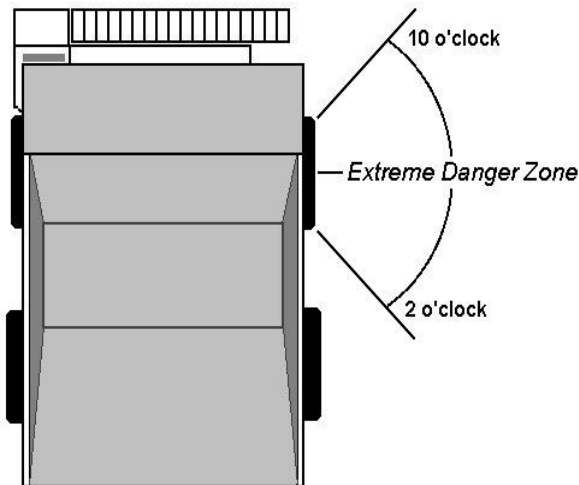
Figure 5: Designated extreme danger zone

Operators should be trained and familiar with the safest evacuation routes off their vehicles if they catch on fire. These procedures should avoid the designated extreme danger zone as shown in Figure 5.
