# Weekly incident summary

## Week ending 10 November 2023

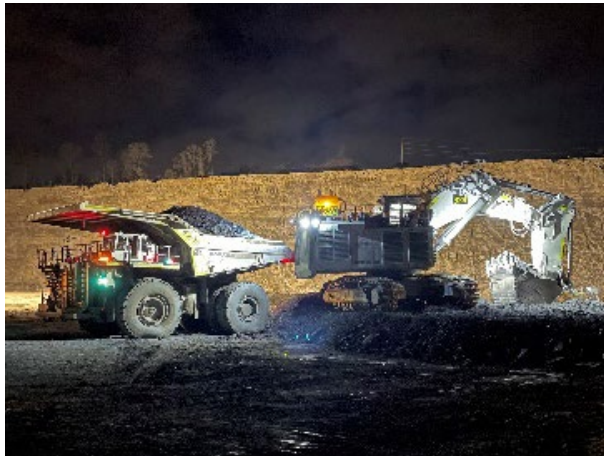
Incident type	Summary	Comments to industry
Dangerous incident IncNot0045758 Open cut coal Roads or other vehicle operating areas	A haul truck was loaded by an excavator and kicked out. The truck driver did not hear the horn. Before the truck drove away the excavator started to reposition. In the process, the excavator counterweight hit the dovetail of the tray. No workers were injured.	Excavator operators must remain situationally aware and ensure that loaded trucks have left the swing radius of the excavator before manoeuvring for the next load.  Visual confirmation of truck departure should be established instead of relying on soft controls such as lights and horns and assuming the truck has moved away.

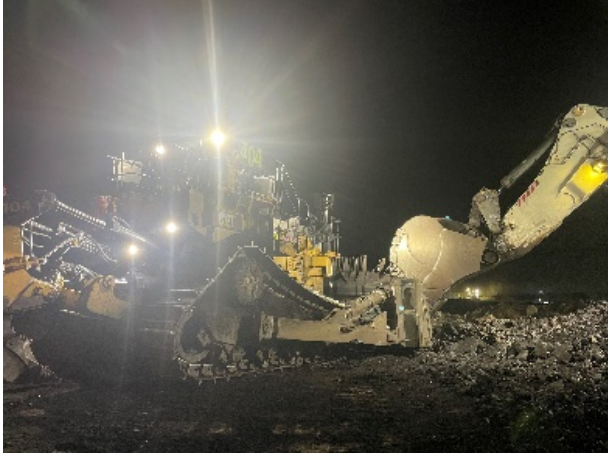
Incident type	Summary	Comments to industry
Dangerous incident IncNot0045793 Open cut coal Roads or other vehicle operating areas

A dozer was hit by an excavator bucket while the excavator was slewing for a bucket of coal. The dozer was too close to the swing radius of the excavator and when activating the steer clutch went the wrong way.

Dozer drivers should maintain a sufficient buffer between their machine and the swing radius of an operating excavator.  Clear and specific procedures must be in place for when dozers are cleaning up within the swing radius.  Dozers should not try to work close to the edge of the swing radius and should at all times remain aware of the demarcation area.
